BLUE BIRD

R11TA

## Starter Cable May Contact Power Steering Hose

**Models Affected: 2004 through 2006 Model Year "Vision"**

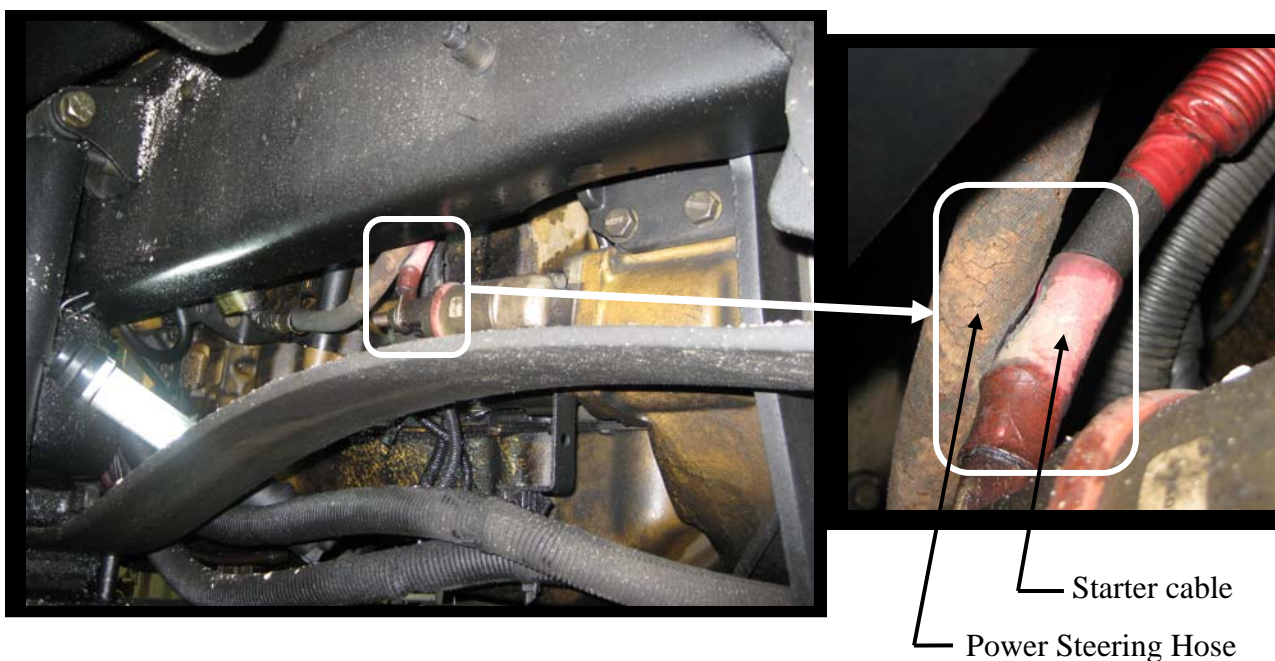
The starter cable may contact and potentially chafe against the steel braided power steering hose thereby creating a direct short which could result in a fire.

1. Park the bus on a level surface, apply parking brake, and remove ignition key and chock wheels.
2. Disconnect Batteries: Note when disconnecting the batteries, remove the Negative cable first.
3. On lower left side (driver's) of engine; inspect the positive starter cable and power steering hose for possible contact as shown below.

4. If the starter cable has contacted the power steering hose, separate and inspect both for any possible damage. If either has been damaged, contact Blue Bird Recall Administrator for a replacement.
5. If there is no contact and a minimum of one (1) inch clearance between the starter cable and power steering hose, no further action is required.
6. If there less than one (1) inch clearance, install a dual swivel saddle mount and two cables ties between the power steering hose and starter cable and secure with two cable ties.

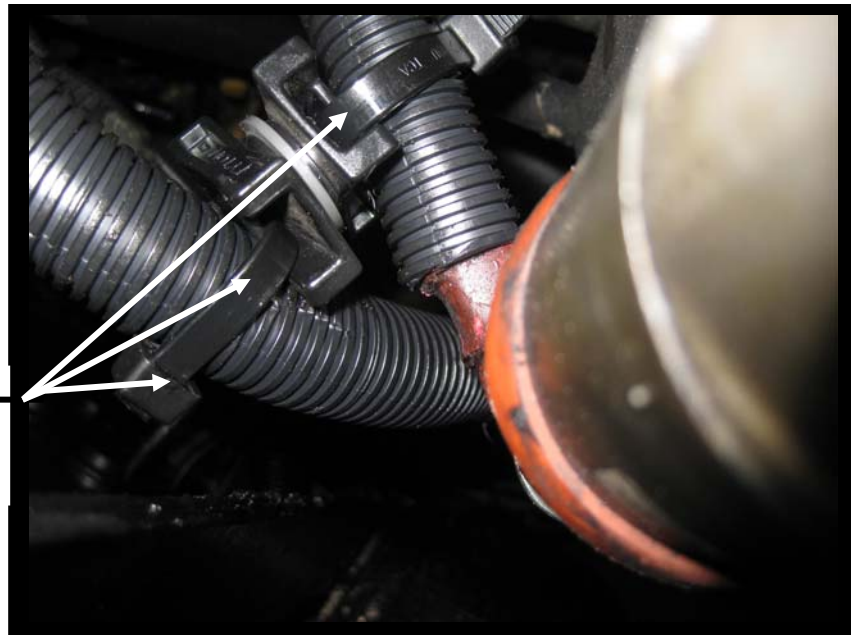
Install dual swivel saddle mount and cable ties.
