SAFETY RECALL NOTICE

Remote Control Replacement Instructions For BF6000, BF6000*, DF2603, NNF5500

How to identify recalled plug-in remote control receivers:

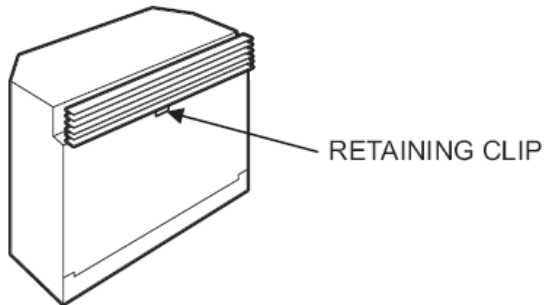
- a) Remove retaining clip using a slot screwdriver

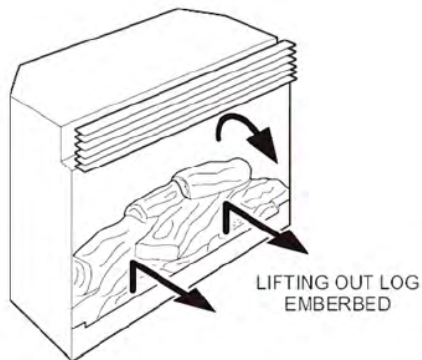
- c) Remove log set

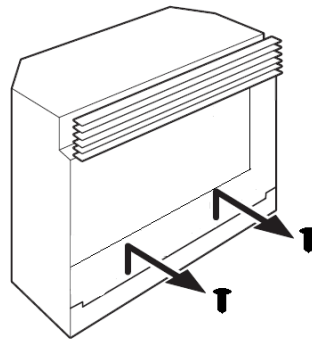
- d) Remove the screws that fasten the bottom of the fireplace to the floor.

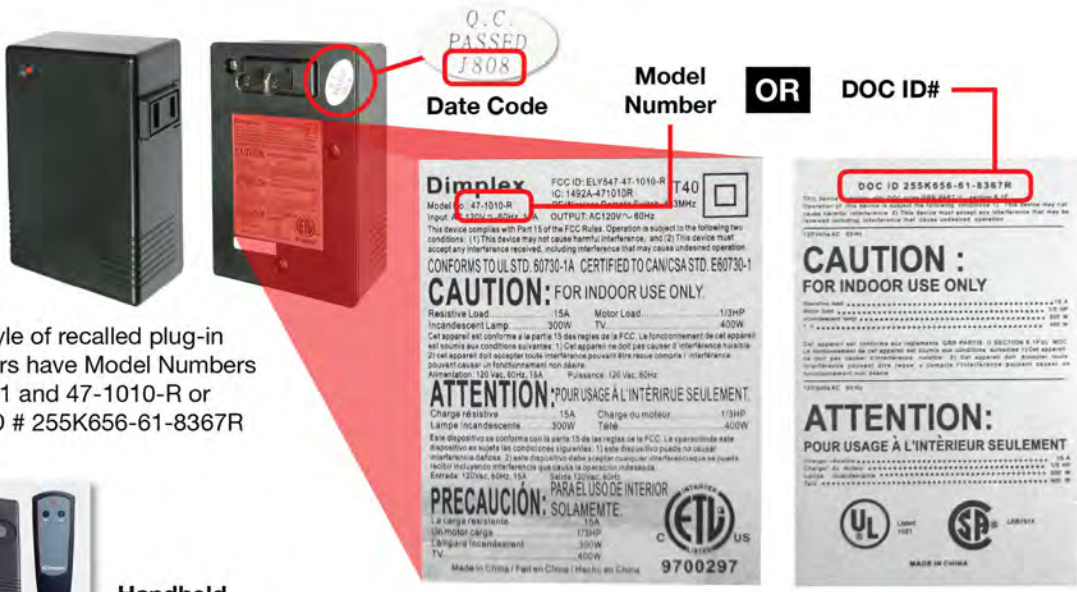
This style of recalled plug-in receivers have Model Numbers 47-1001 and 47-1010-R or DOC ID # 255K656-61-8367R

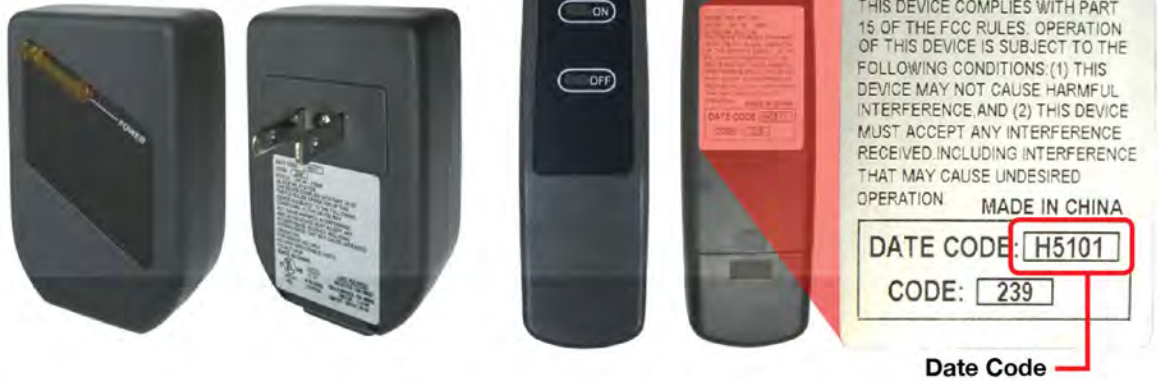
This style of recalled plug-in receiver has Model Number APT-1315
