IDENTIFICATION OF DEFECTIVE CONTROL ARM ASSEMBLIES

Duralast® Brand Control Arm Assembly Recall: FA4510X, FA4611X & 10946

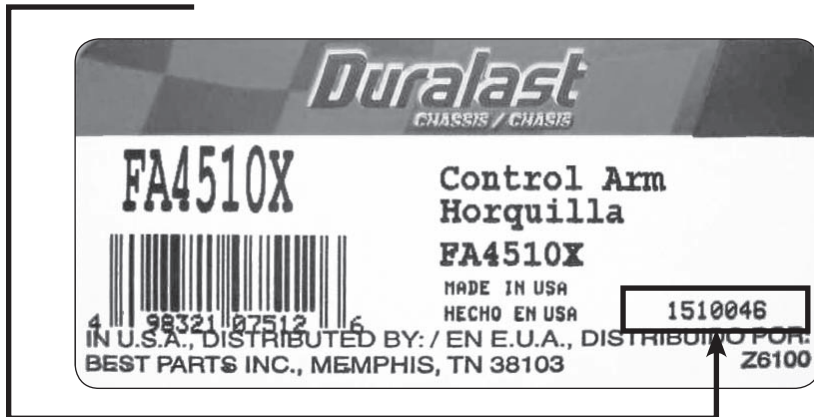
Figure 1

Figure 1: Date Code on the Control Arm Assembly package (see page 2, column 5, for the affected date codes)

NOTE: If a GREEN DOT is present on the package (the green dot will be located left of the part number label), the part is **good**.
If no green dot is present, check the packaging date code.

ACTION REQUIRED: If you find defective product in your stock, please **quarantine** those control arm assemblies and return per the instructions in the accompanying letter.

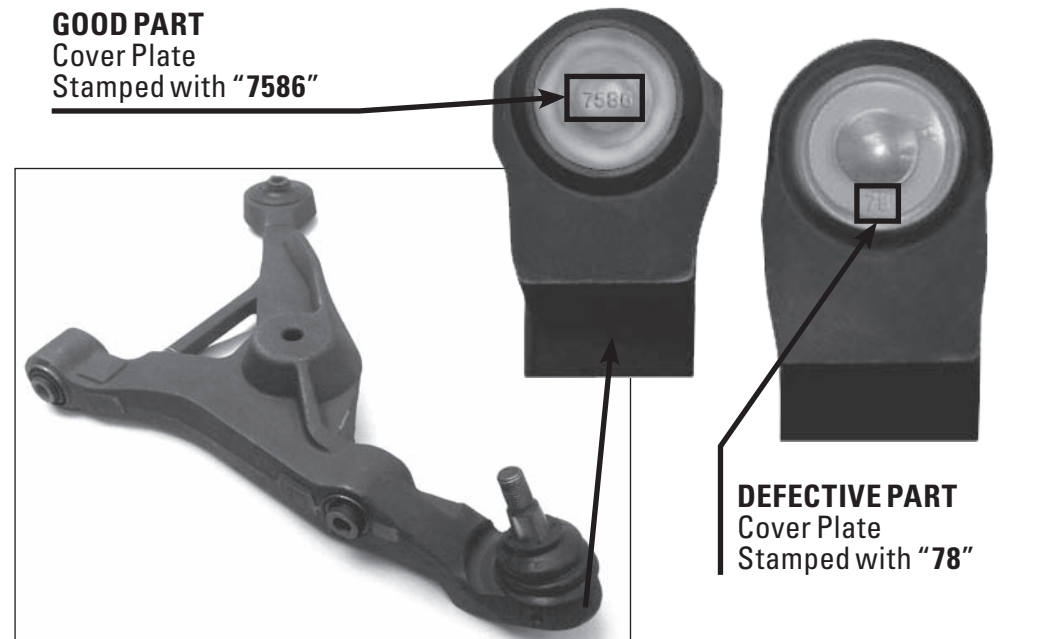
Figure 2

Figure 2: Numerical Stamp on the Control Arm Assembly's ball joint cover plate (see page 2, column 6, for the affected numerical stamp)
