# SAFETY RECALL BULLETIN

**AUTOCAR SAFETY RECALL A-1002**  
**NHTSA RECALL 10V-046**

**March, 2010**

ACX Steering Gear Bracket

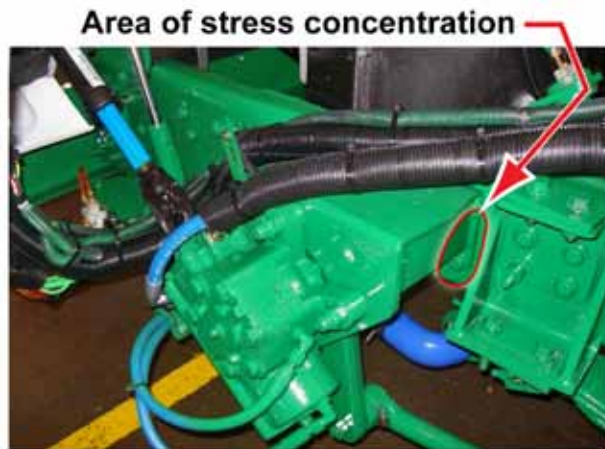
**Figure 1**

Autocar has identified a defect in 2008 and 2009 model-year ACX model heavy-duty class 8 LCOE vehicles. The affected vehicles may experience a fatigue failure of the steering gear mounting bracket. Over time, this failure may cause cracks that will result in undesirable movement of the steering gear mounted to that bracket (see *Figure 1*).

**REPAIR:**

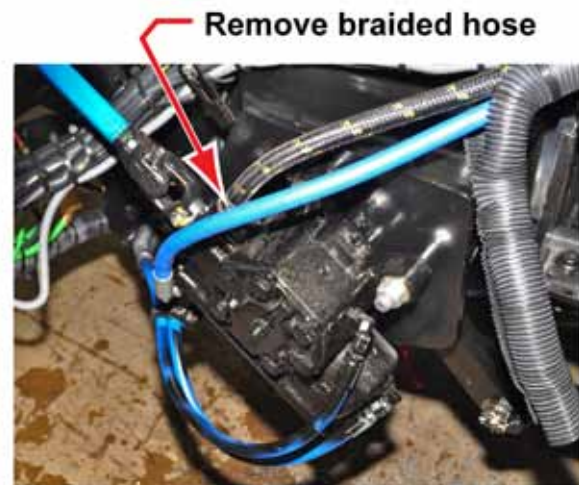
**Figure 2**

3. Place a clean oil drain catch container under the steering gear box. Drain the power steering system at the steering gear box by removing the braided hose, and release the fluid into the container (see Figure 2).

(1) 3083736 HEX SCREW  
(1) 945989 LOCK NUT 7/16-20  
See Torque Specifications on *page 2*.
13. Reinstall the four power steering lines to the steering gear box (reference *Figures 2 and 3*).

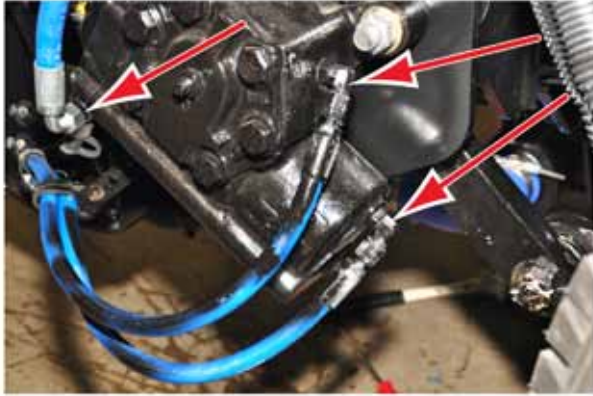
**Figure 3**

4. Remove the remaining three hoses from the steering gear box (see Figure 3).

**NOTE** - Mark one of the hoses for the steering assist cylinder (if equipped) at the hose and the fitting. This will ensure that the hoses are reinstalled to the proper location.

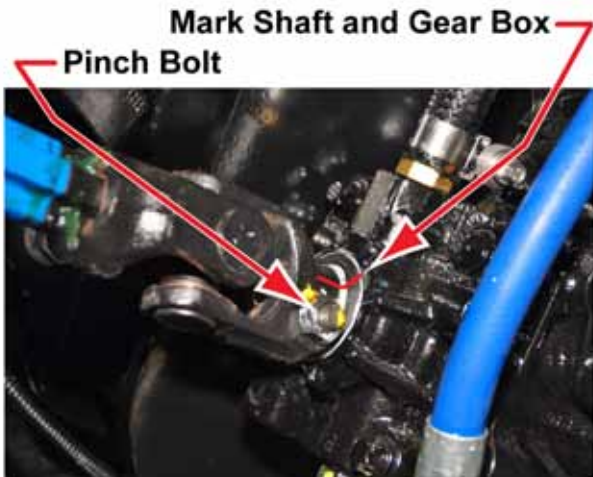
**Figure 4**

5. Remove the steering shaft from the steering gear box by first removing the steering shaft pinch bolt (see *Figure 4*).

**NOTE** - Mark the steering shaft and the gear box before removing the shaft in order to facilitate proper alignment at reinstallation.

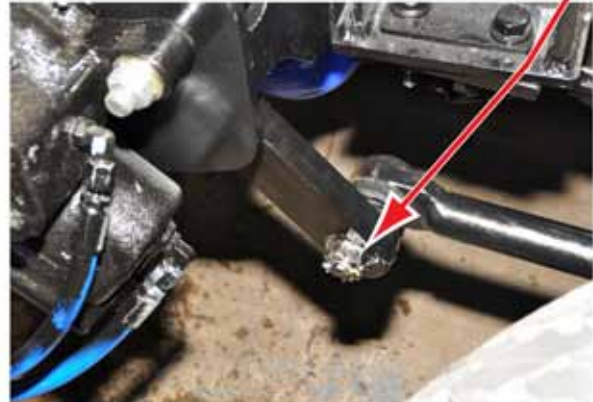
**Figure 5**

6. Remove the drag link from the pitman arm by removing one cotter pin and the castle nut (see *Figure 5*).

**Remove cotter pin and castle nut**

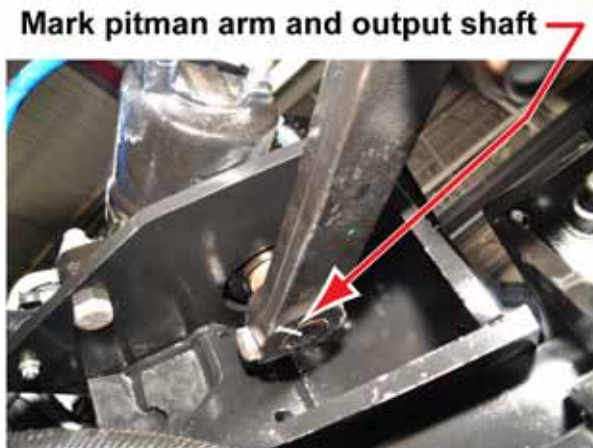
**Figure 6**

7. Remove the pitman arm from the steering gear box output shaft by removing the pinch bolt from the pitman arm (see *Figure 6*).

**NOTE** - Mark the pitman arm and the output shaft before removing the pitman arm in order to facilitate proper alignment at reinstallation.

**(Viewed from under steering gear box)**

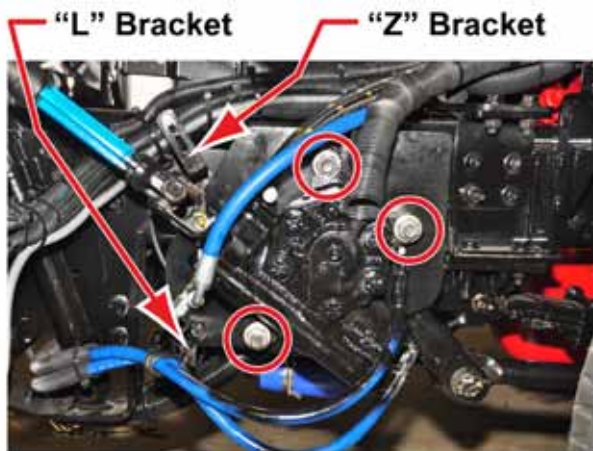
**Figure 7**

8. Remove the steering gear box by first removing the "L" bracket that is attached to the steering gear bracket, then remove three bolts that hold the steering gear box to the bracket (see Figure 7).

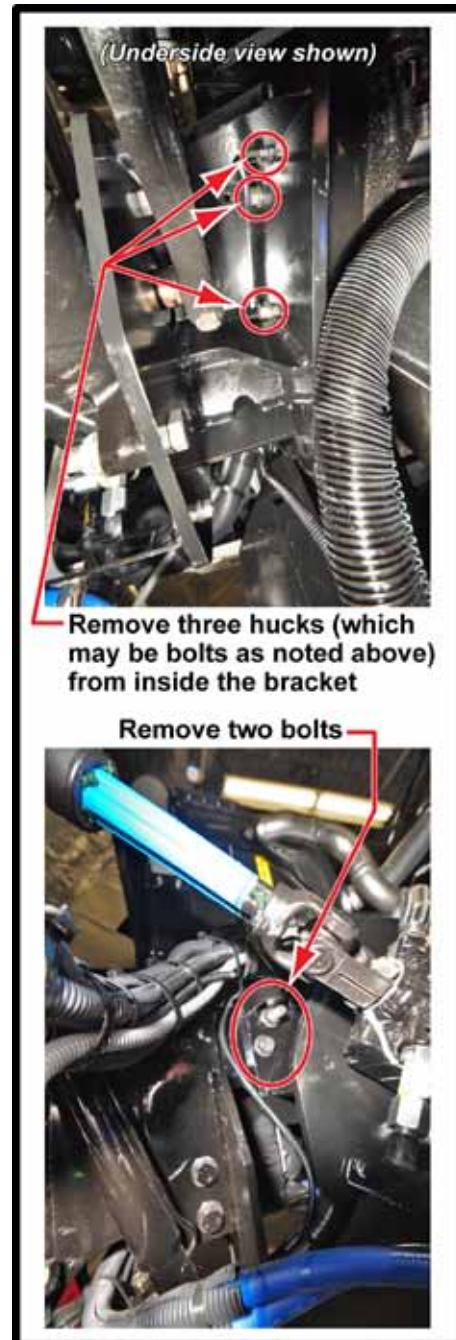
**Figure 8**

9. Remove the steering gear bracket by removing the the three hucks and two bolts that hold the steering gear box to the frame (see Figure 8). Also remove the "Z" bracket which is retained by one of the above-mentioned bolts (see Figure 7).

**NOTE** - The three hucks may have been replaced by bolts, depending on when the vehicle was built.

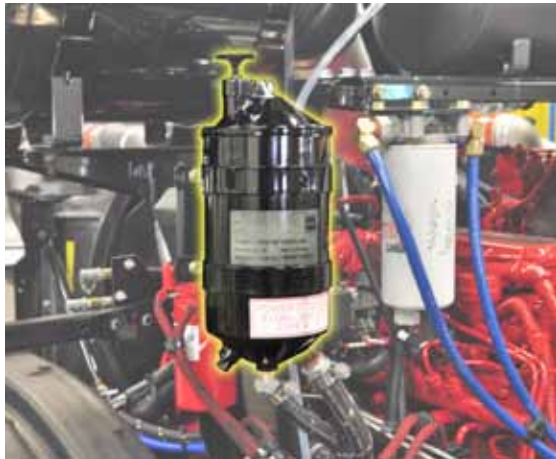
**Figure 9**

18. Fill the power steering system to the required level using approved fluid (Type A or F), as indicated on the reservoir (see *Figure 9*).

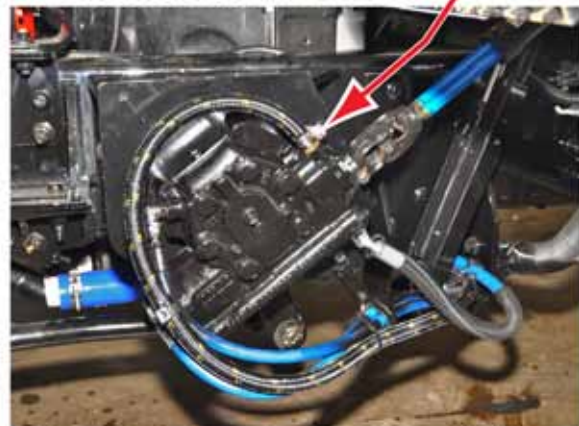
**Figure 2**

3. Place a clean oil drain catch container under the steering gear box. Drain the power steering system at the steering gear box by removing the braided hose, and release the fluid into the container (see Figure 2).

Remove braided hose

13. Reinstall the four power steering lines to the steering gear box (reference *Figures 2 and 3*).

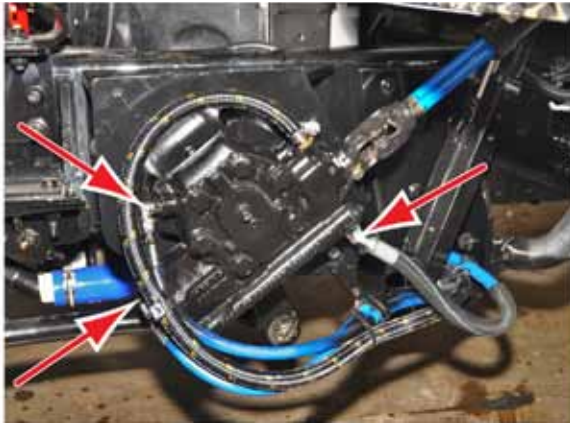
**Figure 3**

4. Remove the remaining three hoses from the steering gear box (see Figure 3).

**NOTE** - Mark one of the hoses for the steering assist cylinder (if equipped) at the hose and the fitting. This will ensure that the hoses are reinstalled to the proper location.

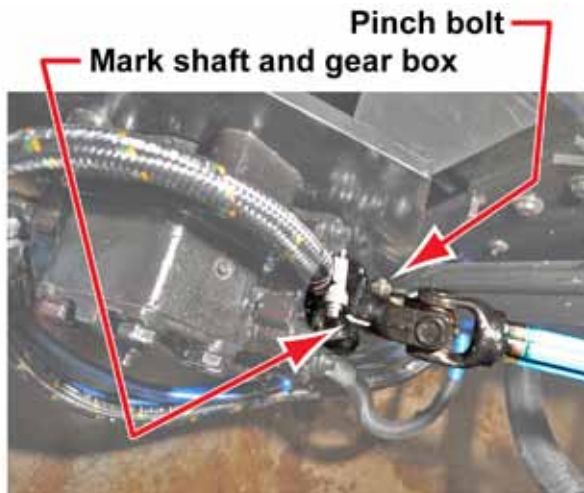
**Figure 4**

5. Remove the steering shaft from the steering gear box by first removing the steering shaft pinch bolt (see Figure 4).

**NOTE** - Mark the steering shaft and the gear box before removing the shaft in order to facilitate proper alignment at reinstallation.

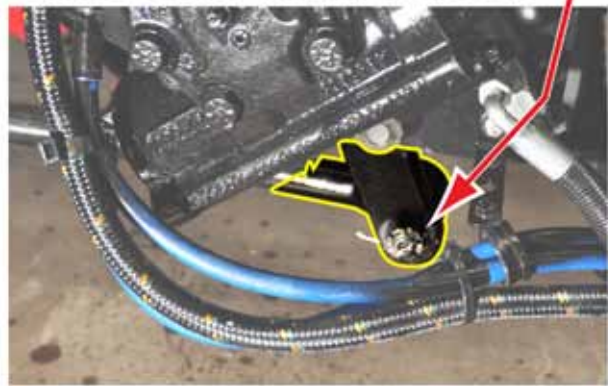
**Figure 5**

6. Remove the drag link from the pitman arm by removing one cotter pin and the castle nut (see Figure 5).

**Remove cotter pin and castle nut**

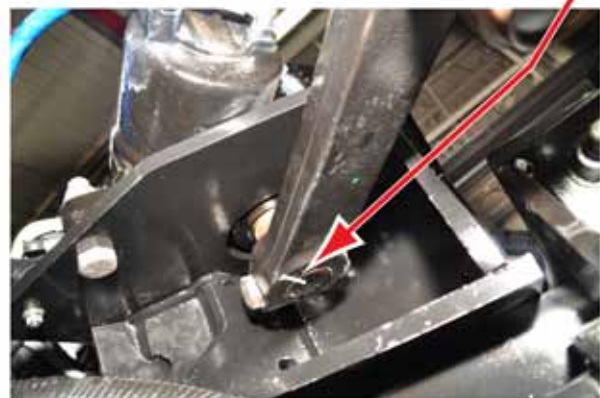
**Figure 6**

7. Remove the pitman arm from the steering gear box output shaft by removing the pinch bolt from the pitman arm (see Figure 6).

**NOTE** - Mark the pitman arm and the output shaft before removing the pitman arm in order to facilitate proper alignment at reinstallation.

**Mark pitman arm and output shaft**

**(Viewed from under steering gear box)**

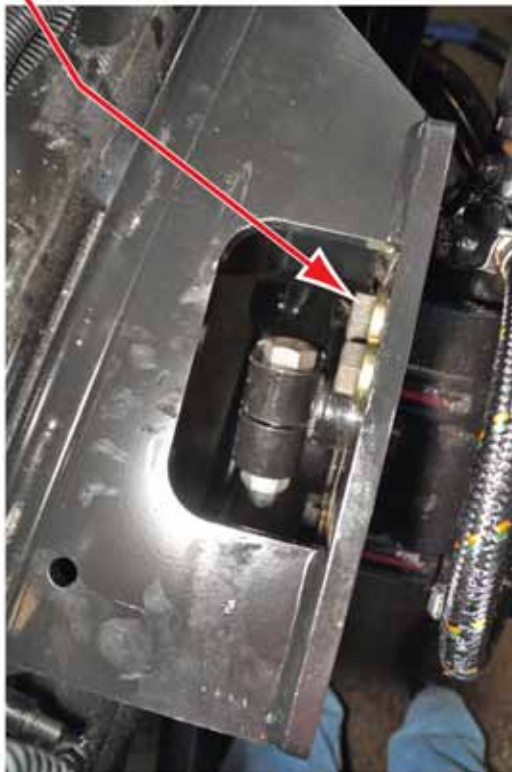
**Figure 7**

8. Remove the steering gear box by first removing the “L” bracket that is attached to the steering gear bracket, then remove five bolts that hold the steering gear box to the bracket (see *Figure 7*).

Remove five bolts from inside bracket  
(all bolts not seen in this view)

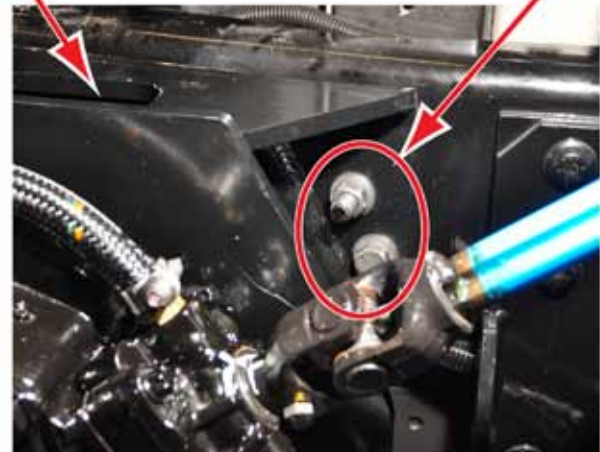
**Figure 8**

9. Remove the steering gear bracket by removing the the three hucks and two bolts that hold the steering gear box to the frame (see *Figure 8*).

**NOTE** - The three hucks may have been replaced by bolts, depending on when the vehicle was built.

Remove two bolts

Remove three hucks (which  
may be bolts as noted above)  
from inside the bracket

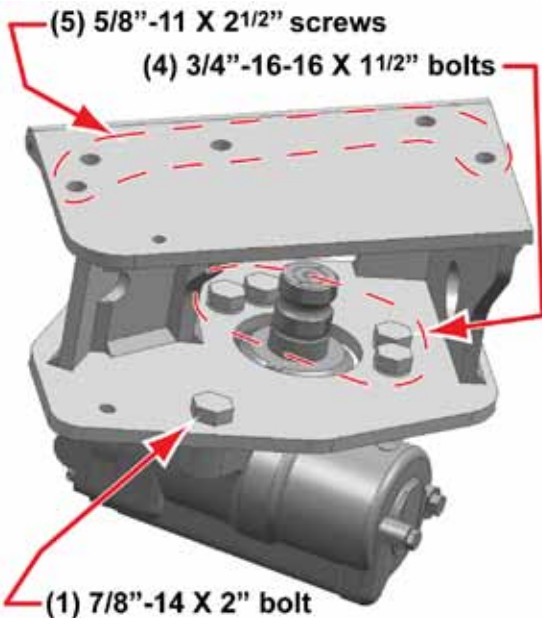
**Figure 9**

10. Install the new steering gear bracket using the following parts (see *Figure 9*):  
**S3831002K001, SVC KIT, ACX RHD STRG GEAR BRKT**

11. Reinstall the steering gear box to the new bracket using the following new hardware (see *Figure 9*):

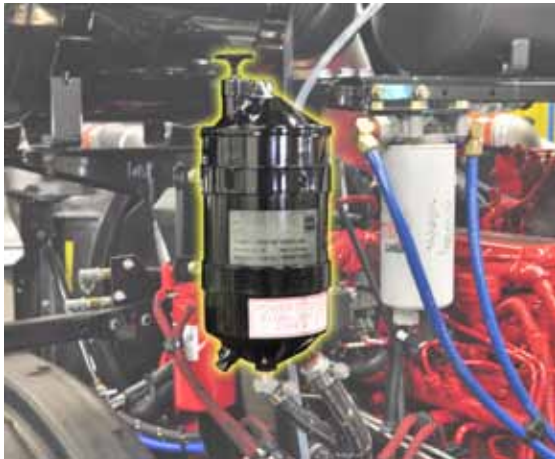
**Figure 10**

16. Reinstall the drag link to the pitman arm using the existing castle nut and the following new cotter pin:  
*From S3831002K002, SVC KIT, HDW, ACX RHD STRG GEAR - (1) 907863 SPLIT PIN*
17. Lower the cab.
18. Fill the power steering system to the required level using approved fluid (Type A or F), as indicated on the reservoir (see *Figure 10*).
21. Check for any fluid leaks and if found, correct as necessary. The repair procedure is complete.
