RECALL CAMPAIGN BULLETIN

NTB10-030a

VOLUNTARY RECALL CAMPAIGN 2008 - 2010 ARMADA & TITAN AND 2008 - 2009 QUEST BRAKE PEDAL PIVOT PIN INSPECTION

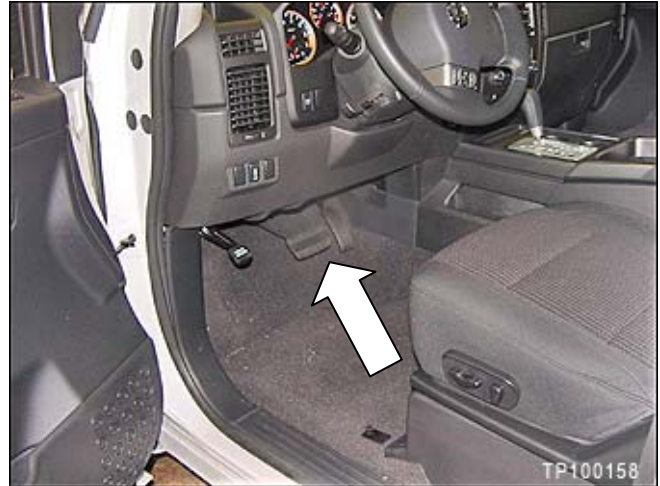
Figure 1

1. Look under the dash to view the brake pedal pivot pin.

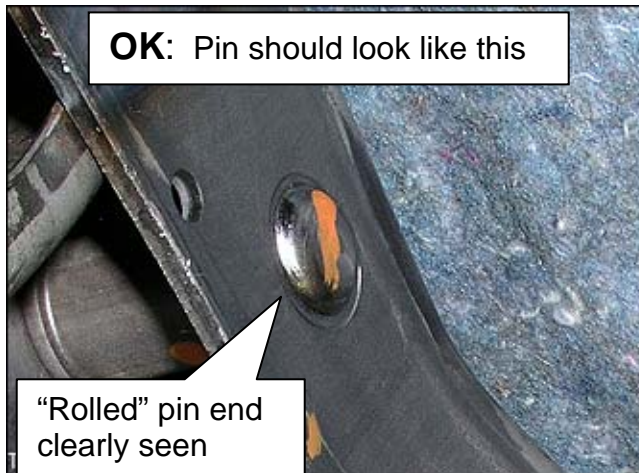
Figure 3

3. Inspection results (see Figures below):

- **OK** – No further action required.
- **NG** – Replace the brake pedal assembly.
