Service Bulletin No. 342

MODEL D Series Coaches	TYPE Field Change Program	SECTION/GROUP 22 – Wheelchair	DATE
SUBJECT RICON F9TF RESTRAINT BELT			
CONDITIONS

Ref. Ricon NHTSA Recall No.: 09E–060

Ref. MCI NHTSA Recall No.: 10V–114

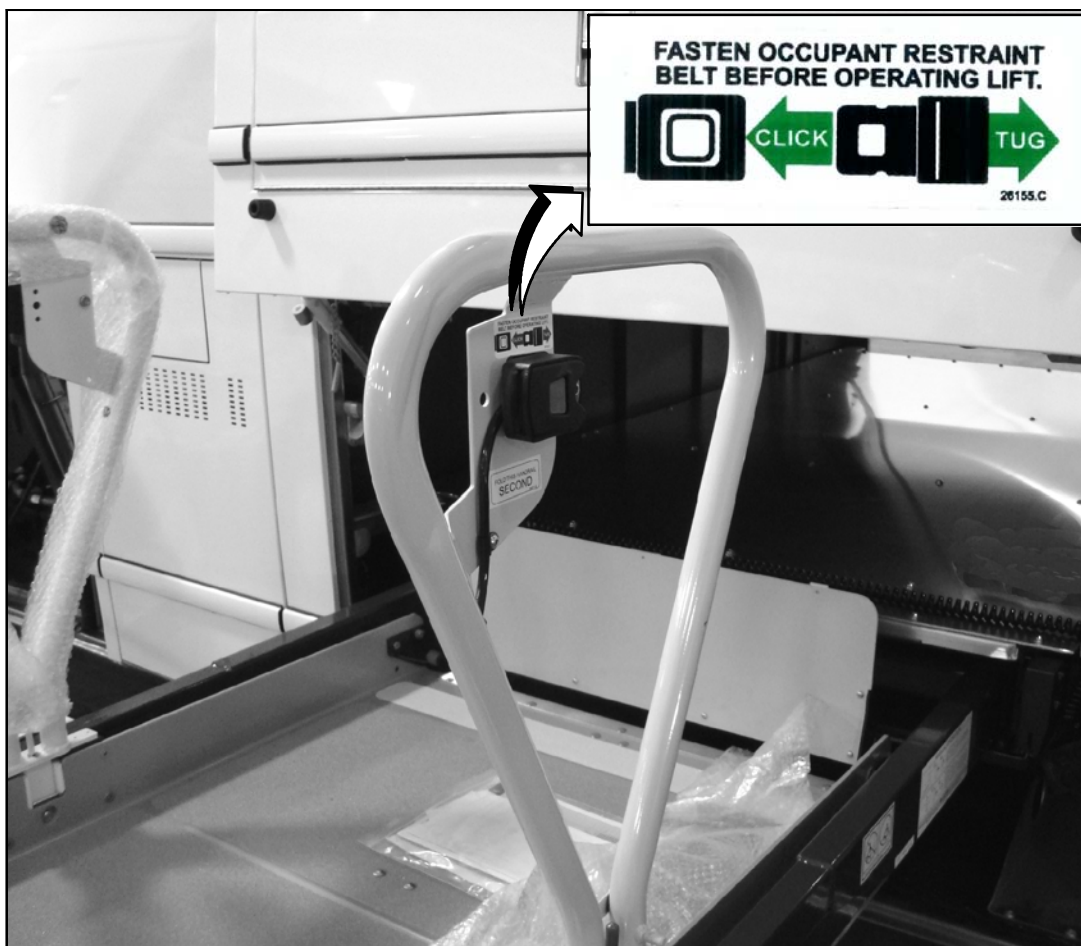
Figure 1.

1. Customers are instructed to watch the DVD – based training aid and install the warning decal to the exterior face of the handrail, above the buckle (refer to Figure 1).

Ricon is providing affected customers with a warning decal to be affixed on the wheelchair lift, which reminds operators to fully engage the restraint belt by listening for a “click” of the belt buckle and “tugging” on the belt to ensure it does not release from the buckle. Ricon is also providing affected customers with a training DVD to promote its “Click and Tug” campaign.
