BLUE BIRD

**SUBJECT: RECALL R11SV FOOT OPERATED PARKING BRAKE PEDAL
DEFORMATION**

PARKING BRAKE PEDAL DEFORMATION

Models Affected: 2011 model year Vision models with hydraulic brakes and foot operated parking brake

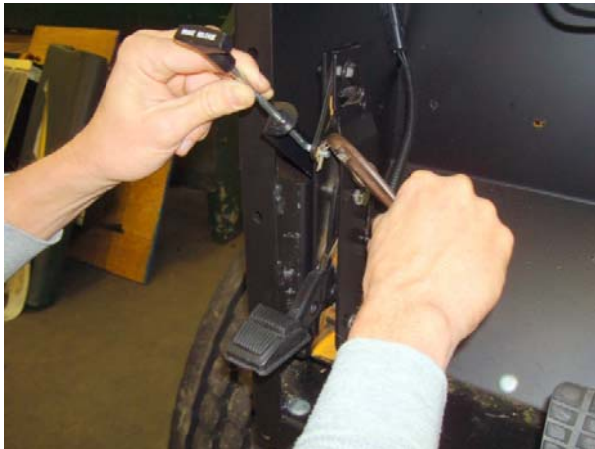
Fig. 1

1. Park bus on a level surface, apply parking brake, switch engine off, remove ignition key.
2. Chock wheels then release parking brake.
3. Disconnect parking brake release handle by removing the cotter pin and flat washer and set aside for use later. (Fig. 1)
4. Remove two 5/16-18 x 2.00 capscrews holding parking brake assembly to parking brake mounting bracket. Discard capscrews. (Fig. 2)

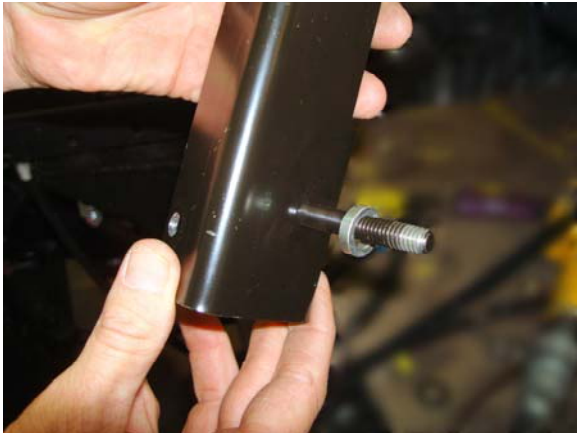
Fig. 8

9. Place spacer on lower stud of adapter bracket (Fig. 8) then place park brake release handle bracket on upper stud and then install parking brake assembly onto adapter bracket with two flanged lock nuts. Leave lock nuts finger tight at this time. (Fig. 9)

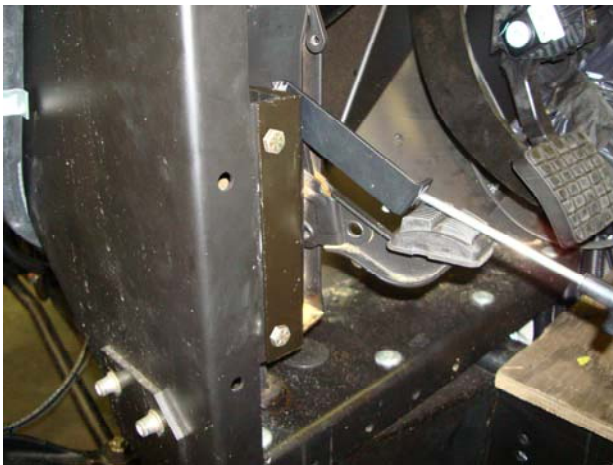
Fig. 10

10. Place adapter bracket with assembled parts onto the parking brake mounting bracket, align holes, and fasten with two 5/16-18 x 2 1/2 capscrews and flanged lock nuts through drilled holes. Tighten to 150-200 in-lb. (Fig. 10)

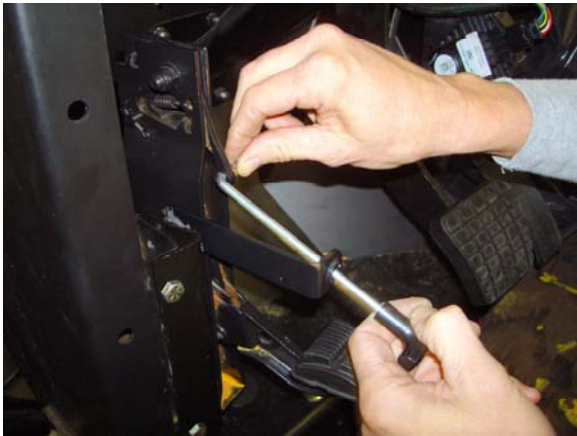
Fig. 11

11. Thread parking brake release handle through hole in parking brake release handle support bracket, insert end into parking brake assembly, and fasten using flat washer and cotter pin. (Fig. 11)
12. Tighten the flanged nuts on the studs of the adapter bracket to 150-200 in-lbs. Be sure parking brake release handle support bracket is between 45-50 degrees from horizontal when finished. (Fig. 12)
13. Parking brake release handle must retract freely when pulled & released. Bend parking brake release handle support bracket side-to-side as needed to relieve any rod binding on support bracket bushing.
14. Reconnect electrical plug. (Fig. 13)
15. If park brake cable adjustment is necessary, follow procedure outlined in Blue Bird Vision service manual.

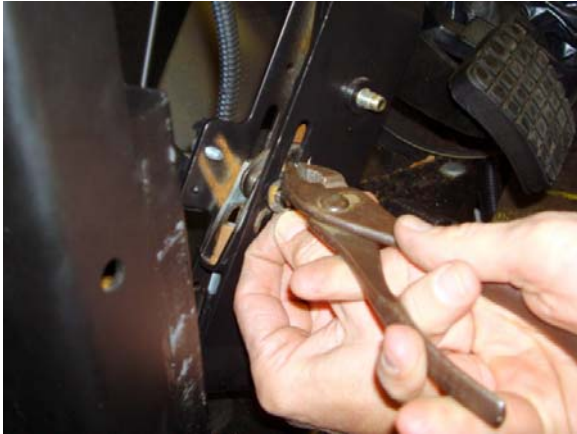
Fig. 1

1. Disconnect park brake cable by removing the cotter pin and retaining pin that hold the cable yoke. (Fig. 1)
2. Pull yoke out of parking brake assembly (Fig 2), turn 90 degrees (Fig.3), and remove it from the cable. (Fig. 4)

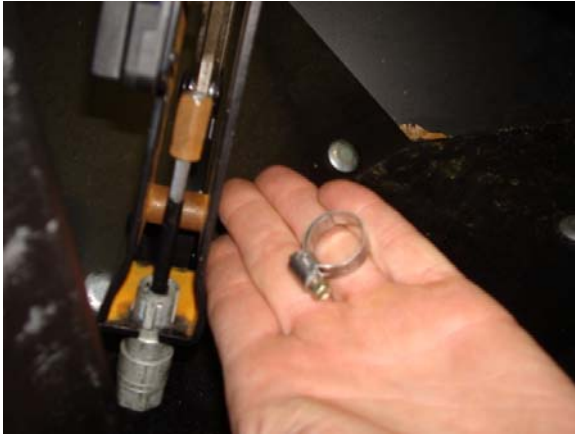
Fig. 5

3. Place a small hose clamp around the fingers on the cable retainer. (Fig. 5 & 6)
4. Tighten clamp (you may have to use a screw driver to keep the clamp in position on the back side as seen in Fig. 7) just enough to pull cable retainer down through the clamp and out of the bottom of the parking brake assembly. (Fig. 8)

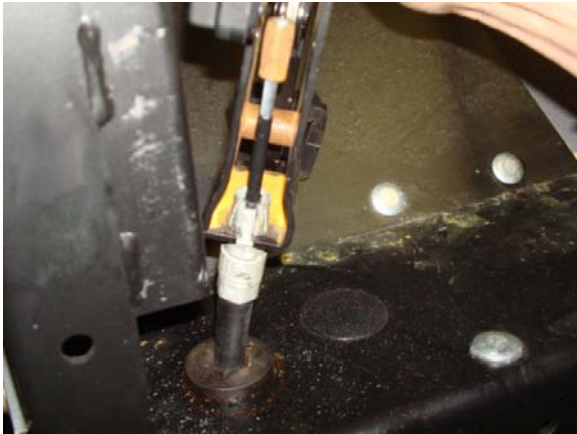
Fig. 9

5. Push cable retainer up through the new parking brake assembly (Fig. 9), slide yoke on cable end (Fig. 10), and install the retaining pin through the parking brake assembly and yoke (Fig. 11), and install cotter pin. (Fig. 12)

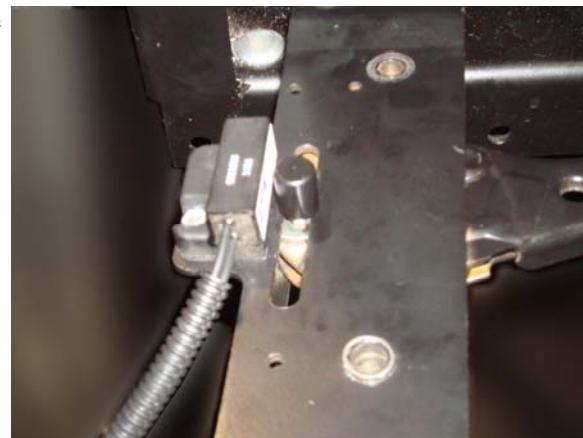
Fig. 13

6. Make sure large end of retaining pin is on the sensor side of the parking brake assembly. (Fig. 13)
