Safety Defect and Noncompliance Report Guide for Vehicles
PART 573 Defect and Noncompliance Report

Provan Industries, LLC DBA Tiger Motorhomes ("Tiger") has determined that a defect which relates to motor vehicle safety compliance exists in the motor vehicles listed below, and is furnishing notification to the National Highway Traffic Safety Administration in accordance with 49 CFR Part 573 Defect and Noncompliance Reports.

Make(s): Ford F-350/Chevy 3500 based Class "C"
motor homes

Model Years and Models Involved: 2009-2011 Tiger Motorhomes

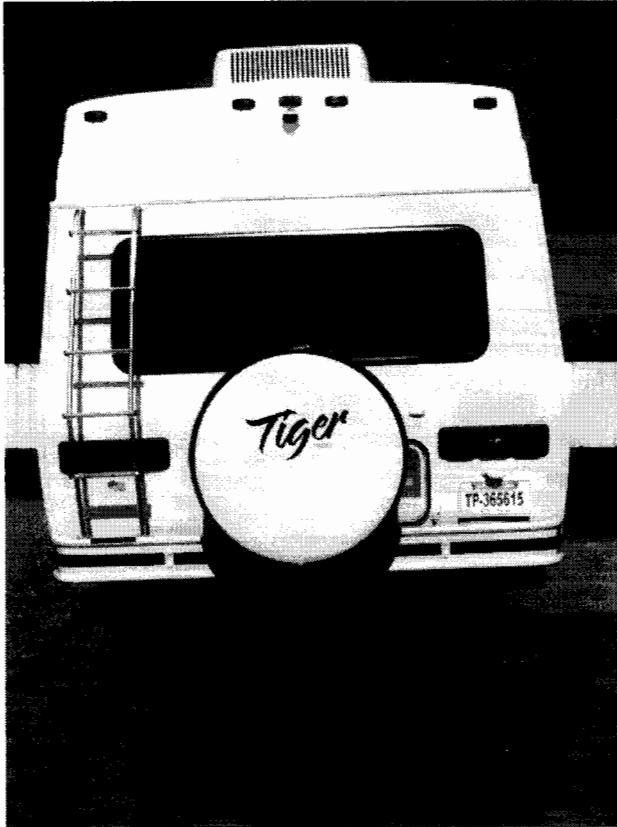
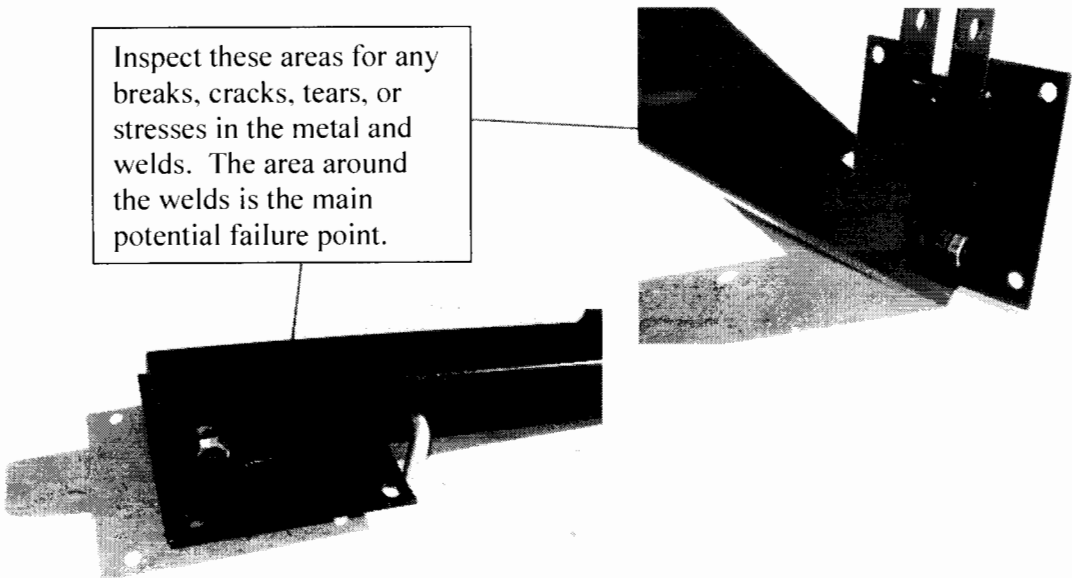
EXEMPLAR IMAGE OF TIRE CARRIER ASSEMBLY AT ISSUE

The weld joints in the assembly are developing premature fatigue cracks/tears to the point where the tire carrier may be in danger of separating from the bumper.

Premature fatigue cracks/tears are seen developing at the weld joints in the assembly.

10/2010 - The first of 2 potential failures was reported to Tiger. A customer identified cracking/tearing at a weld between the mounting plate and the tire frame tube. A replacement was provided and the unit was returned for review. There had been no previous complaints relating to the tire carrier and after review of the assembly it was determined to be a product anomaly. There have been no other occurrences reported until the second discussed next/below.

08/08/2011 - The second incident was reported by a customer. After having a discussion, it was determined that this issue had similar signs of fatigue cracking/tearing at the weld between the mounting plate and the tire frame tube.

Inspect these areas for any breaks, cracks, tears, or stresses in the metal and welds. The area around the welds is the main potential failure point.

Customers owning the affected vehicles will be instructed to replace the spare tire carrier supplied by Provan or remove it permanently. In addition, they will be given the option of having Tiger replace the tire carrier with the new design or have the assembly shipped to local service facility of their choice.

The new tire carrier is a more robust design therefore there is no risk of premature fatigue cracking/tearing developing.
