RECALL CAMPAIGN BULLETIN

NTB12-038b

VOLUNTARY RECALL CAMPAIGN 2012 TITAN AND ARMADA CERTIFICATION LABEL

CAMPAIGN I.D. # PC135
NHTSA #: 12V-143
APPLIED VEHICLE: 2012 Titan (A60)
2012 Armada (TA60)

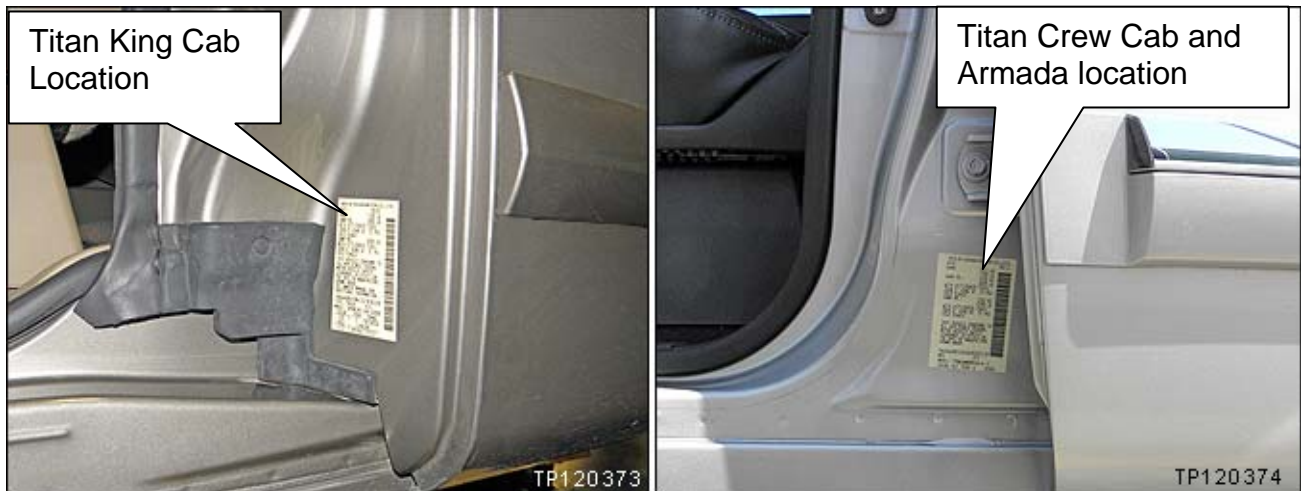
Figure 1

1. Park the vehicle in a safe place with the ignition OFF, the parking brake ON, and the automatic transmission in "P".
2. Open the driver's door.
3. Locate the existing certification label (see Figure 1).

NOTE: The certification label has the VIN on it.

4. Make sure the VIN on the new certification label matches the VIN on the old certification label.

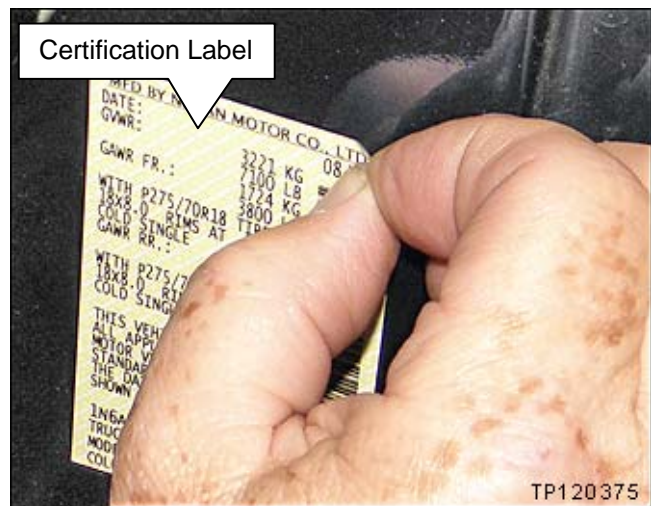
Figure 2

5. Clean the area around the certification label with a dry clean cloth.
6. Remove the old certification label.
 - Use a finger nail to pull / lift one corner of the label and then slowly peel off 100% of the old label.

NOTE: If needed, use a smooth thin tipped finesse stick to lift up one corner of cert. label.

7. Install the new certification label in the same location as the old label.

NOTE: If needed, clean surface before applying the new label with isopropyl alcohol and allow to dry.
