Gunite – Service Advisory

March 30, 2011

NO: GUN2.0014 Rev. 3

Gunite® Automatic Slack Adjuster Inspection Instructions

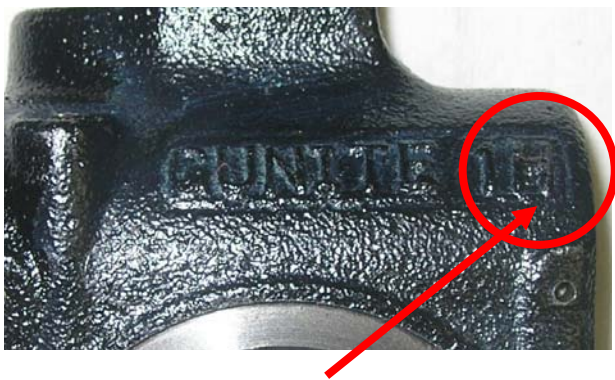
Figure A: Mold Line Nomenclature

Side of Slack Adjuster Housing

1. Remove the automatic slack adjuster from the box and plastic shipping bag.
2. Inspect the automatic slack adjuster in two locations to determine the lot number.
 - a. On the side of the slack adjuster housing you will see the name Gunite and either an "H" or "1H". See Figure A. This is the mold line nomenclature.
 - b. On the bottom of the slack adjuster you will see the lot number information. See Figure B.
 - c. If the combination of slack adjuster mold line and lot number exactly match any of the combinations in the table below, see Figure C, the slack adjuster must be returned to Gunite. Please contact Customer Service at 1-800-677-3786 to obtain a Return Goods Authorization (RGA) document.

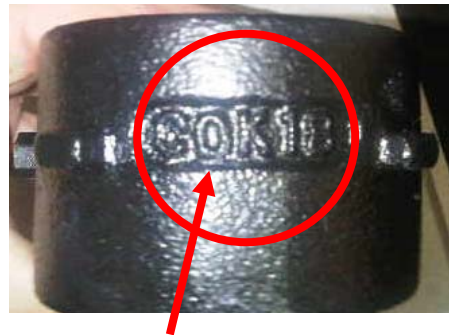
Figure B: Lot Number

Bottom of Slack Adjuster Housing

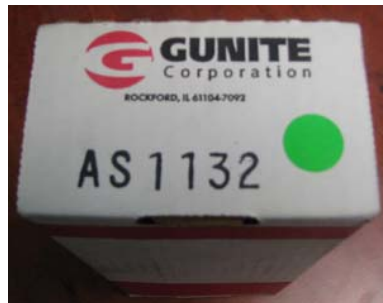
Figure D

Any Gunite slack adjuster that has passed inspection can be identified by either a green dot appearing on the box, see Figure D, or on the part, see Figure E and Figure F, and / or a capital letter "C" at the end of the run number, see Figure G. This will signify the housing has been certified okay to use.

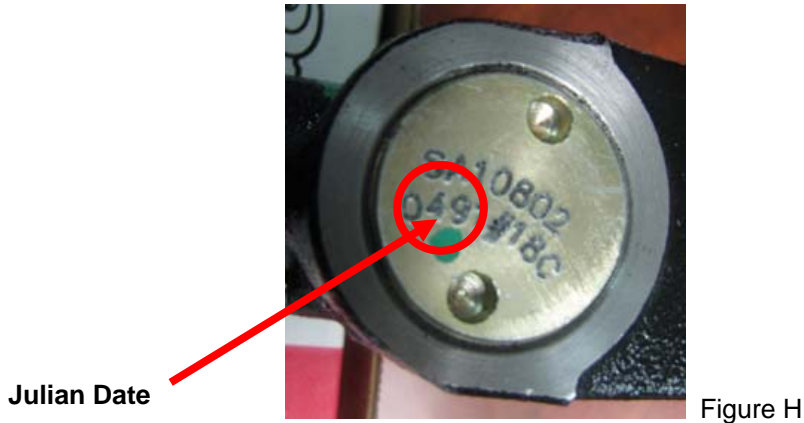
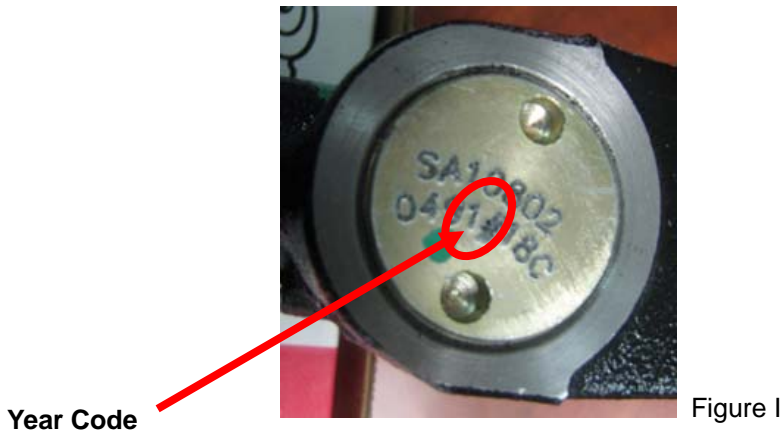
Assembly Date Codes on End Plate

If you are inspecting slack adjusters on a vehicle and are not able to see the mold line and lot number, you can use the assembly date code on the end plate of the slack adjuster to determine if the slack adjuster could be in the suspect lot. If the code on the end plate is not contained on the list, no further inspection is necessary. If the code on the end plate is contained on the list the slack adjuster must be removed from the vehicle if necessary for further inspection to identify the mold line and lot number code on the housing. Some slack adjusters with the listed assembly code on the end plate will not have the mold line and lot number codes and can be used in service.

For example in the Figures H and I, the Julian date is 049 and the year code is 1. Therefore, this slack adjuster is not in the suspect lot.

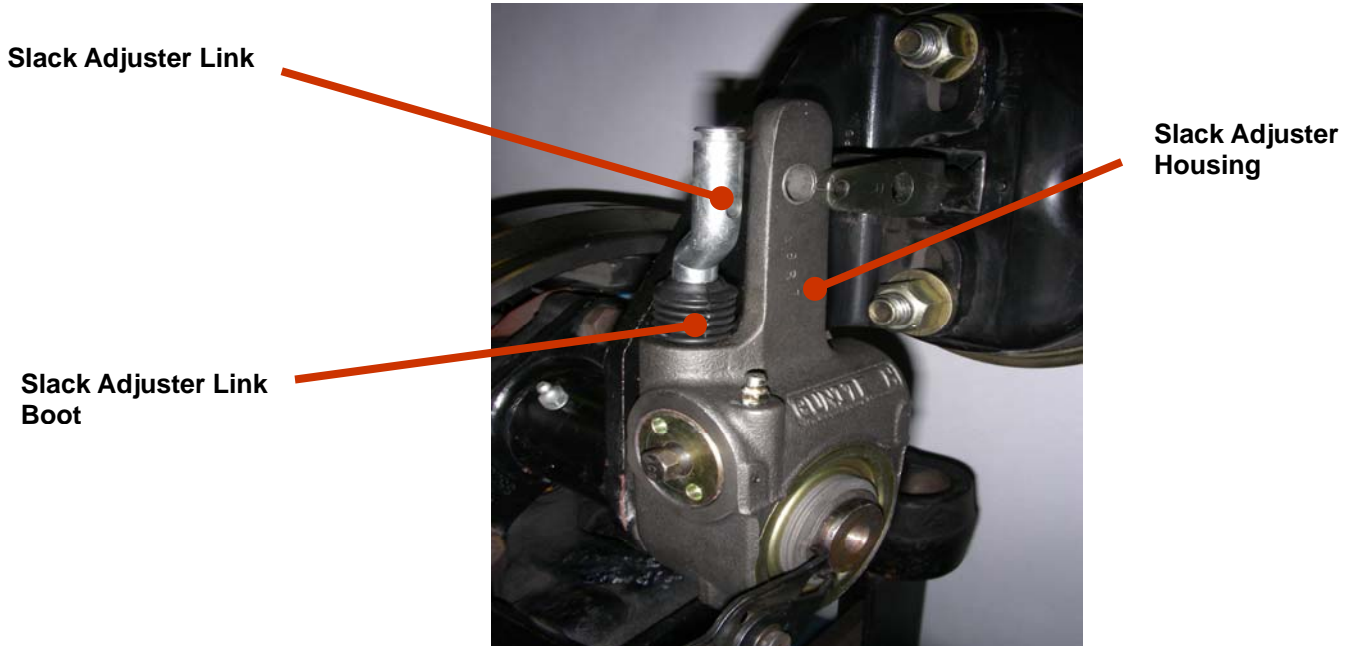
Step 1:
Using a 7/16 socket and wrench rotate adjusting hex head clockwise a minimum of a 1/4 turn allowing for the link to travel in a direction away from the slack adjuster housing. This allows the link to disengage the internal drive mechanism.

Instead of returning used Slack Adjusters removed from vehicles to Gunite, the Slack Adjuster can be rendered inoperative by using the following procedure. Documentation of the number of Slack Adjusters made inoperative is needed for reporting requirements.

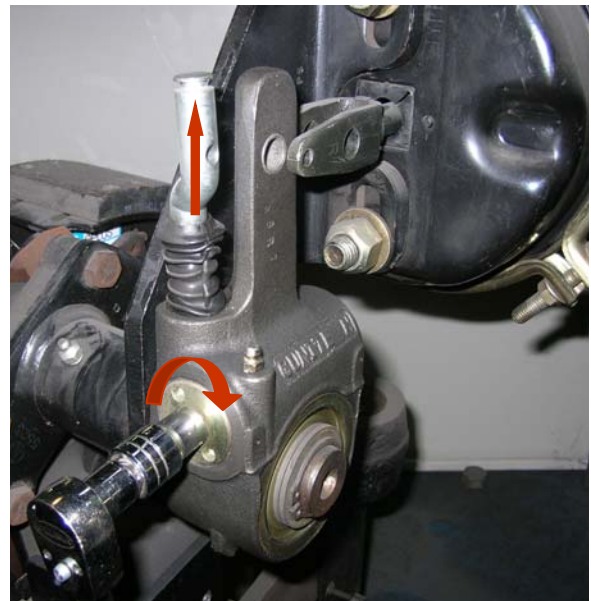
Step 2:
Using a little force pull on the link
away from the slack adjuster
housing until it is removed from the
link boot.
