**SAFETY
RECALL**

TITLE: Flat floor SB (torn wire insulation)

PRODUCT: Girardin G5 school bus 2006 to 2010 Ford flat floor

Reference: Recall 11-045-EHU/NHTSA #11V-309

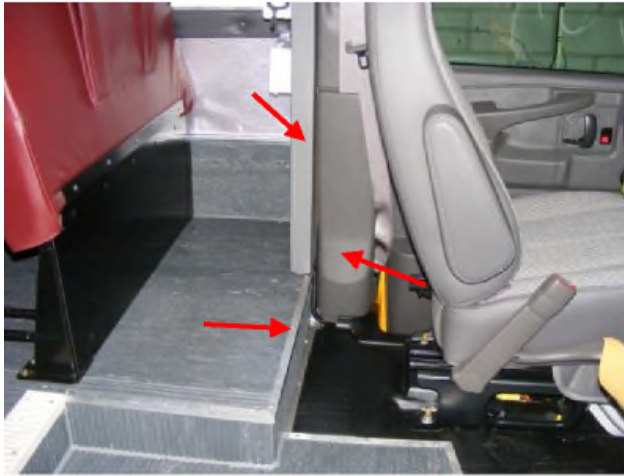
- 1- Push the driver's seat to the farthest position near the dash.
- 2- Remove the corner trim and the B Pillar trim.

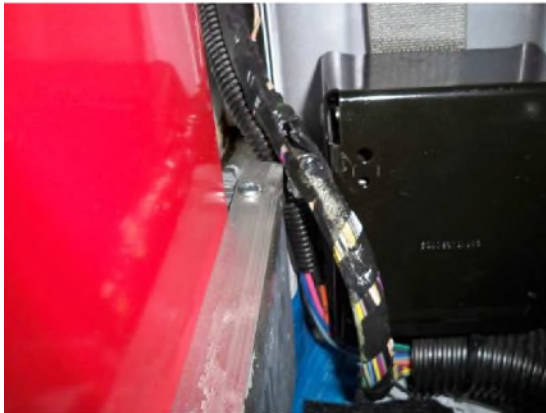
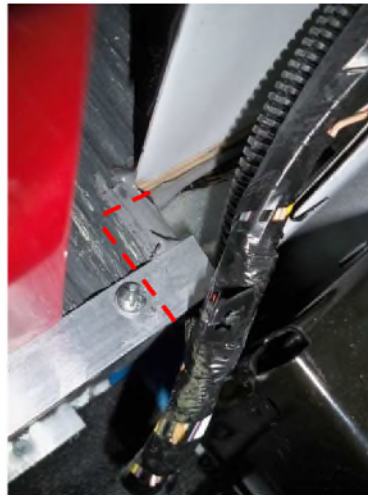
- 3- Remove the aluminum trim and cut approximately one inch at the end.
- 4- Remove the same area on the corner of the floor using a wood chisel to allow clearance of the electrical harness. (The use of any saw is not recommended since there is a metal sheet under the plywood.)

- 5- Install a loom or any other protection against abrasion over the OEM harness. An electrical tape is not sufficient.
- 6- **Fix the harness in place using sealant (very important).**
- 7- Reinstall the aluminum trim.
