**RECALL BULLETIN:**  
110728FRV

**PRODUCT(S) AFFECTED:**  
American Eagle,  
American Heritage,  
American Tradition,  
Boulder,  
Boulder Classic,  
Discovery,  
Expedition,  
Providence,  
Revolution LE,  
Southwind

**SUBJECT:**  
Replacement of Siemens or Murray (by Siemens) brand circuit breakers

**ISSUE DATE:**  
August 2011

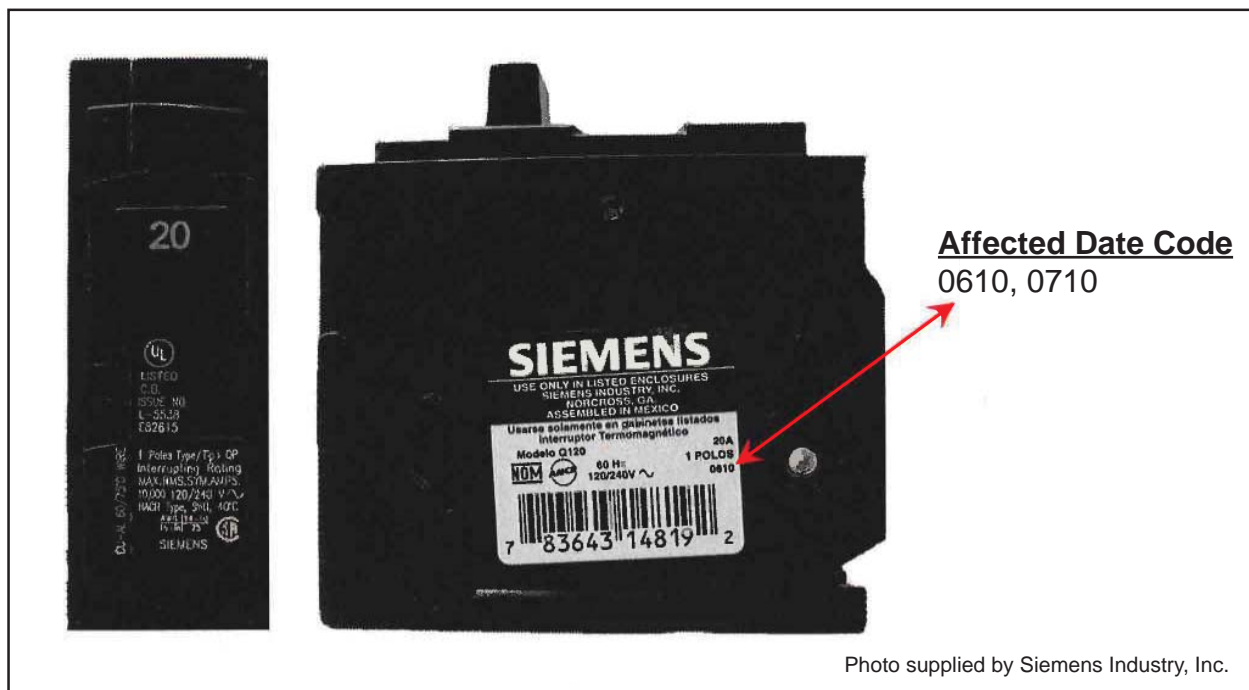
Figure 1

3. Locate and open the 120 Volt breaker box.
4. Visually inspect the inside of the breaker box and each 15 amp, 20 amp, or 30 amp circuit breaker by removing it and checking its casing for a date code marking.
  - A. If any damage to the breaker box is found, stop and contact Fleetwood's Dealer Technical Assistance for further instructions before proceeding with any further steps.
  - B. For each breaker inspected, if the brand name printed on the label is "Siemens" or "Murray" and the date code marking is "0610" (or "June 2010"), or "0710" (or "July 2010"), it is being recalled and must be replaced by a new circuit breaker of the same amperage capacity. Refer to Figure 1.
  - C. Set each recalled circuit breaker aside for return to Fleetwood.
  - D. Reinstall each circuit breaker that does not need to be replaced, ensuring it is in the correct location for its amperage rating.

5. For each recalled circuit breaker, obtain a replacement circuit breaker of the same amperage capacity through Fleetwood RV Parts. Refer to the Parts list below for the appropriate replacement part numbers.
6. Install each replacement circuit breaker, ensuring it is in the correct location for its amperage rating.
7. Reconnect the inverter cable, enable Auto-Gen-Start (if equipped), and enable the 12-volt power using the battery disconnect.
