Safety Recall: Seat Belt May Not Be Completely Stitched

Dear Service Manager:

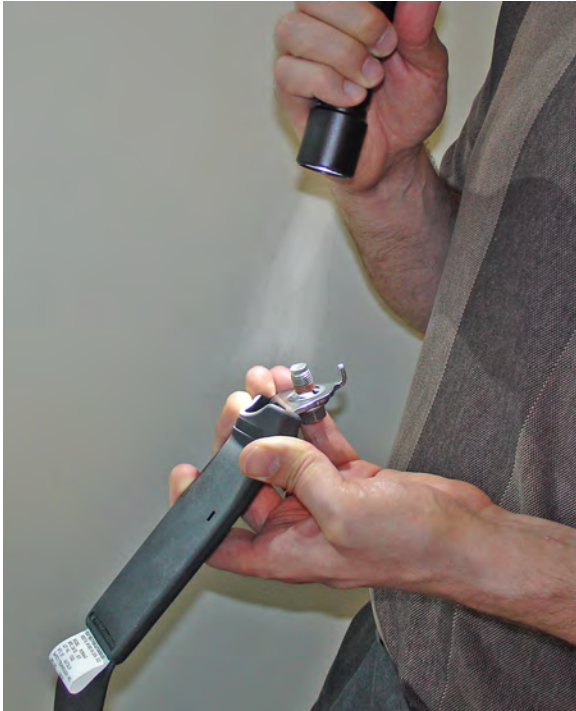
4. Using a flashlight, inspect the stitching on the seat belt webbing on the side that is facing the seat:
 - Gently squeeze the sides of the cover so you can see the stitching, about 1.5 to 2 inches inside the cover.

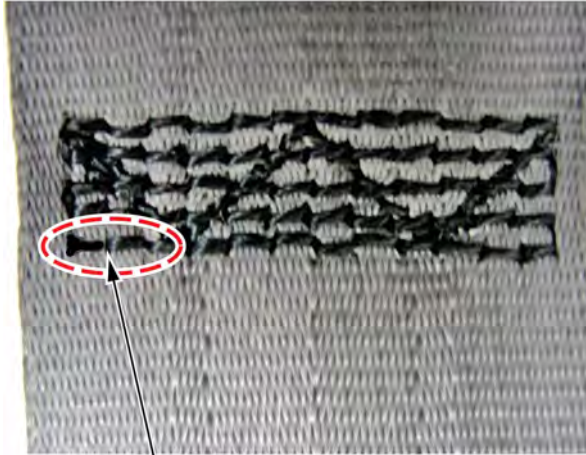
- Make sure there are five **complete** rows of stitching. The row that is closest to the anchor is the last row sewn. The "W" stitch is done at the very beginning of the stitching procedure, and you may not be able to see these stitches.
- The stitching is OK.**

Look for missing stitches here.

- If there are five complete rows, the seat belt is OK. Go to step 5 to reinstall the seat belt.
- If there are not five complete rows, replace the seat belt. Go to REPAIR PROCEDURE.

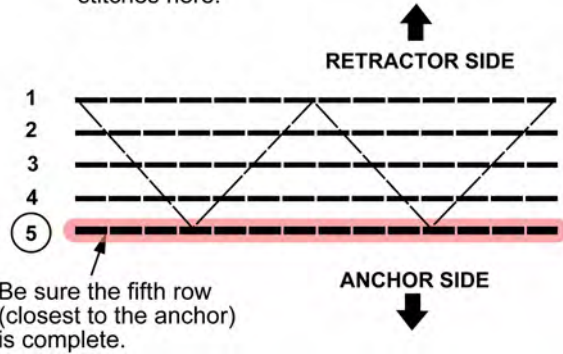
Be sure the fifth row (closest to the anchor) is complete.

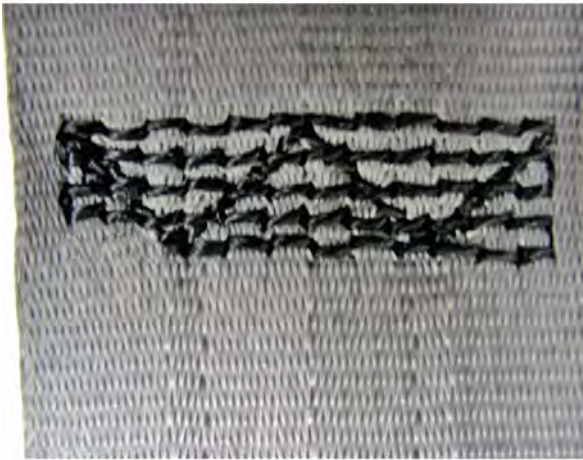
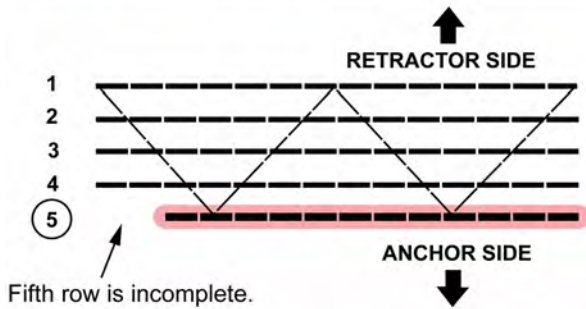
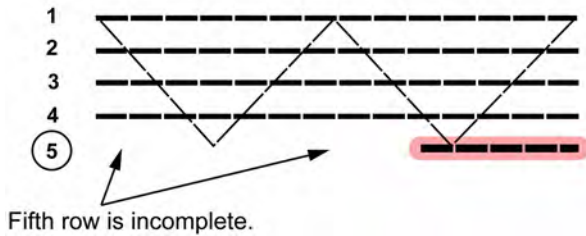
The stitching is NG - replace.

1. Replace the driver's and/or front passenger's front seat belt based on the result of the inspection procedure. Refer to the applicable service manual procedure, or, online, use keywords **SEAT BELT** and select **Front Seat Belt Replacement** from the list.
2. Center-punch a completion mark above the fifth character of the engine compartment VIN:
