SAFETY RECALL ALERT

Bulletin: SRA-M12-02
Date: January 26, 2012
Replaces: N/A
Action Required? **YES**

Subject: Safety Recall, SC0363, Bendix® ATR-6™ Valve Action_012412

The Bendix® ATR-6™ Valve Action – Understanding the Issue

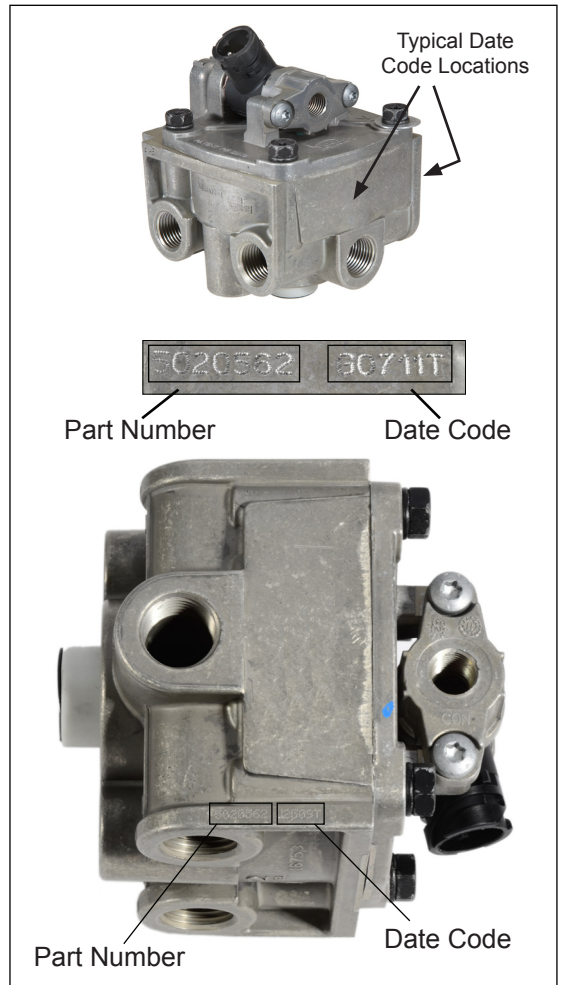
Verifying the Bendix® ATR-6™ Valve's Date Code.

Look for the date code that is pin-stamped (not cast) on the valve, following the part number. *(Remove the paint coating, if necessary, to read the code.)*

- The first field is the month (A=January, B=February, etc. — excluding the letter I — , so that J=September, and so on).
- The next two fields are the date (e.g. 04=4th day of the month)
- The next two fields are the year (e.g. 11=2011).
- The final code in the sequence is the Plant Code (T), in all cases.

Valves included in this field action were manufactured during the period:

December 2, 2010 through January 18, 2012
 That is, M0210T through A1812T.

Codes for December 2010	<table border="1"> <tr> <td>M</td> <td></td> <td></td> <td>1</td> <td>0</td> <td>T</td> </tr> <tr> <td></td> <td>02</td> <td></td> <td></td> <td></td> <td></td> </tr> <tr> <td></td> <td>through 31</td> <td></td> <td></td> <td></td> <td></td> </tr> </table> <i>example: L0310T</i>	M			1	0	T		02						through 31				
M			1	0	T														
	02																		
	through 31																		
Codes for all of 2011	<table border="1"> <tr> <td></td> <td></td> <td></td> <td>1</td> <td>1</td> <td>T</td> </tr> <tr> <td>(alpha character)</td> <td></td> <td>Any Digit</td> <td></td> <td></td> <td></td> </tr> <tr> <td>in the range A through M</td> <td></td> <td></td> <td></td> <td></td> <td></td> </tr> </table> <i>examples: A3011T</i> <i>F2511T</i> <i>H1411T</i>				1	1	T	(alpha character)		Any Digit				in the range A through M					
			1	1	T														
(alpha character)		Any Digit

in the range A through M																			
Codes for January 2012	<table border="1"> <tr> <td>A</td> <td></td> <td></td> <td>1</td> <td>2</td> <td>T</td> </tr> <tr> <td></td> <td>01</td> <td></td> <td></td> <td></td> <td></td> </tr> <tr> <td></td> <td>through 18</td> <td></td> <td></td> <td></td> <td></td> </tr> </table> <i>example: A0312T</i>	A			1	2	T		01						through 18				
A			1	2	T														
	01																		
	through 18

Inspect your vehicle(s) as soon as possible to 1) verify whether an ATR-6 valve was used to service the vehicle; and 2) to verify the date code on the valve. If an ATR-6 valve was used, examine the date code stamped into the valve to confirm whether it is a part of the impacted population. **The photo and instructions at the close of this document will help you complete the inspection.**

Inspect your vehicle(s) as soon as possible to 1) verify whether an ATR-6 valve was used to service the vehicle; and 2) to verify the date code on the valve. If an ATR-6 valve was used, examine the date code stamped into the valve to confirm whether it is a part of the affected population. **The photo and instructions at the close of this document will help you complete the inspection.**
