Recall Notice

Recall #TS-0026 : Brake Caliper Slider Pins

Condition: Brake caliper pins not tightened to correct torque specification

**11/18/11 Re-Installation Instructions for TDE Caliper Slider Pins
Prepared for Tracker Trailers**

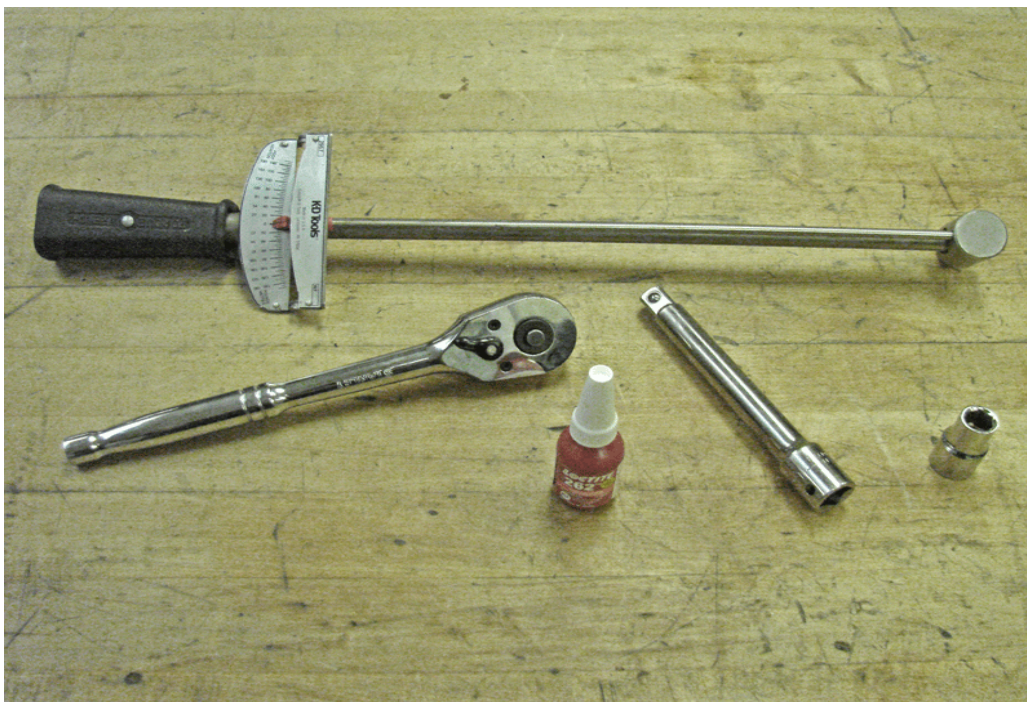
Photo 1 - Tools Needed for TDE Caliper Slider Pins Re-Installation: 1) 7/16" Socket, 2) Ratchet/Socket Drive, 3) Socket Extension, 4) Torque Wrench With Capacity of 50 Ft. Lbs. and 5) **Loctite 262 or Equivalent.**

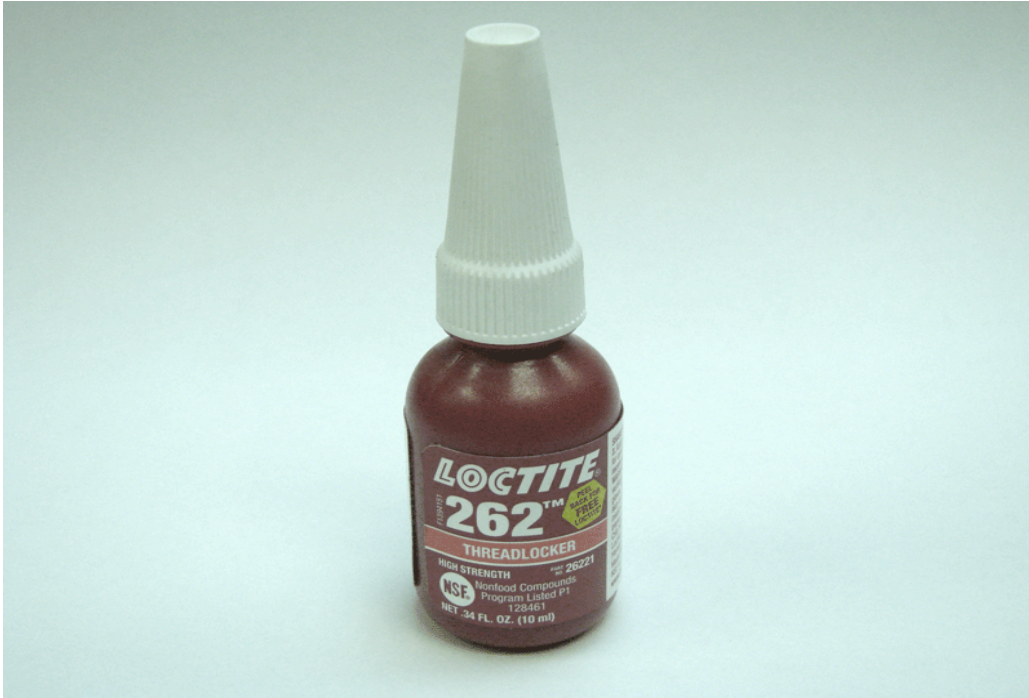
Photo 2 - Liquid Loctite 262 "Red", High Strength, Thread Locker. This is the Product Recommended by TDE In this Application.

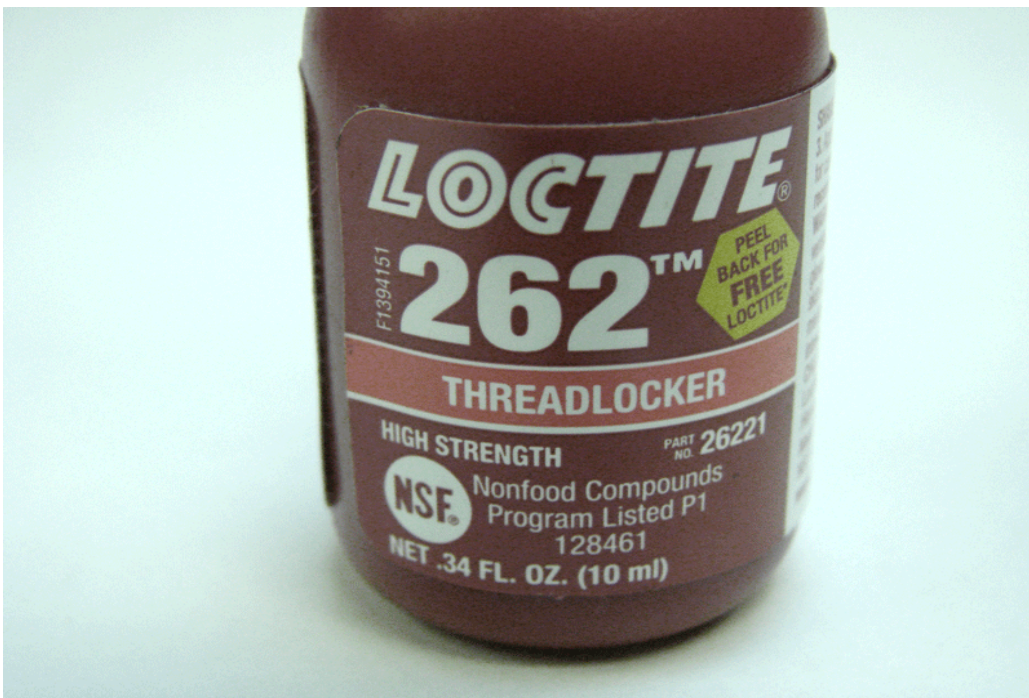
Photo 3 - Label Close-Up of Loctite 262.

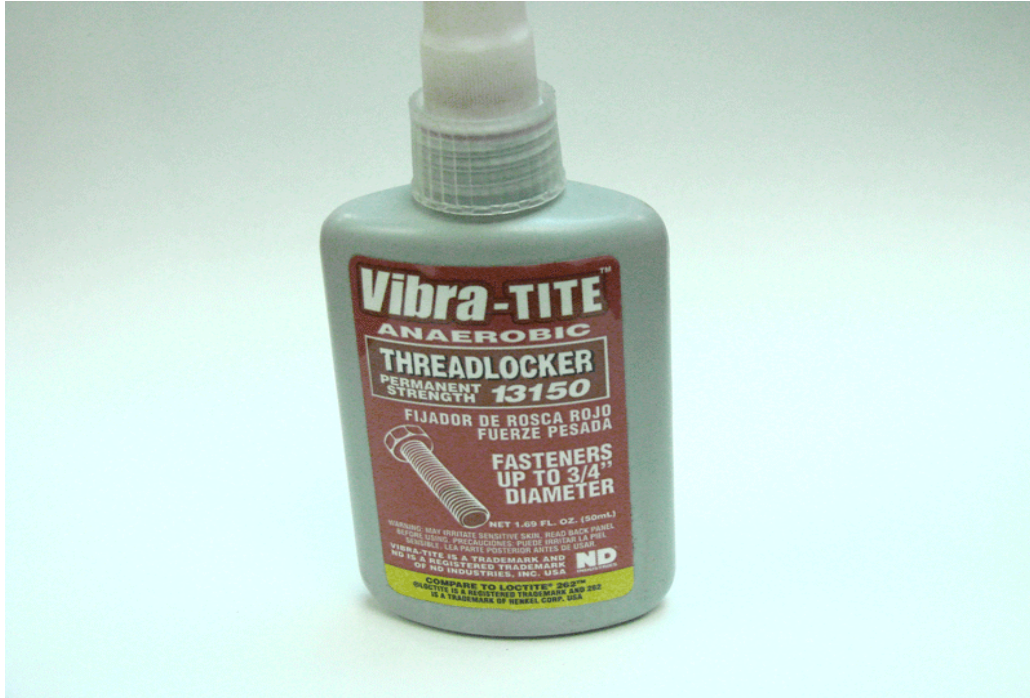
Photo 4 - Alternative, High Strength Threadlocker Produced by ND Industries. This Substitute Product Is Also Approved by TDE In this Application.

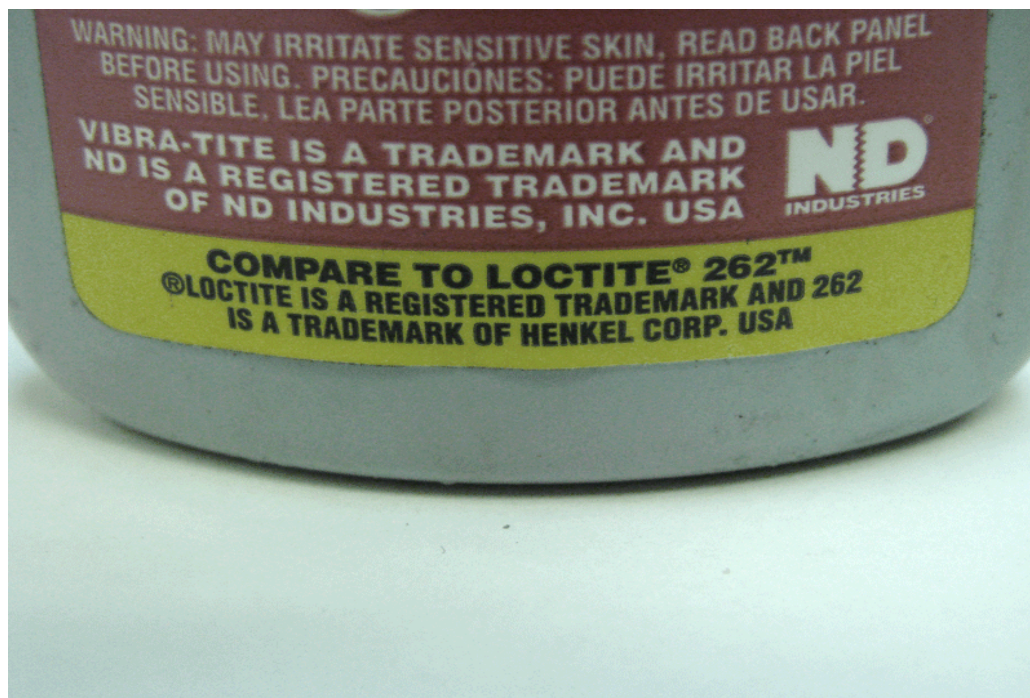
Photo 5 - Label Close-Up of ND Industries "Vibra-Tite" No. 13150 Stating Comparable Properties to Loctite 262.

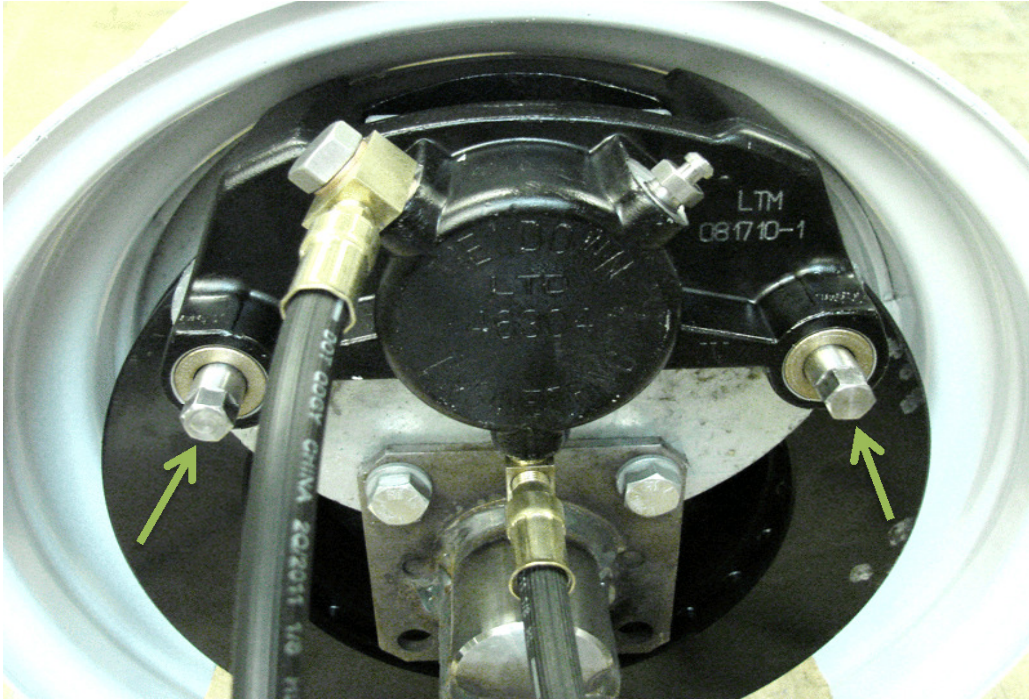
Photo 6 - General View of TDE Caliper As Installed On a Typical Axle Similar to Tracker Trailers. Realize This and the Following Photos Illustrate the Caliper Location in a Studio Setting without the Trailer Frame. Green Arrows Point to the "Slider Pins" That Will Be Removed and Re-Installed.

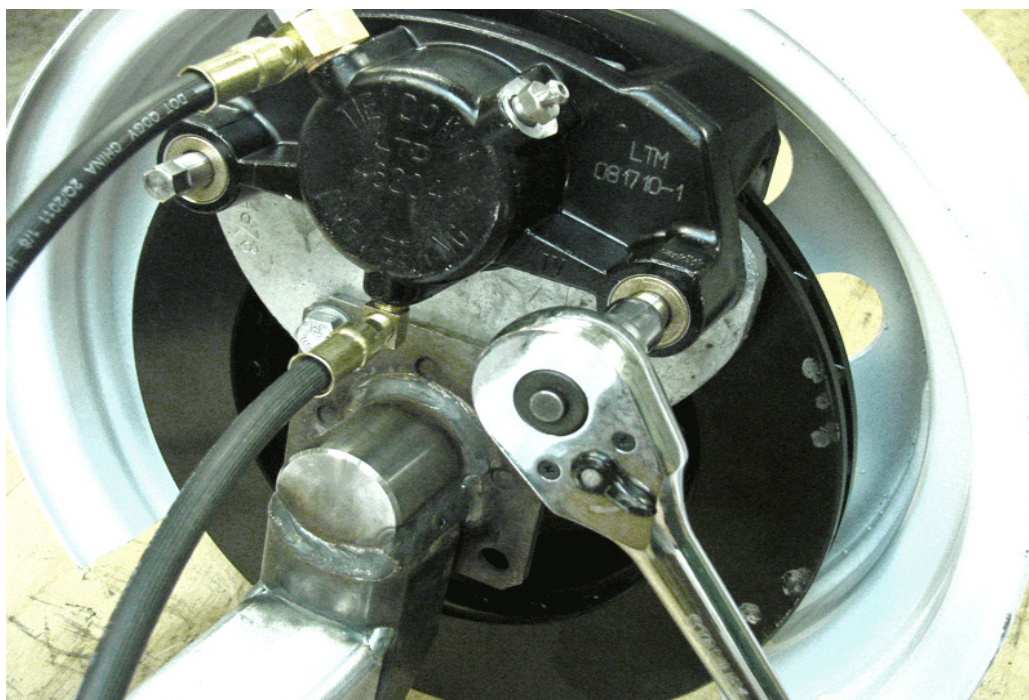
Photo 7 - Using the Socket/Ratchet Drive Loosen the First Slider Pin. You May Start With Either the Left or Right Slider Pin **But Only Remove One Slider Pin.**

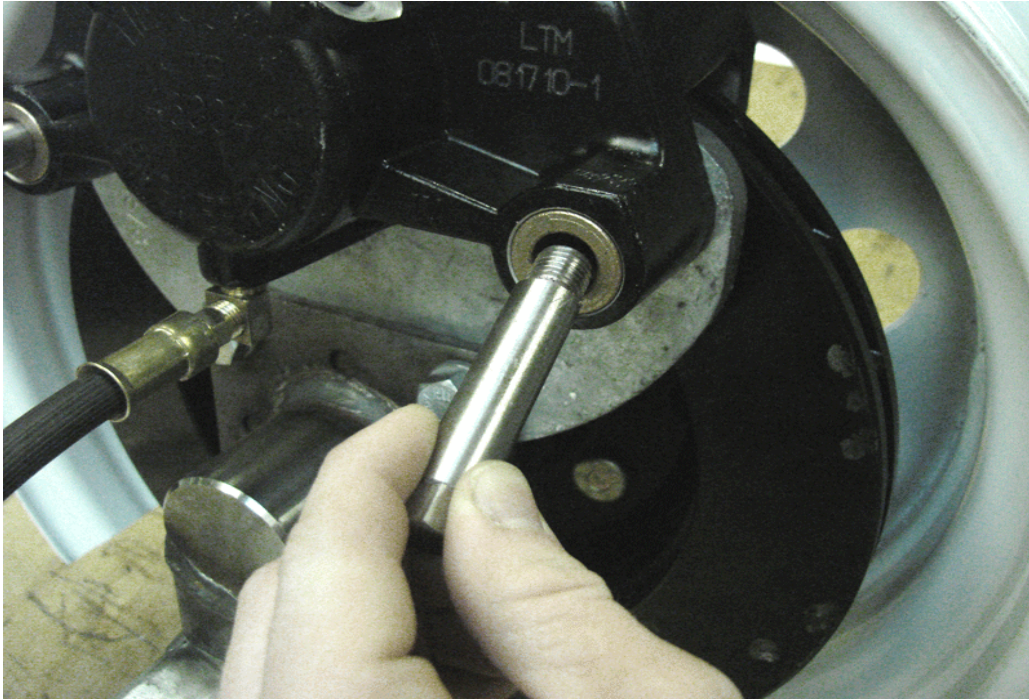
Photo 8 - Remove the Slider Pin Loosened In Photo 7.

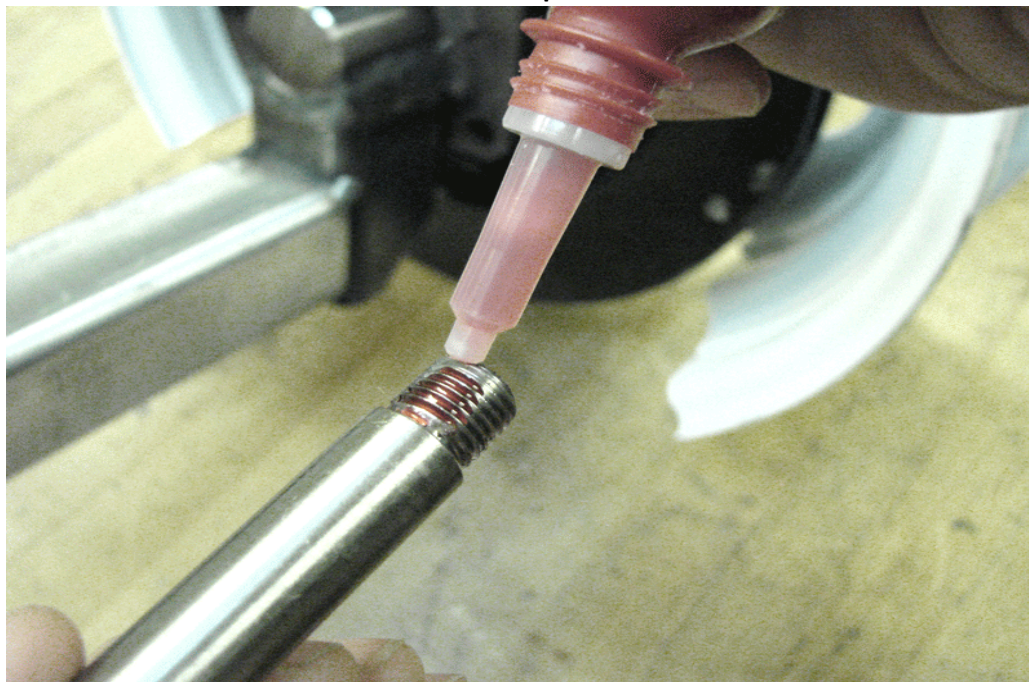
Photo 9 - With the Pin Removed Apply Liquid Loctite 262 To the Threads As Shown In the Photo. Realize Some Factory Applied Threadlocker Residue May Remain In the Threads That Residue Does Not Need to be Removed. **If Too Much Liquid Is Applied Forming A "Drip" - Wipe that Drip Off Before Inserting the Slider Pin Into the Caliper.**

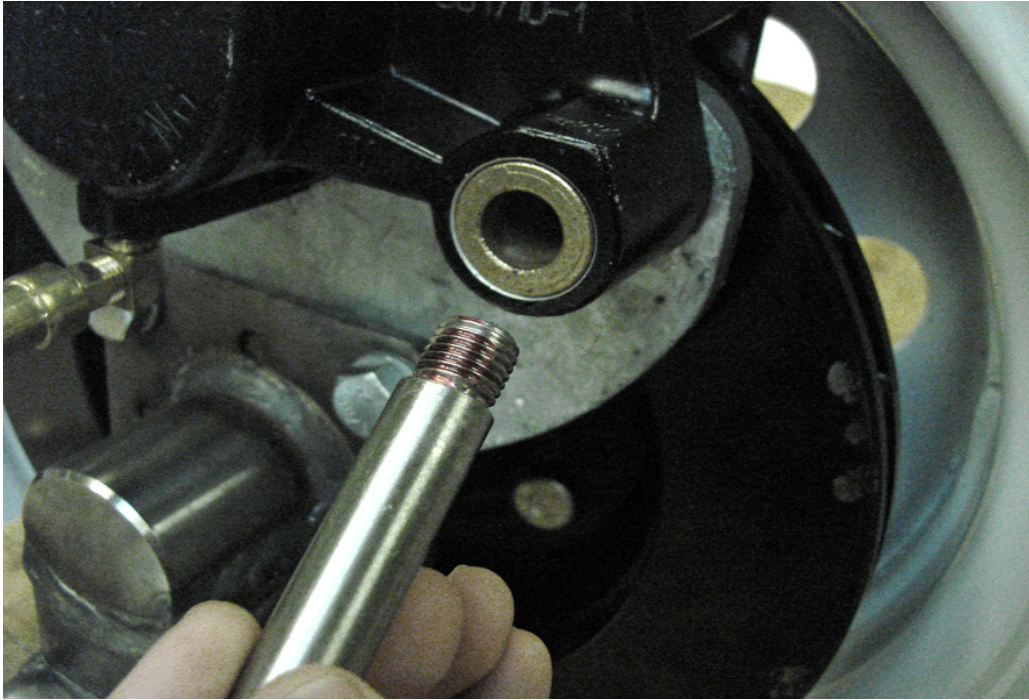
Photo 10 - Re-Install Pin Through Caliper and Into the Bracket.

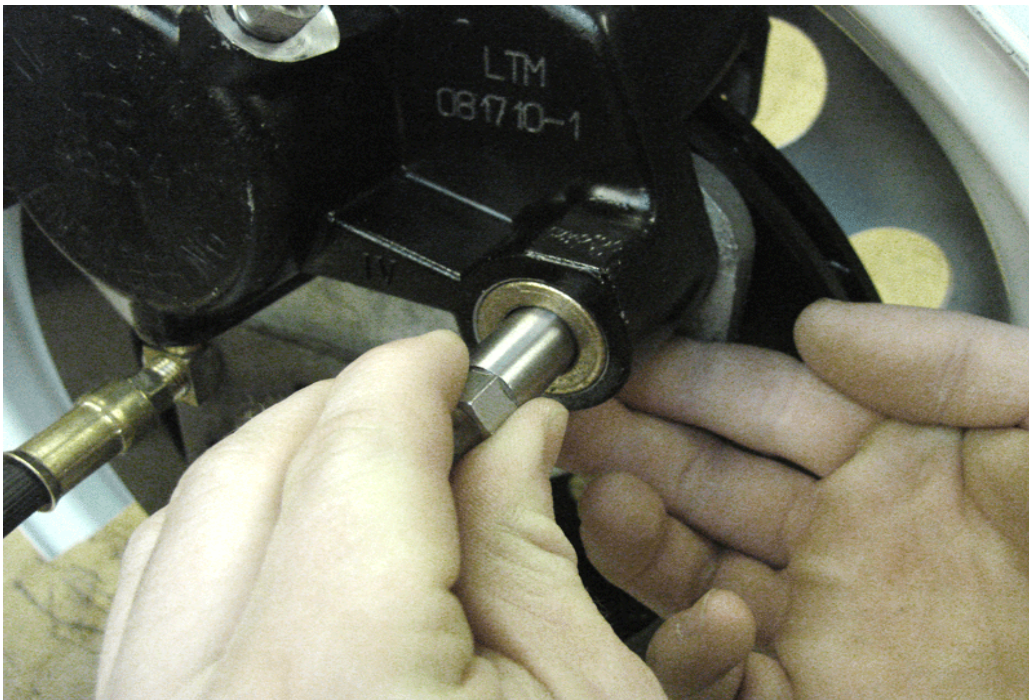
Photo 11 - To Align the Caliper Correctly with the Threaded Hole In the Mounting Bracket Lift the Caliper Slightly. You Will Feel The End of the Pin Align With That Threaded Hole.

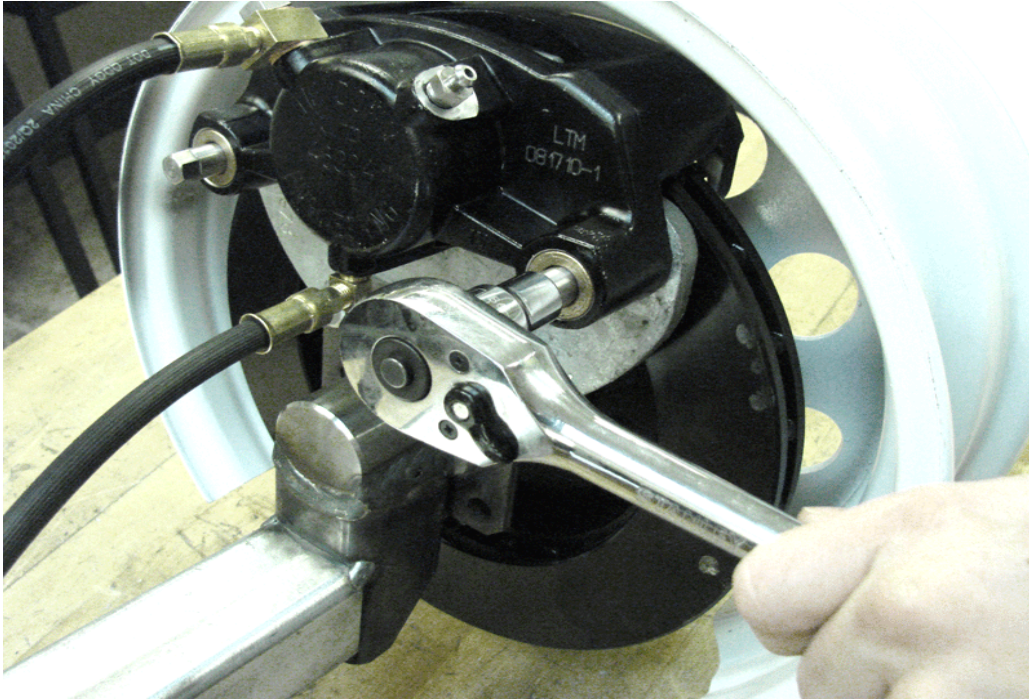
Photo 12 - Using the Socket/Ratchet Drive Tighten the Slider Pin.

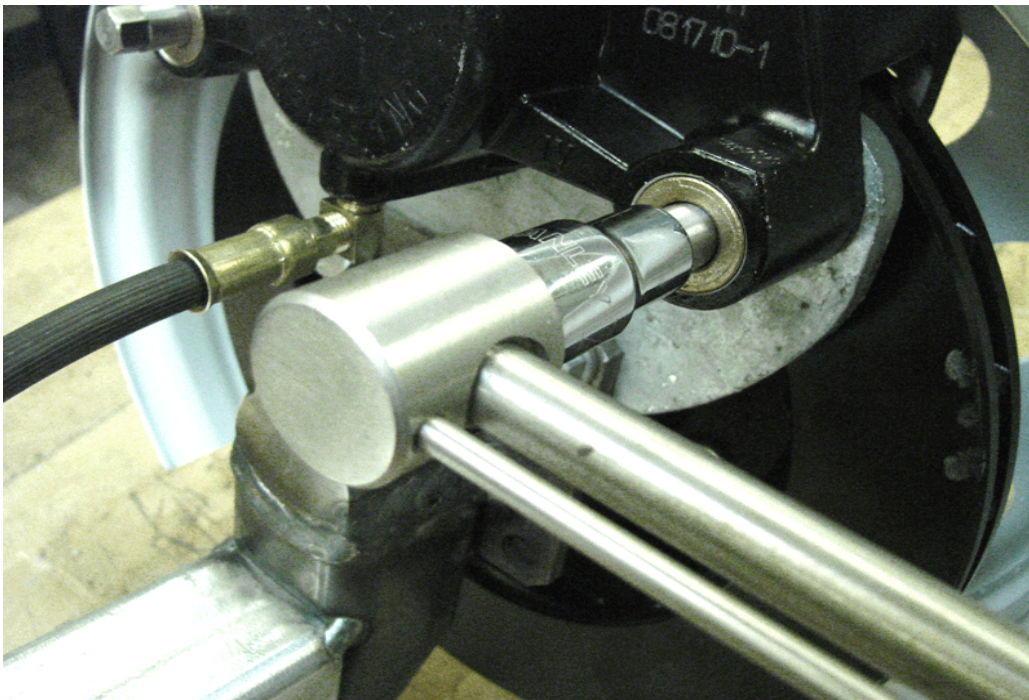
Photo 13 - With the Slider Pin Tight In the Mounting Bracket Now Switch the 7/16" Socket the Torque Wrench.

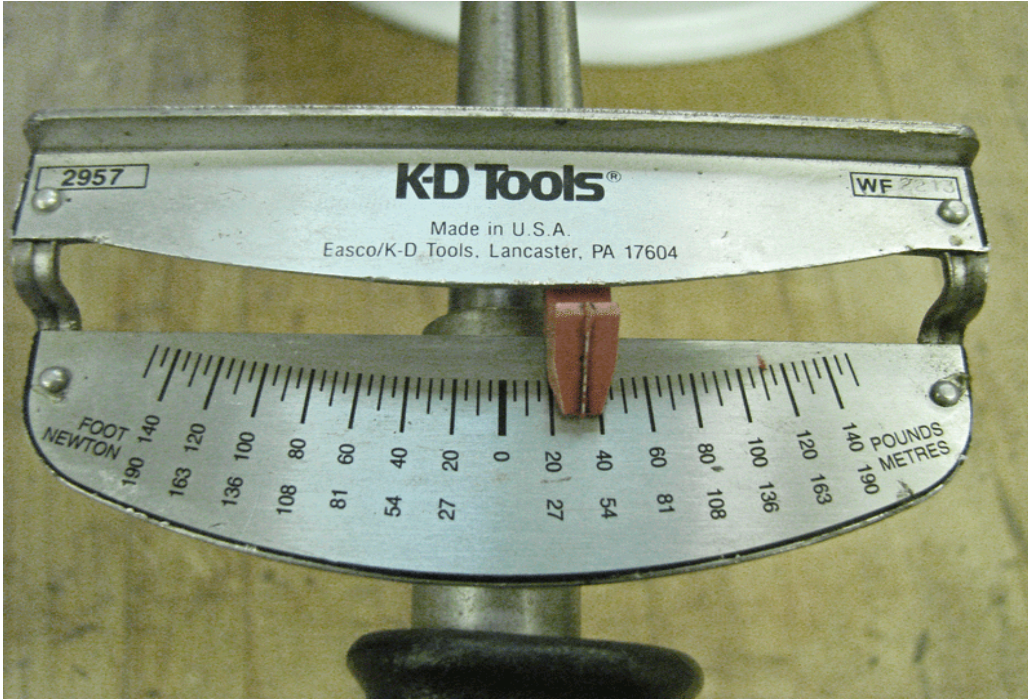
Photo 14 - Torque the Slider Pin to 35 Ft. Lbs. You Are Now Finished Re-Installing the First Slider Pin.

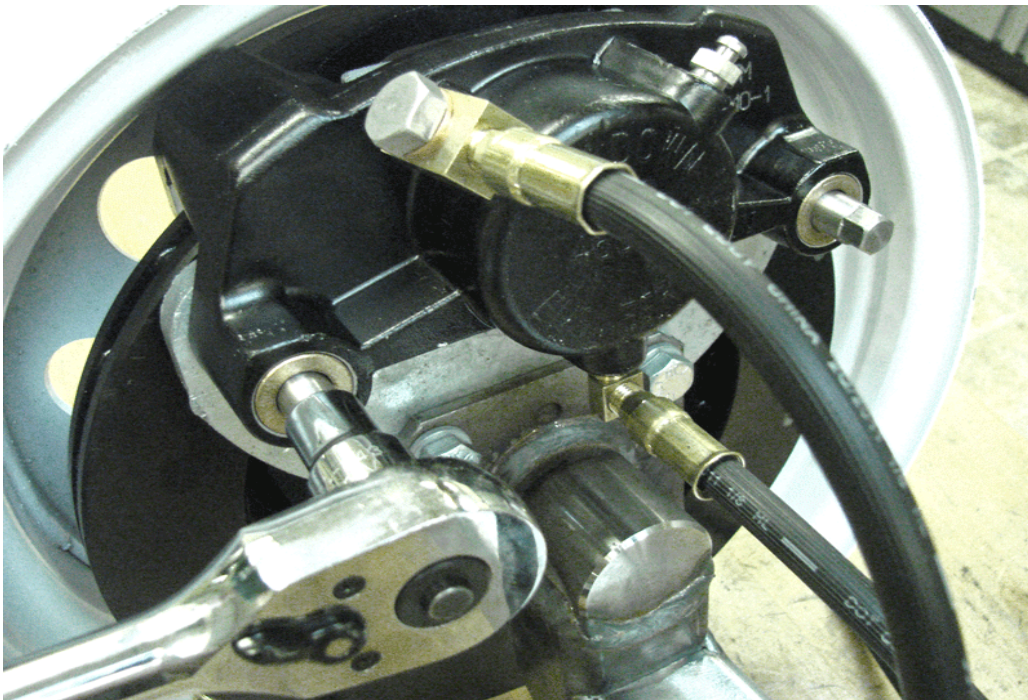
Photo 15 - Now Loosen the Second Slider Pin. Remember Only Work One Slider Pin At a Time. This Allows the Caliper to Remain Aligned with the Mounting Bracket.

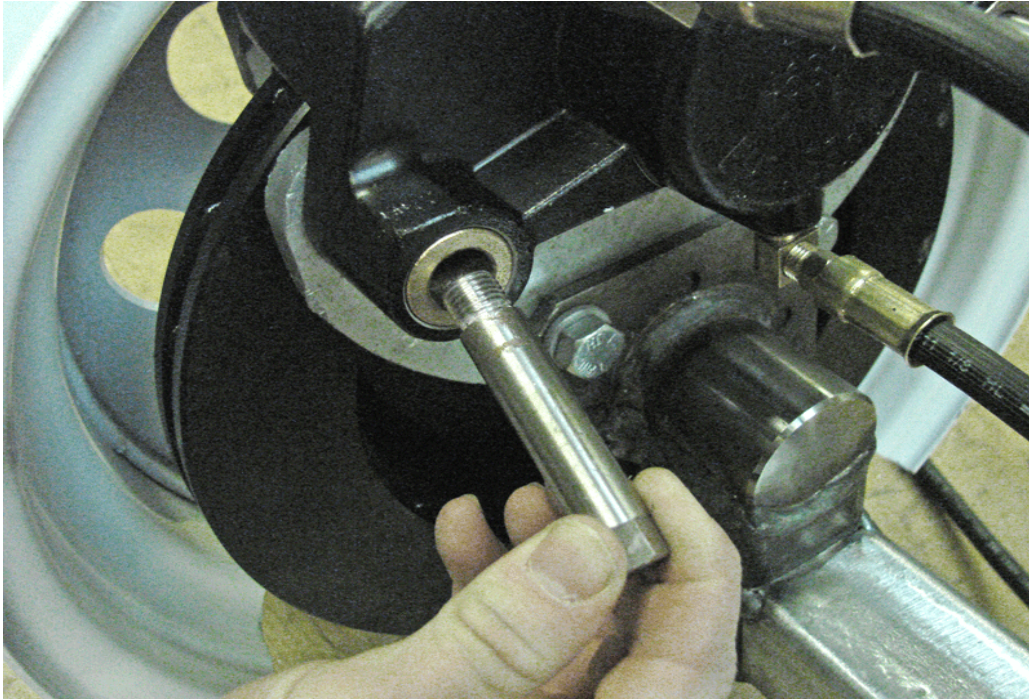
Photo 16 - Remove the Second Slider Pin.

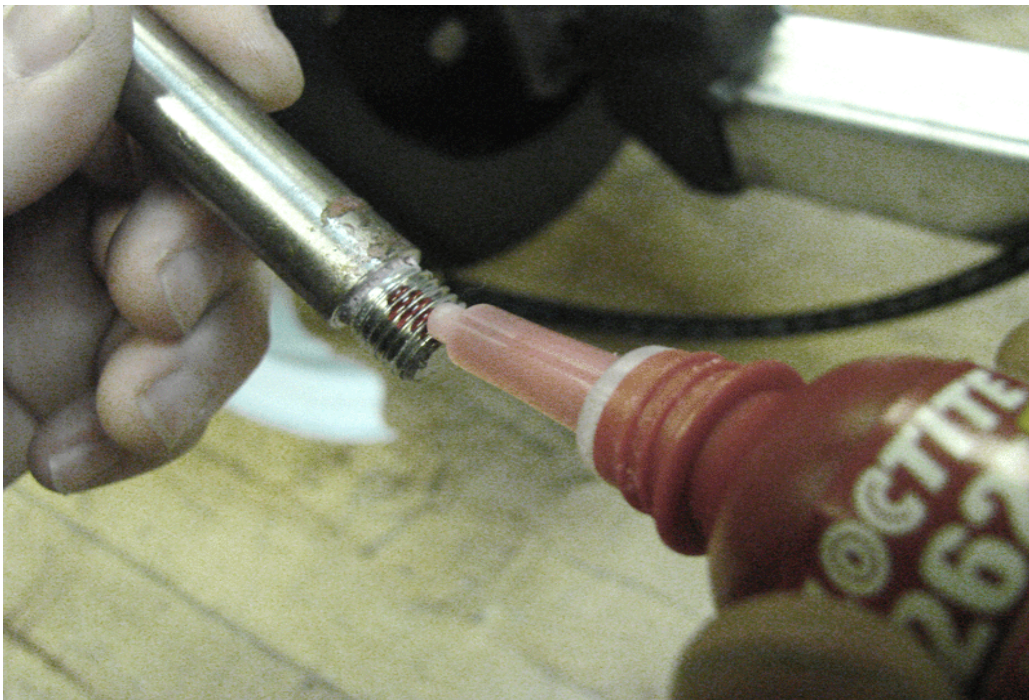
Photo 17 - Apply the Liquid Loctite 262 to the Threads of the Slider Pin As Shown.

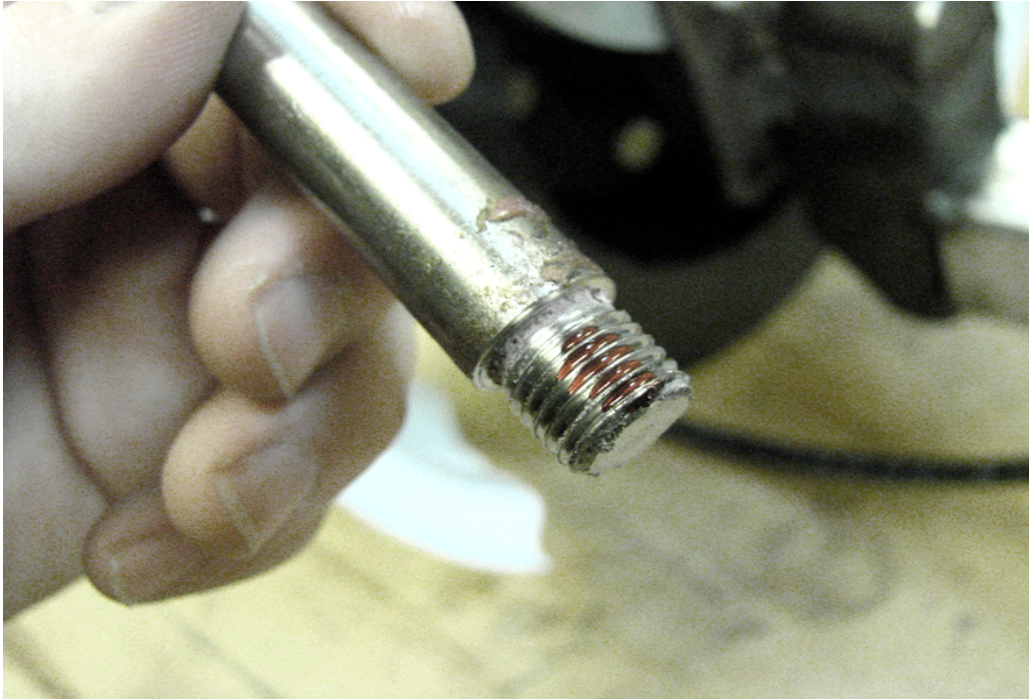
**Photo 18 - After Application the Liquid Loctite the Will Look Like This On the Slider
Pin Threads.**

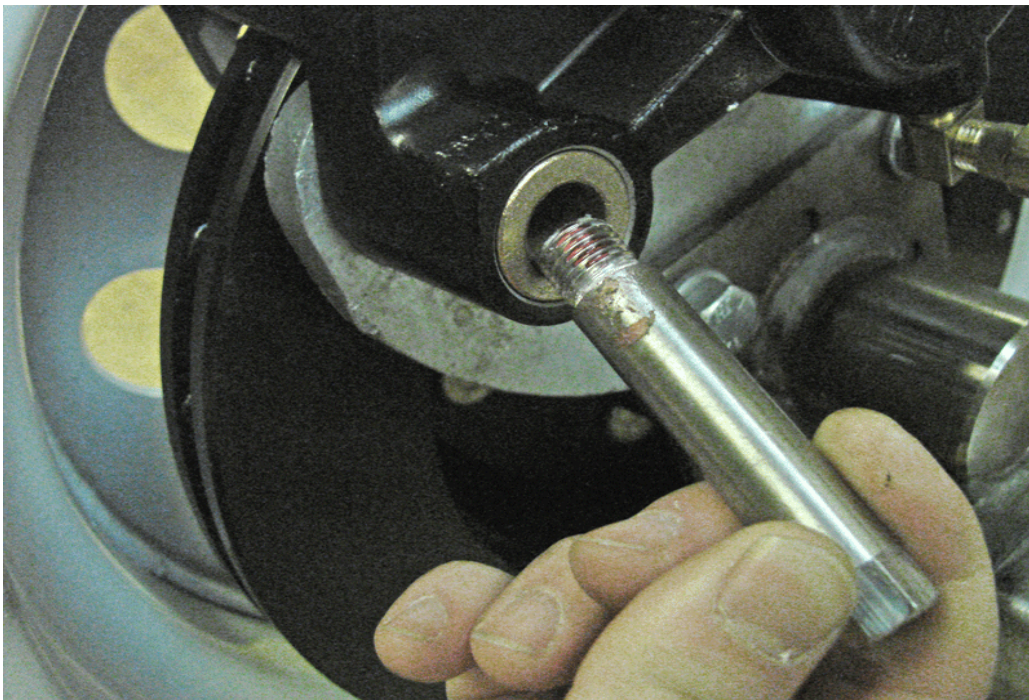
Photo 20 - Re-Install the Slider Pin Into The Caliper.

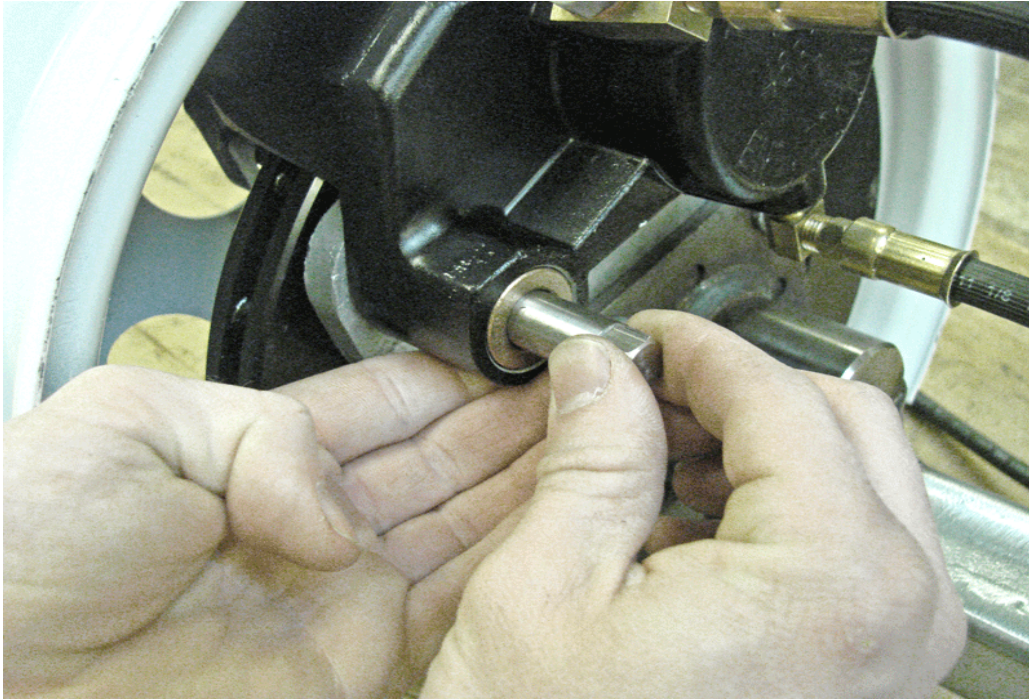
Photo 21 - Lift the Caliper Slightly - You Will Feel The Slider Pin Line Up with the Thread Hole In the Mounting Bracket. Begin to Thread the Slider Pin Into the Mounting Bracket.

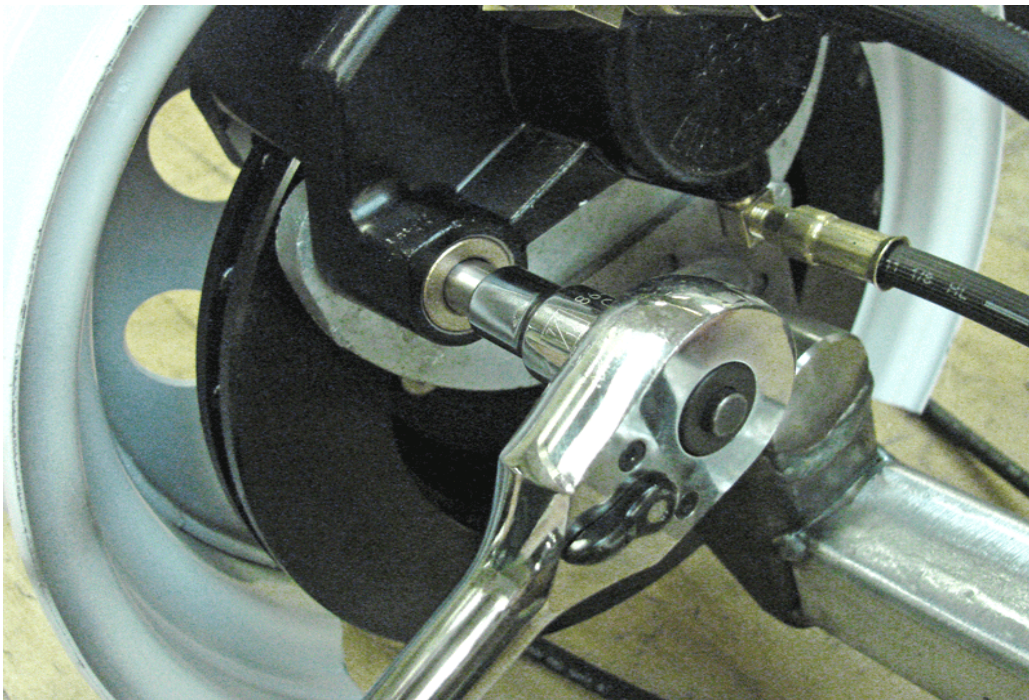
Photo 22 - Using the Socket/Ratchet Drive Tightened the Slider Pin.

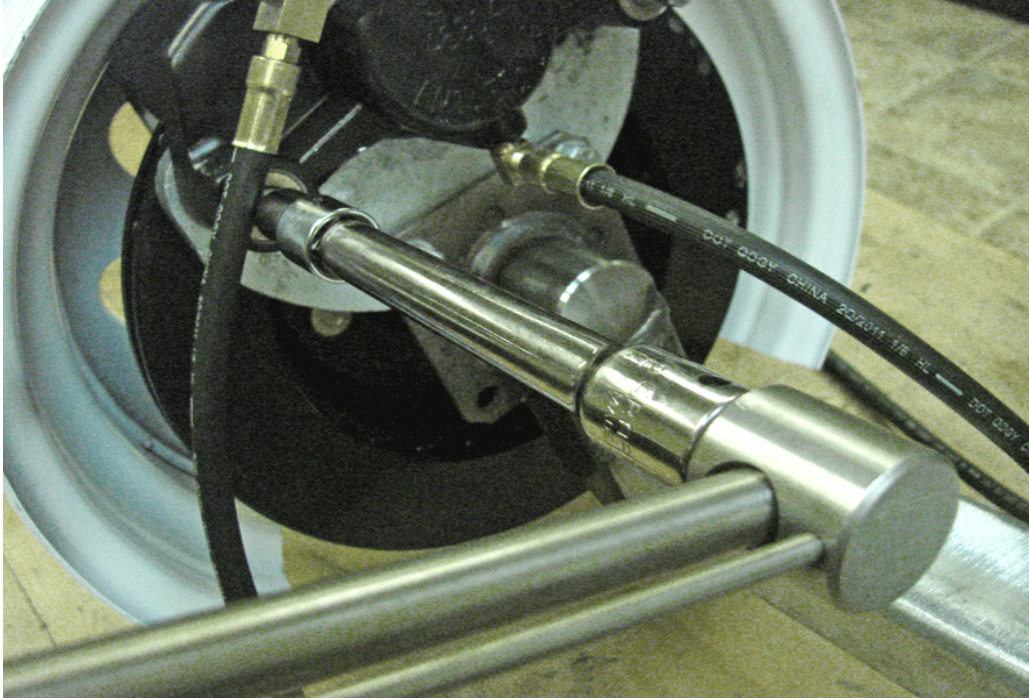
Photo 23 - Switch the 7/16" Socket to the Torque Wrench for Final Tightening. Photo Shows the Use of a Socket Drive Extension. This Extension Will Be Necessary In Field Installation Due to the Trailer Frame.

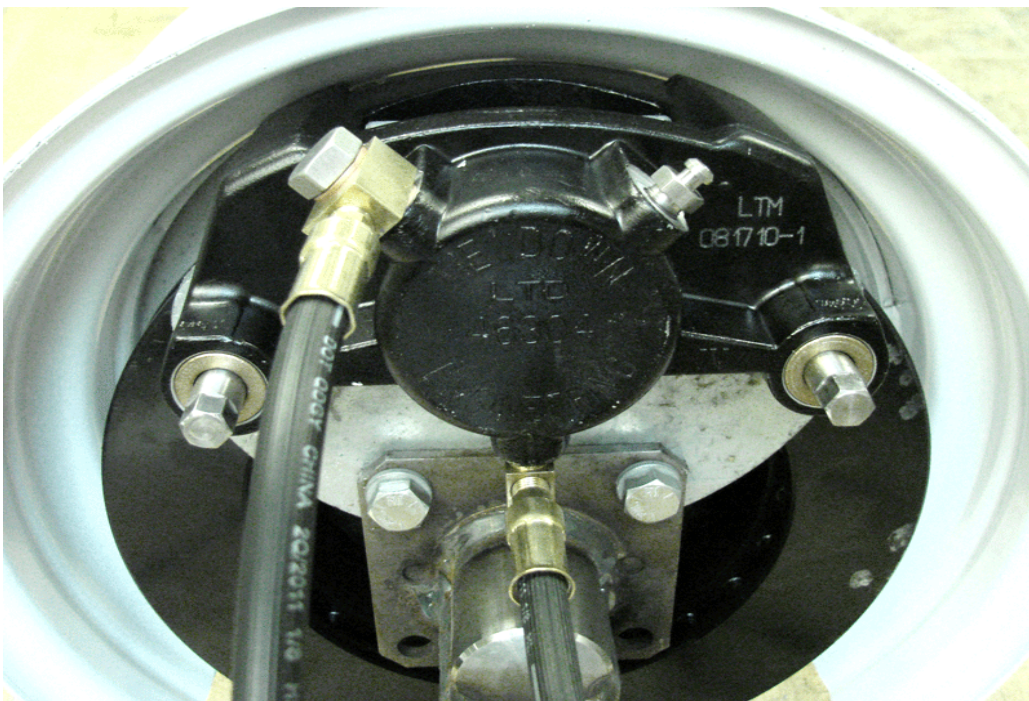
Photo 24 - Completed Re-installation of Slider Pins. Correct Threadlocker Applied, Both Pins Torqued to 35 Foot Pounds.
