R12VA

## Brake Treadle Valve Plumbing

# RECALL

**Models Affected: Certain 2010 through 2013 model year All Americans and Visions.**

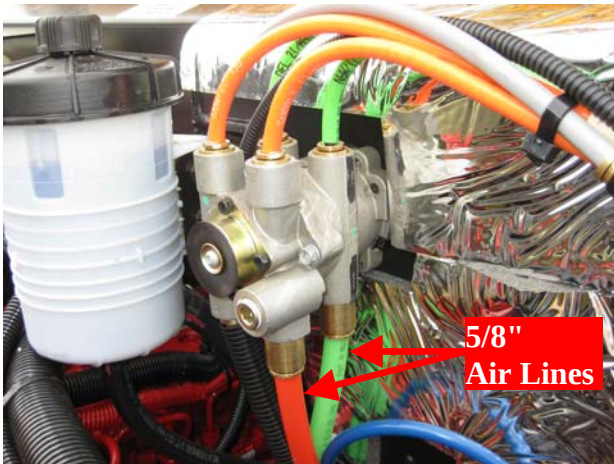
Vision Treadle Valve

The primary and secondary air brake lines may have been crossed at the brake treadle valve.

4. Turn off engine. Remove ignition key. Set parking brake. Drain air reservoirs.
5. At treadle valve, swap positions of 5/8" air lines.
6. Repeat brake pump down test.
7. If any part of the brake pump down test fails again, contact your Blue Bird dealer immediately.

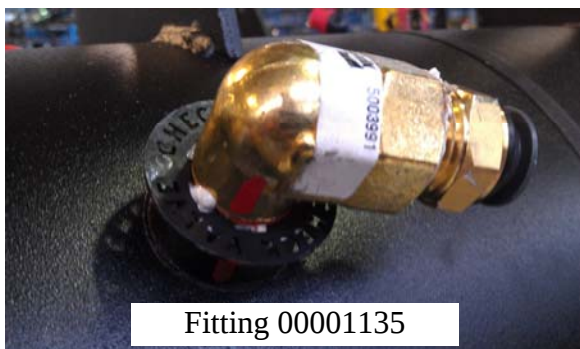
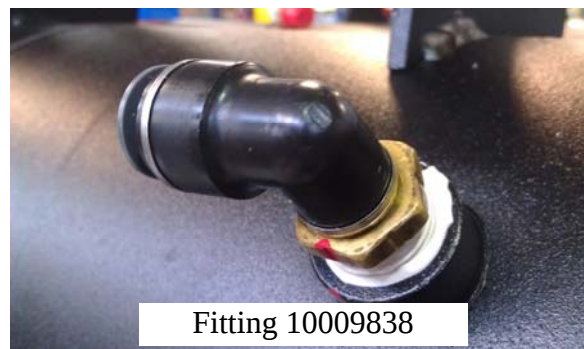
9. Inspect and verify reservoir fittings on outward side of air reservoir tank per illustration below.
10. Inspect and verify air tube routing on inward side of air reservoir tank per illustration below.
11. Move and replace fittings/air tubing that are found to be incorrect.
12. Repeat brake pump down test.
13. If any part of the brake pump down test fails again, contact your Blue Bird dealer immediately.
