TMS-NTC-13003
December 3, 2013

Re: Toyota Safety Recall 12V-305 – Owner Notification (Interim)

**2008 to 2011 Model Year Land Cruiser Vehicles
Potential Floor Mat Interference with Accelerator Pedal
SAFETY RECALL NOTICE (Interim Notice)**

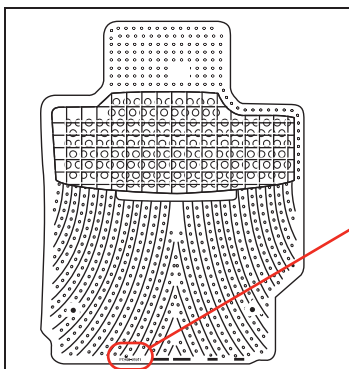
Driver's floor mat part number is located on the bottom of the back side of the mat.

The last 2 digits on the part number indicate the color code

NOTE: Use the Application Information Chart to verify mat-to-vehicle application.

(Sample of Application Information Chart)
See Attachments for details specific to your vehicle.
