**Recall 12-053-RHU/NHTSA Recall # 12V-362
(Roof Hatch ProLo – Increased friction between Rear Plate and Nylon Receiver)**

IMPORTANT SAFETY RECALL

July 2012

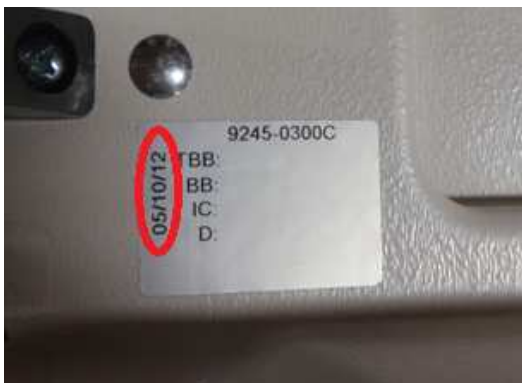
Check the label just to the right of the handle on the hatch lid for the build date to determine if the hatch was manufactured during the period from **April 1, 2011 through March 25, 2012**. Units built within this date range are subject to the campaign.

Replacing the 008956 Nylon Receiver on the ProLo hatch using the **009493 ProLo Repair Service Kit** will resolve the noncompliance. This kit includes (1) 008956 Nylon Receiver, (2) anti-rattle springs, (4) Phillips head screws and detailed work instructions (enclosed).
