## Maserati Technical Bulletin

Date: Feb., 2012  
Bulletin Number: MTB – 201201  
Supersedes: N/A  
Section: Compliance

**Model Type:** Granturismo & Granturismo Convertible Models  
**Model Year:** 2008, 2009, & 2010  
**Subject:** **Vehicle Safety Recall Campaign 198, Rear Tail Lamp Assemblies**

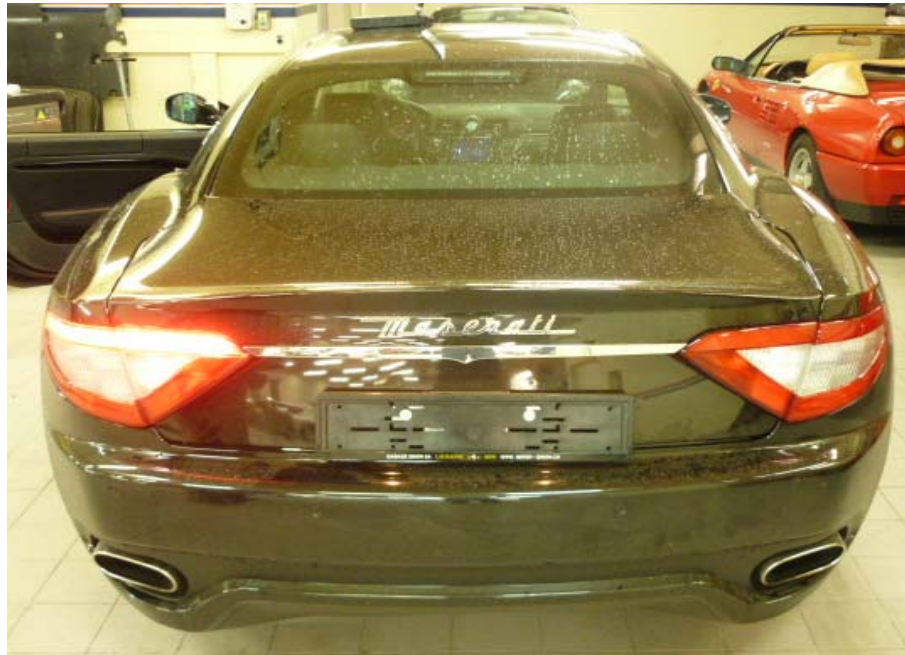
Maserati S.p.A. has determined that certain model year 2008, 2009 and 2010 Granturismo and Granturismo Convertible models were potentially manufactured with rear tail lamp assemblies which may fail due to a loss of functionality resulting in loss of operation which may lead to a reduction of vehicle visibility, increasing the risk of a crash. This **Safety Recall Campaign** involves the removal, checking and possibly replacement of the rear tail lamp assemblies (both right and left side). The illustration below shows one side operative and the other inoperative.

**If rear tail lamp assembly requires replacement, this will be done free of charge to the customer.**

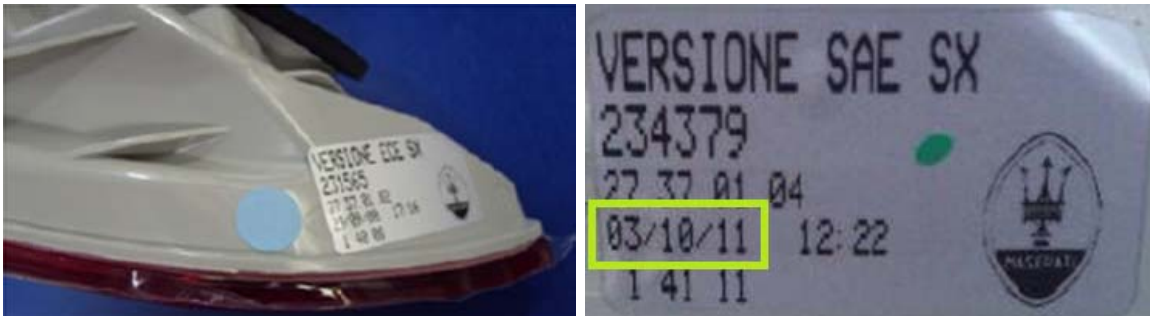
1. Ensure that the vehicle is involved in the action and if the campaign has not been previously performed.
2. Remove both rear tail lamp assemblies (fixed side) from the vehicle.
3. Check the production date of the tail lamp assembly (Please note it is written in European format: DD/MM/YY).

4. If the rear tail lamp production date label indicates a date earlier than 15/01/10 (January 15<sup>th</sup> 2010), install a new rear tail lamp onto the vehicle (**otherwise re-install the original rear tail lamp assemblies back onto the vehicle**).
5. The Recall Procedure completed.
