## Bendix ATR-6 Valve, Permanent Repair

### SC0363, Bendix ATR-6 Valve, Permanent Repair

**How to Install a Replacement Cover Assembly for a  
Bendix® ATR-6™ Traction Relay Valve  
(Kits K070677 and K071015)**

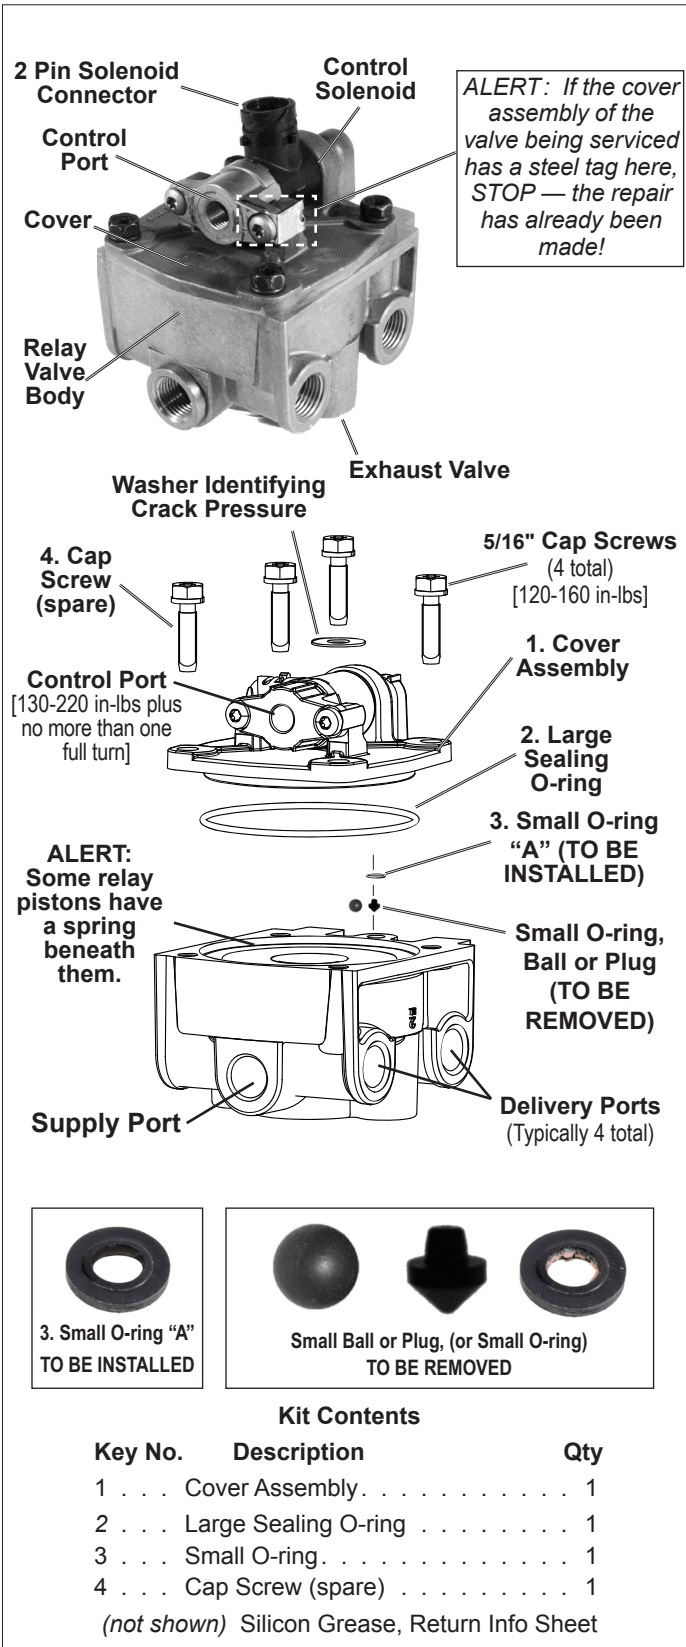
**FIGURE 1 - BENDIX® ATR-6™ TRACTION RELAY VALVE**

1. Verify that the Bendix® ATR-6™ valve does not have a steel tag (See Figure 1) that indicates it has already been serviced.
2. **Clean the valve and take care to avoid any contamination inside the valve during these procedures.**

6. • **Remove and discard the ball or plug** (“A” in Figure 1) from between the cover and the valve, OR,  
• For ATR-6 valves that have not been serviced by a temporary disable kit, there will not be a ball or plug; **remove and discard the original small O-ring.**

8. Grease and install the new large sealing O-ring (2) and the small O-ring (3) supplied, into the NEW valve cover.

5. Be sure to mark the orientation of the cover. Using hand wrenches, remove and retain the four cap screws (and I.D. washer) and bracket(s). (ALERT: Some relay pistons have a spring beneath them).  
NOTE: If cap screw(s) break off, or are stripped, install a replacement ATR-6 valve (or relay valve lower body). A spare cap screw is included in the kit.

9. Verify that no contamination has entered the valve. You **MUST** remove any debris inside. Use a clean shop cloth/shop air and use the supplied grease to replace any removed. With the replacement cover assembly (and mounting bracket) in the same orientation as the original, place the cover assembly into position over the valve body.

USE HAND-WRENCHES (ideally torque-wrenches) to re-install the four cap screws and I.D. washer in the cover and torque (in a cross-pattern) to 120-160 in-lbs. NOTE: All torques specified are assembly torques and can be expected to fall off slightly after assembly. Do not re-torque after the initial assembly torque falls off; **Do not over-tighten — overtightening could crack the cover or strip the threads.**
