Recall Bulletin

PRODUCT SAFETY RECALL

SUBJECT: Steering Gear Pitman Shaft Fracture - Inspect Steering Gear

MODELS: 2012 Chevrolet Express, Suburban
2012 GMC Savana, Yukon XL
Heavy Duty Vehicles

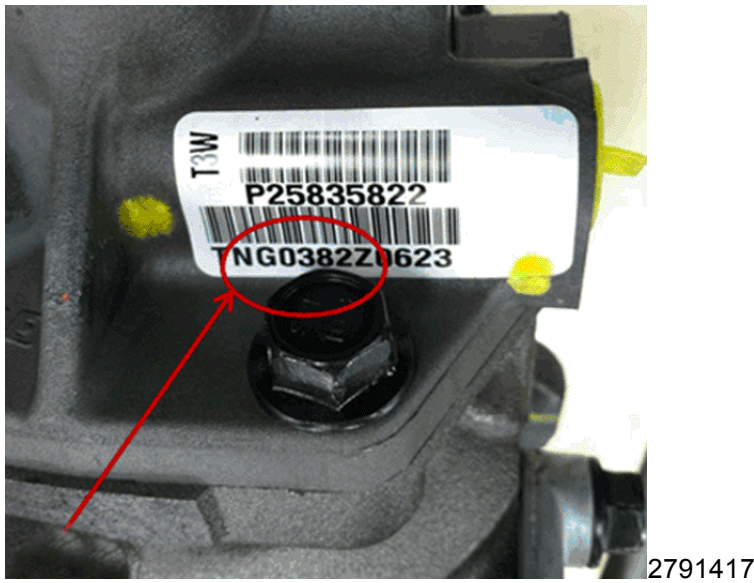
Digits 4-8 of the TNG number signify day and year of the build. The digits in the 4-8 position in the illustration are 0382, which means the steering gear was built on the 38th day in 2012. This steering gear would require replacement of the steering gear pitman shaft and housing.

Note: A flashlight and mirror may be required to view the digits on the TNG label.

3. Determine the build date of the steering gear by reading the TNG number on the label. Refer to illustration. Refer to the table below to determine if the steering gear pitman shaft must be replaced.

Steering Gear Date Code	Action Required
January 19, 2012 or earlier	Proceed to Step 7
January 20, 2012 through February 22, 2012 (0202 through 0532)	Proceed to Step 4
February 23, 2012 or later	Proceed to Step 7

4. Remove the steering gear and replace the steering gear pitman shaft and housing cover. Refer to *Steering Gear Pitman Shaft Replacement* in SI.
5. Road test the vehicle. Drive the vehicle on the highway for ten minutes to determine steering effort and steering wheel return-to-center characteristics. If steering effort or steering return-to-center is poor, verify power steering fluid level, steering gear pitman shaft over-center preload and wheel angle and toe alignment.
6. Check power steering fluid level. Add fluid if required.
7. Record the TNG number on the repair order.
