**PREVOST**

**SAFETY  
RECALL**

SR12-26

<b>DATE :</b> JULY 2012	<b>SECTION :</b> 06-ELECTRICAL
<b>SUBJECT :</b> PROTECTION AGAINST POWER CABLE RUBBING

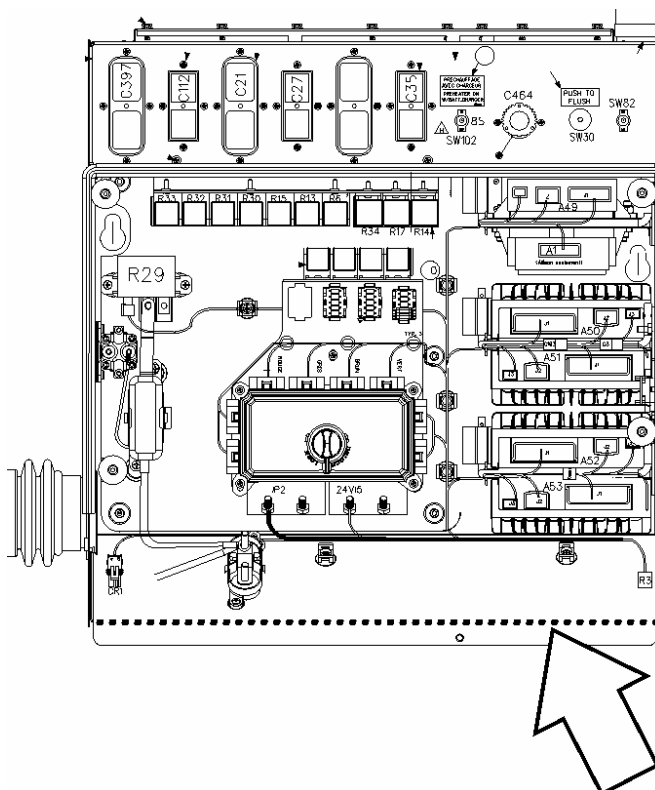
1. In the rear electrical compartment, locate the panel lower edge.

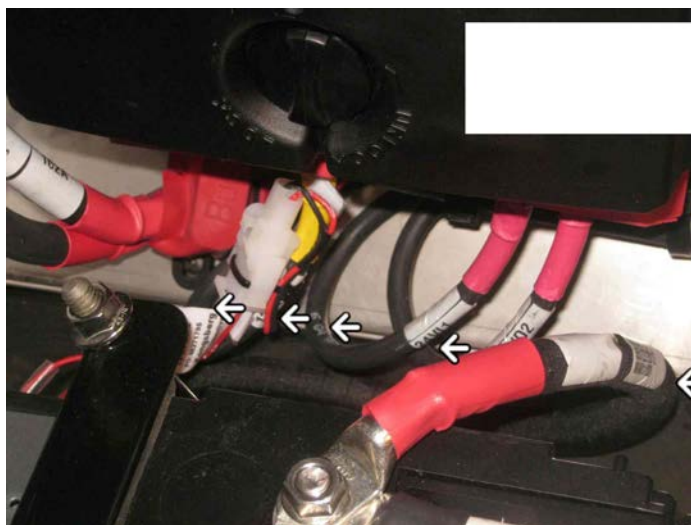
2. No cable should touch this edge even if it is rounded.

Along the complete edge, make sure that no cable touches it.

If required, use cable ties to route cables away from the edge.

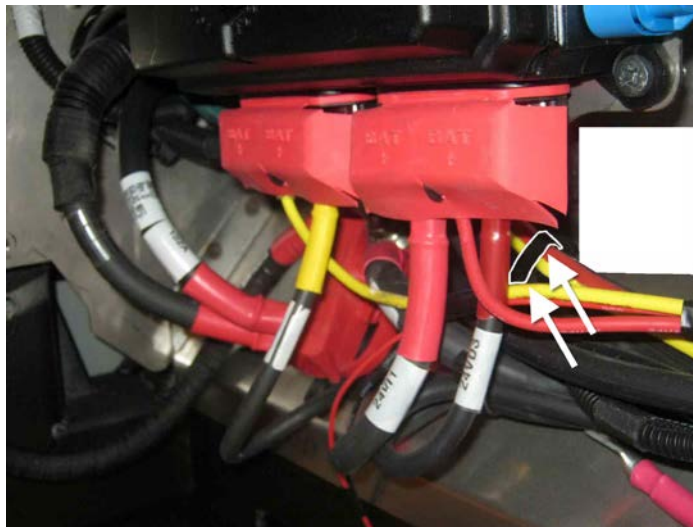
3. Make sure this cable tie is tight (arrows). It is mounted on a cable tie base.

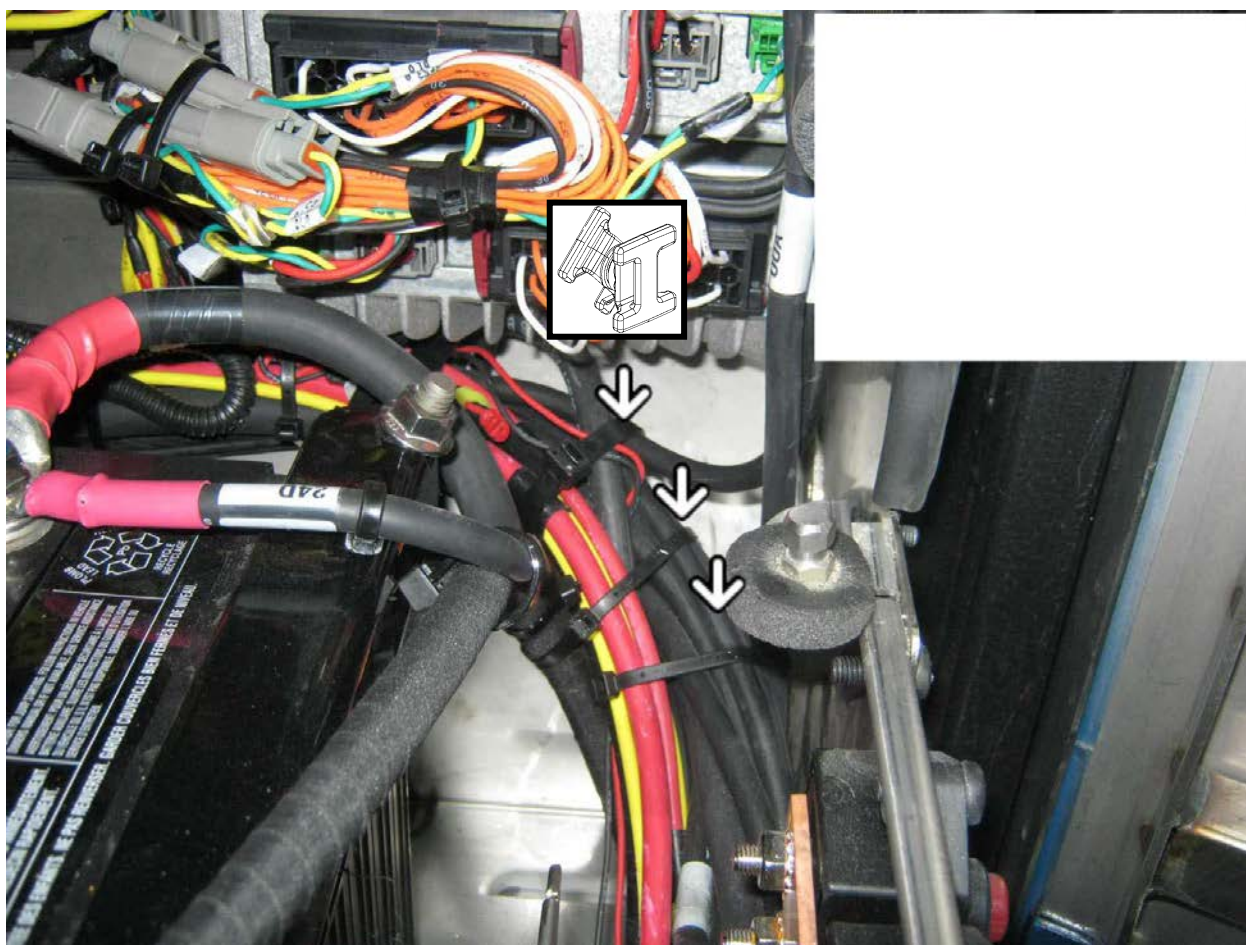
Secure cable bundle at arrow locations making sure to clear the heat sink of the IO module.

Install #504751 double swivel cable tie base with 509491 cable tie on cable bundle.

Base should be installed behind the bundle and bearing on the edge.

Use base as a permanent spacer to maintain a distance from the edge.

Secure the remainder of the bundle with 504016 cable ties.
