Applies To: **2012 Ridgeline** – Check the iN VIN status for eligibility

**Safety Recall: Hazard Switch Assembly With Incorrect “Passenger Airbag Off” Indicator**

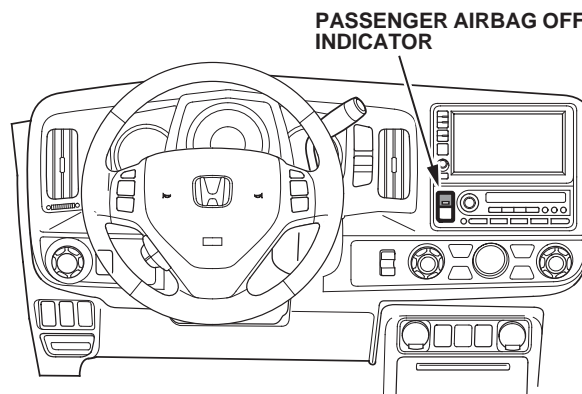
Inspect the passenger airbag off indicator; it is on the dashboard hazard switch assembly.

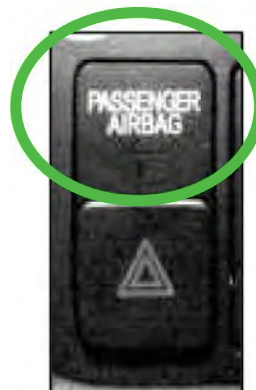
**CORRECT**

Use the illustrations to determine if the indicator is correct or not correct.

**Correct** – If the indicator is correct, no repair is necessary.

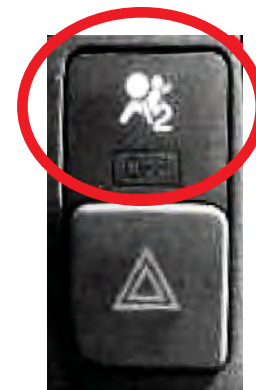
A dashboard hazard switch assembly incorporating an incorrect “passenger airbag off” indicator may have been installed on seventeen 2012 Ridgelines. The passenger airbag off indicator on the switch does not comply with FMVSS 208.

**NOT CORRECT**  
Replace the switch.

**Not Correct** – If the indicator is **not** correct, go to **REPAIR PROCEDURE**.

Replace the hazard switch assembly:

- Refer to the appropriate service manual, or
- Online, enter keyword **INSTRUMENT**, and select **Instrument Panel Removal/Installation** from the list.
