Applies To: **2002–06 CR-V** –  
ALL VINs Beginning with SHS – Check the iN VIN Status Inquiry

**April 8, 2014**

## Safety Recall: 2002–06 CR-V Driver's Power Window Switch Does Not Work or Works Intermittently

(Supersedes 12-067, dated January 18, 2013; see REVISION SUMMARY)

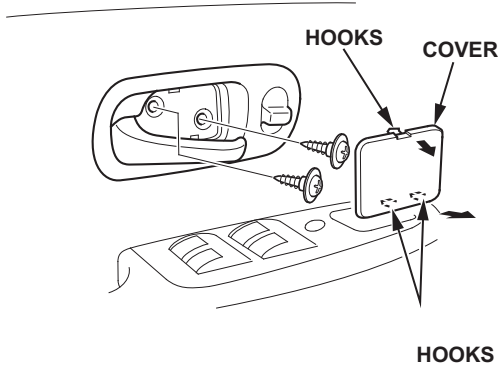
1. Make sure the window is up, then using the appropriate trim tool, pry out the upper portion of the cover to release the hooks, then remove the cover.

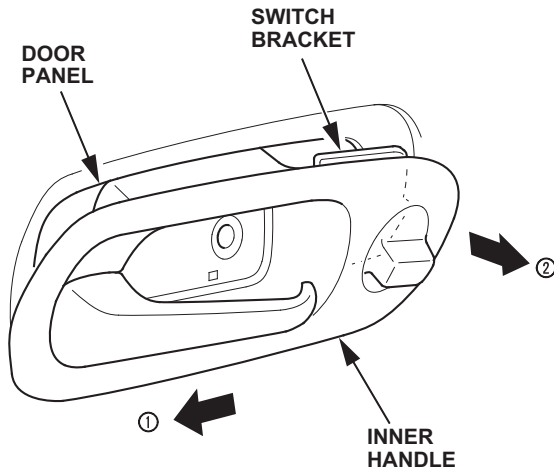
2. Remove the screws.
3. Release the power door lock switch bracket from the door panel by pulling the inner handle rearward and out halfway.

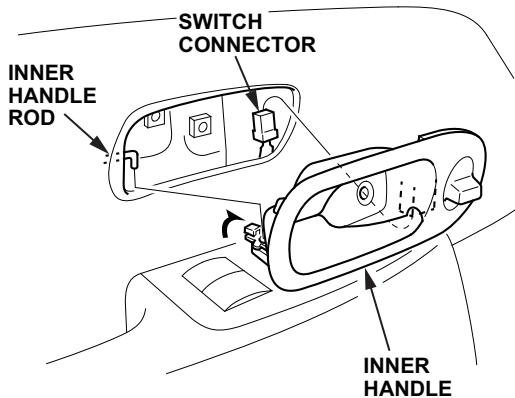
4. Disconnect the power door lock switch connector. Disconnect the inner handle rod, and remove the inner handle.

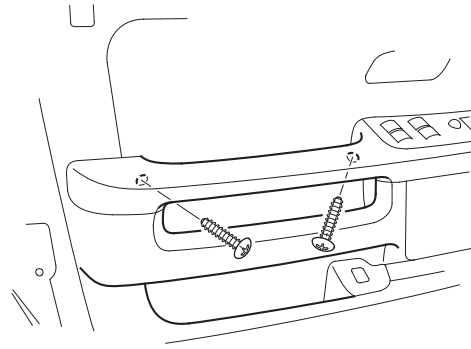
5. Remove the screws from under the armrest.

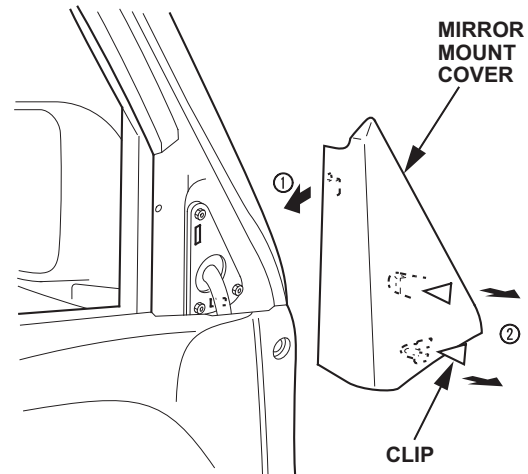
6. Carefully pry out the mirror mount cover by hand in the sequence shown.

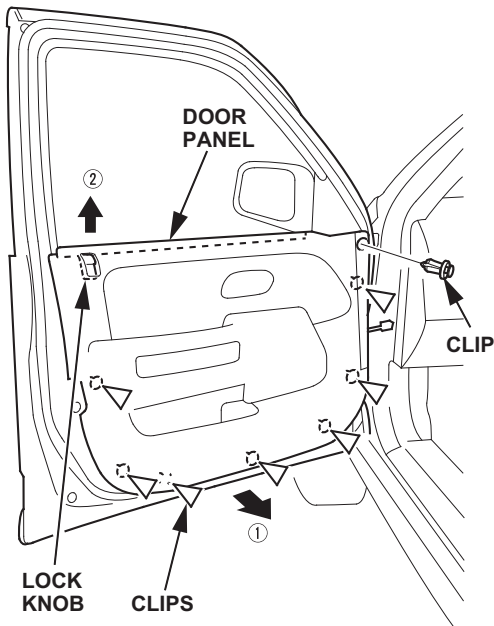
7. Remove the door panel.

- Remove the clip.

- With the appropriate trim tool, pry up to release the clips that hold the door panel.
- Starting at the rear, pull the door panel upward, then release the lock knob.

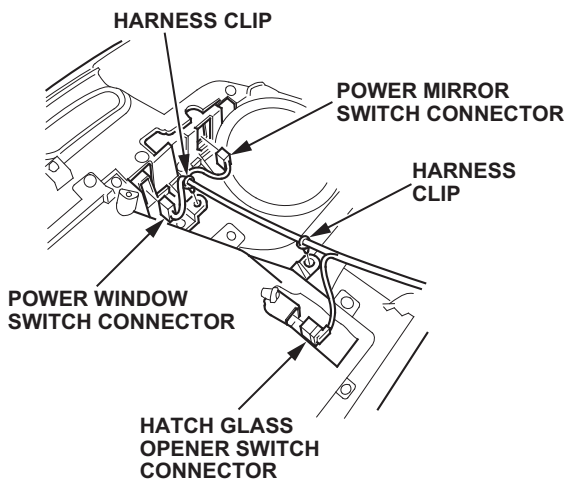
8. Disconnect the power window switch connector, the power mirror switch connector, and the hatch glass opener switch connector, and detach the harness clips from the back of the door panel.

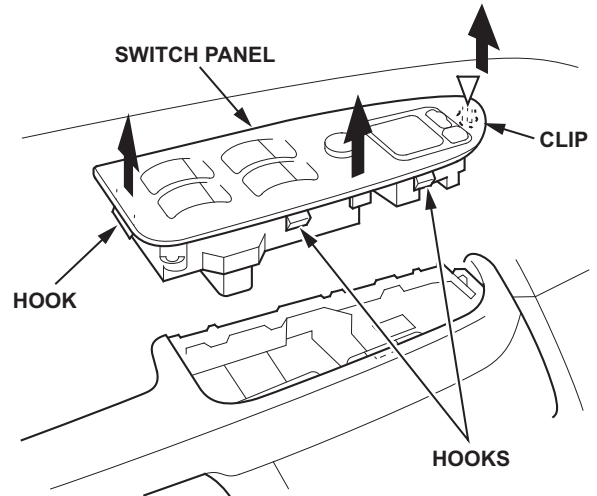
9. Push up on the bottom of the power window switch to release the clip and the hooks, then remove the switch.

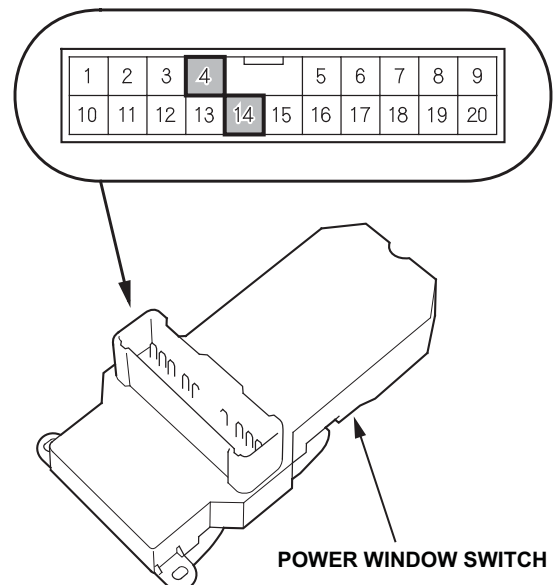
11. Measure the resistance between window switch terminal No. 4 and No. 14.

- If the resistance is less than 10k ohms, replace the power window master switch, then reinstall the door panel, the mirror mount cover, and the door lock switch. The repair is complete.
- If the resistance is at least 10k ohms, the power window master switch is OK. Go to REPAIR PROCEDURE A.

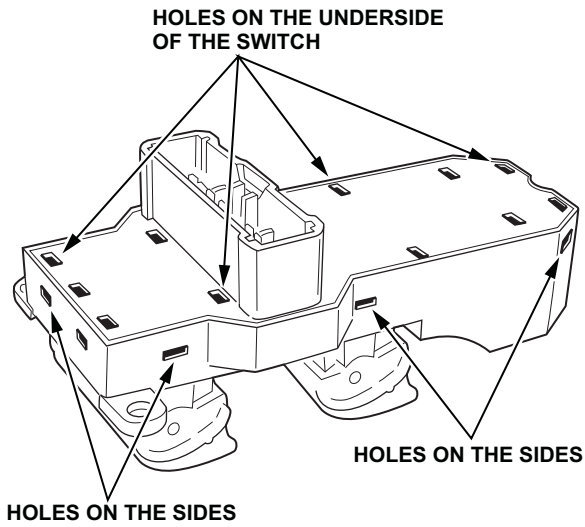
NOTE: You must cover all the holes in the power window master switch with the butyl tape and plastic sheet. If the holes are not completely covered, liquid can still enter the switch.

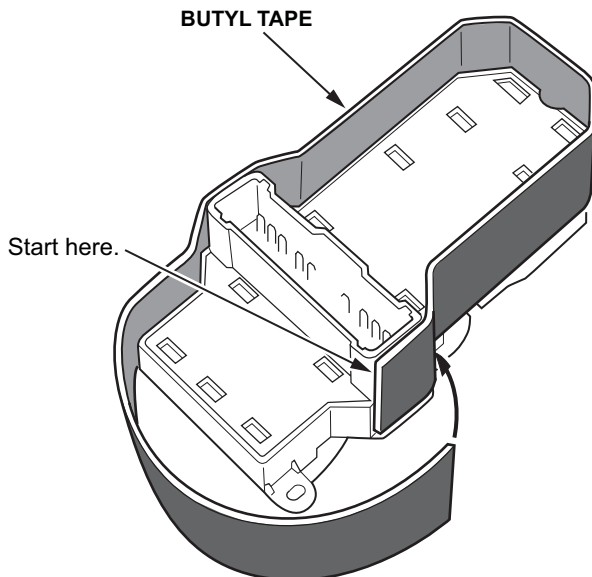
1. Clean the power window switch with a shop towel and rubbing alcohol. Apply the alcohol to the towel, but do not apply alcohol directly to the switch.
2. Affix the butyl tape onto the switch, starting at the connector as shown.

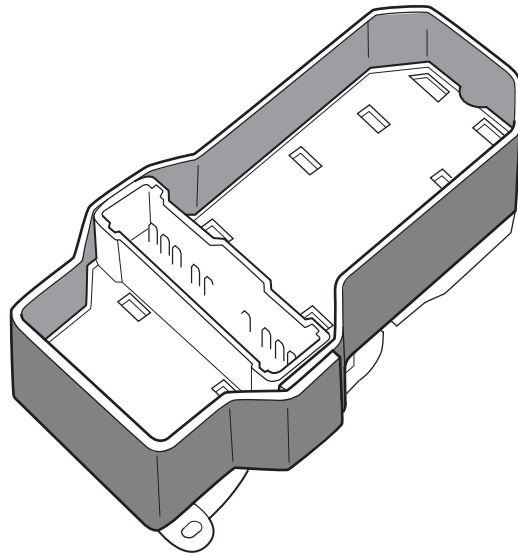
3. Wrap the tape counterclockwise around the entire switch, peeling off the backing sheet as you go.

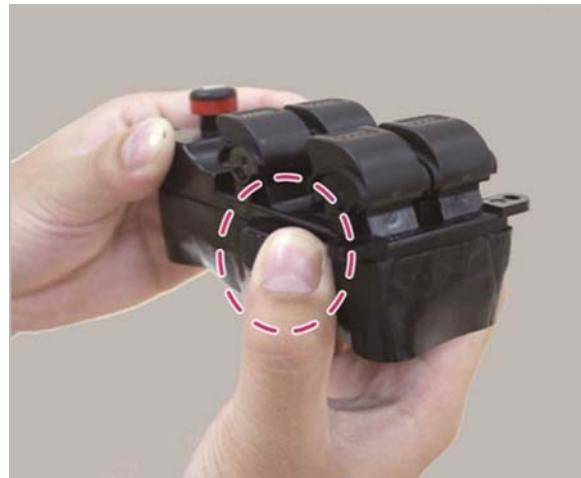
4. Make sure the butyl tape is secure around the corners by pressing it with your fingers.

NOTE: To avoid getting your fingers stuck to the butyl tape, use the removed tape backing to press the butyl tape down.

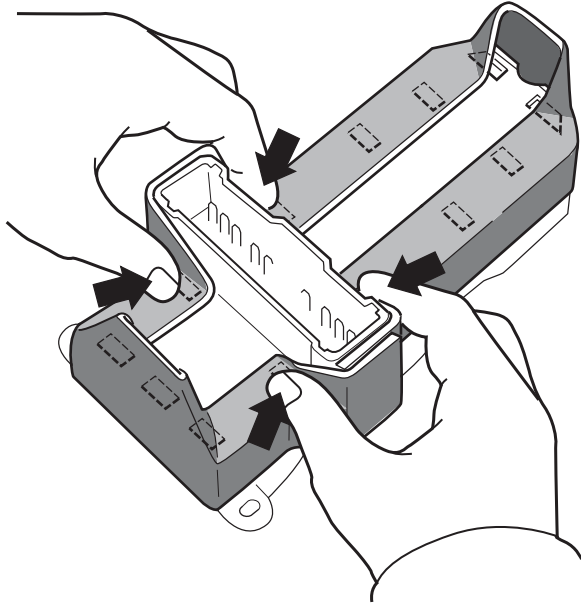
5. Pinch the butyl tape at the connector so that it sticks properly, with no creases in the butyl tape. Make sure the holes by the connector are covered.

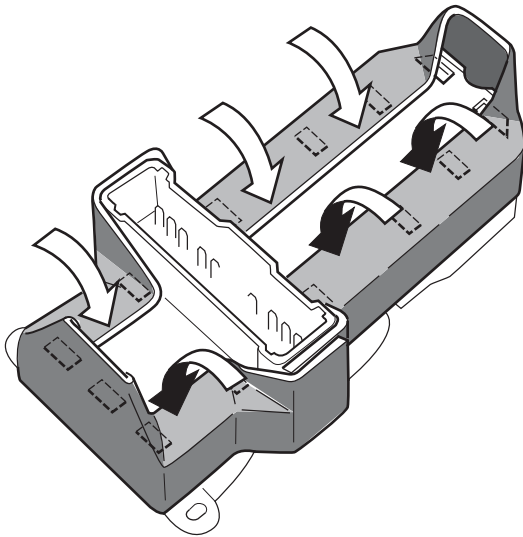
6. Fold the butyl tape over the rear face so that it covers all of the holes.

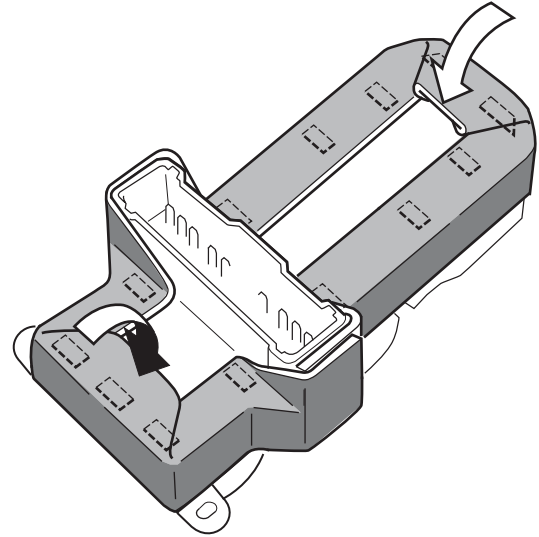
7. Fold the butyl tape at the top and bottom areas of the switch and stick it to the rear face. Make sure the holes are covered.

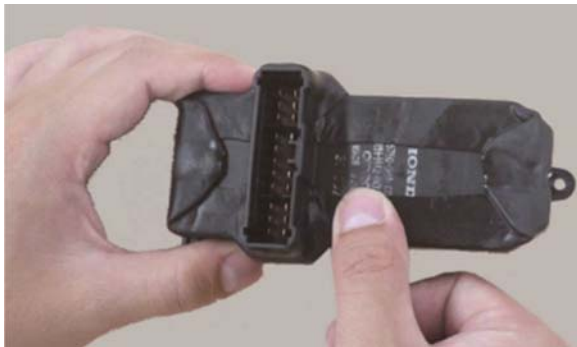
8. Make sure all the butyl tape is secure by pressing it with your fingers. Make sure there are no gaps between the butyl tape and the switch.

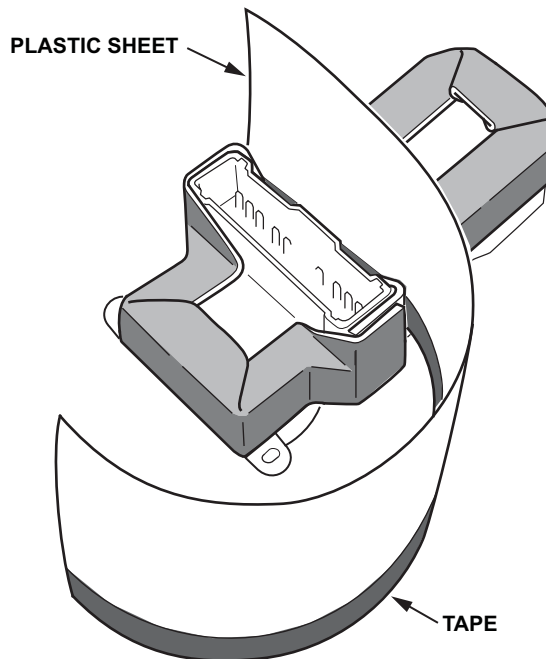
9. Align the tape on the plastic sheet to the starting point of the base of the connector as shown, then apply the plastic sheet.

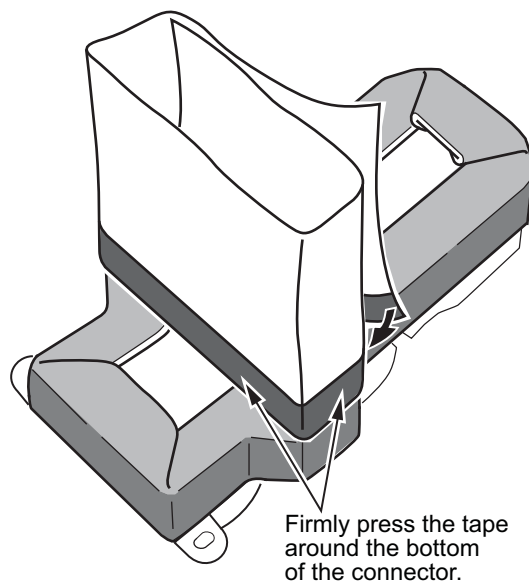
10. Wrap the plastic sheet around the connector, peeling off the backing paper.

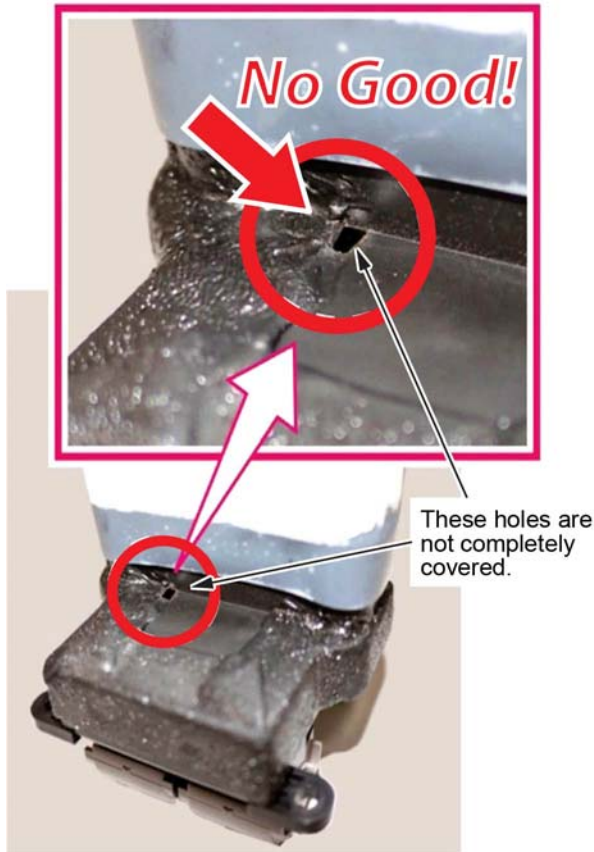
11. Make sure there are no gaps between the tape and the connector by firmly pressing the tape with your finger.

- If you damage the plastic sheet, remove it, and repeat steps 9-10 with a new plastic sheet.
- Make sure the plastic sheet covers the holes at the top and bottom of the connector. If they are not covered, remove the sheet and the butyl tape, and go back to step 1.

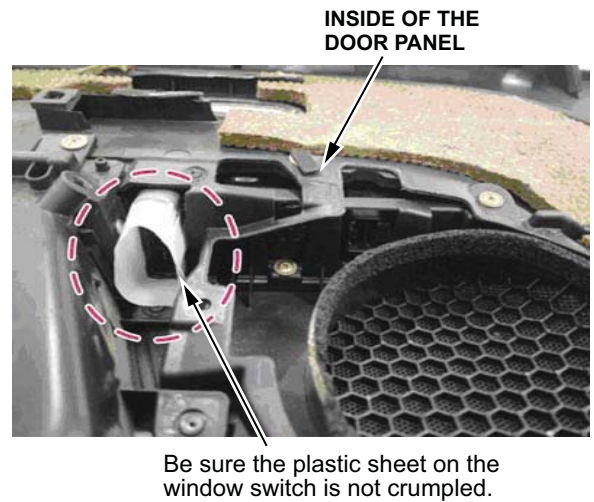
12. Reinstall the driver's switch panel into the door panel. Make sure the plastic sheet is not crushed, crumpled, or folded when you reinstall the switch panel in the door.

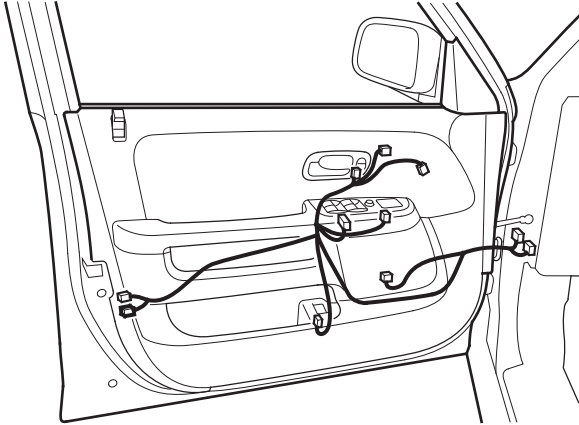
1. Replace the driver's door harness.
