Re: Toyota Safety Recall 12V-491 – Updated Remedy Instructions

TECHNICAL INSTRUCTIONS
FOR
SAFETY RECALL COM
POWER WINDOW MASTER SWITCH
CERTAIN
2007 – 2009 MODEL YEAR CAMRY
2007 – 2009 MODEL YEAR CAMRY HYBRID
2009 MODEL YEAR COROLLA
2008 MODEL YEAR HIGHLANDER
2008 MODEL YEAR HIGHLANDER HV
2009 MODEL YEAR MATRIX
2007 – 2009 MODEL YEAR RAV4
2008 – 2009 MODEL YEAR SCION xB
2008 – 2009 MODEL YEAR SCION xD
2008 – 2009 MODEL YEAR SEQUOIA
2007 – 2009 MODEL YEAR TUNDRA
2007 – 2008 MODEL YEAR YARIS

UPDATED APRIL 23, 2013

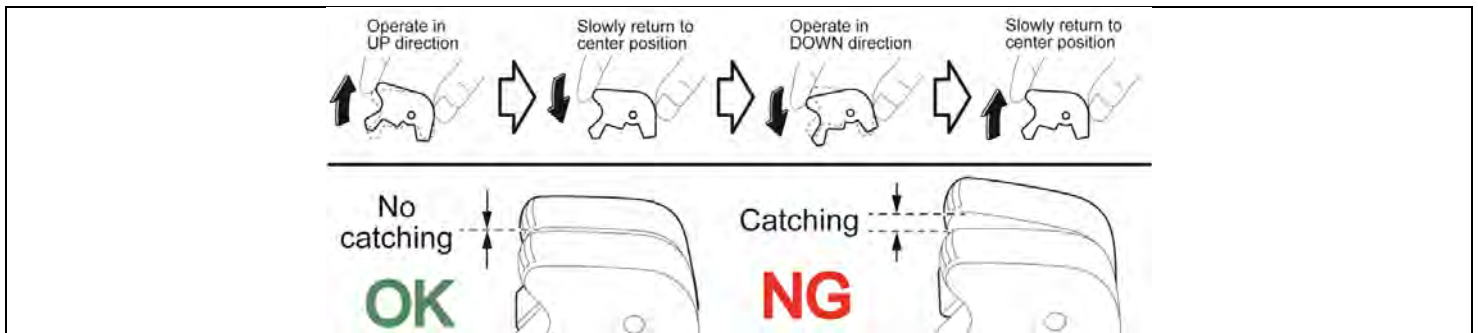
A. CHECK THE SWITCHES FOR CATCHING CONDITION

- a) Check all switches that do not have the AUTO function.

- b) Operate each switch in the up direction, then slowly return the switch using two fingers. **Perform this operation several times.**
- c) Operate each switch in the down direction, then slowly return the switch using two fingers. **Perform this operation several times.**

- **ALL** switches that **ARE NOT** AUTO **MUST** be inspected.
- The switches **MUST** be operated slowly, otherwise the catching cannot be noticed.
- The switches **MUST** be operated with two fingers, otherwise the catching cannot be noticed.
- The switches may feel unsmooth, this **DOES NOT** mean the switch is NG.
- Only a small number of vehicles (approximately less than 1%) will require the replacement of this part.

CONDITION	ACTION REQUIRED
NONE of the switches are catching.	Proceed to STEP B. CHECK THE RESISTANCE OF THE SWITCHES
One or more of the switches are catching.	Replace the power window master switch circuit board. Proceed to STEP B, 1-2 for switch disassembly instructions. NOTE: <ul style="list-style-type: none">• Mark the NG circuit board with an 'X' so that it is not reused.• There is NO NEED to apply grease to the new circuit board.
