Recall: Certification Label Noncompliance

The vehicle certification label on the driver's doorjamb may have incorrect weight and tire information. This would cause the vehicle to be noncompliant with Title 49 of the Code of Federal Regulation, Part 567, "Certification."

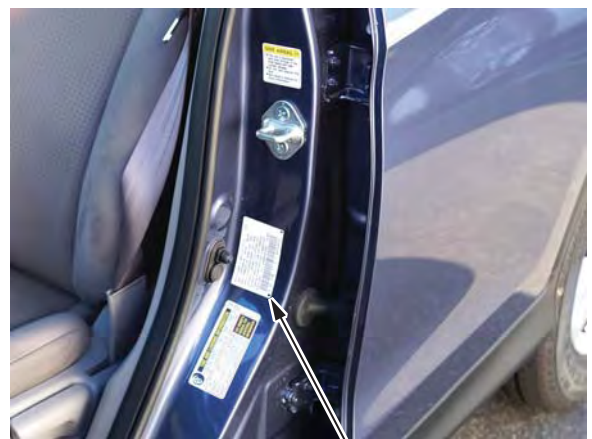
CERTIFICATION LABEL

- Using alcohol and a clean shop towel, clean the certification label on the driver's doorjamb. Allow the label to dry.

2. Peel off the backing from the correction sticker, and apply it to the certification label in the exact position shown below. Press the correction sticker firmly to make sure it sticks.

CORRECTION STICKER

Apply a correction sticker over lines 2, 3, and 4 of the certification label on the driver's doorjamb.
