Subject: NHTSA Campaign 12V521 (Jaguar Safety Recall J027) - Fuel Tank Fuel Outlet Flange – Dealer Communication

Safety Recall: Cracked Fuel Tank Fuel Outlet Mounting Flange

XF (X250) 5.0L Engine vehicle only

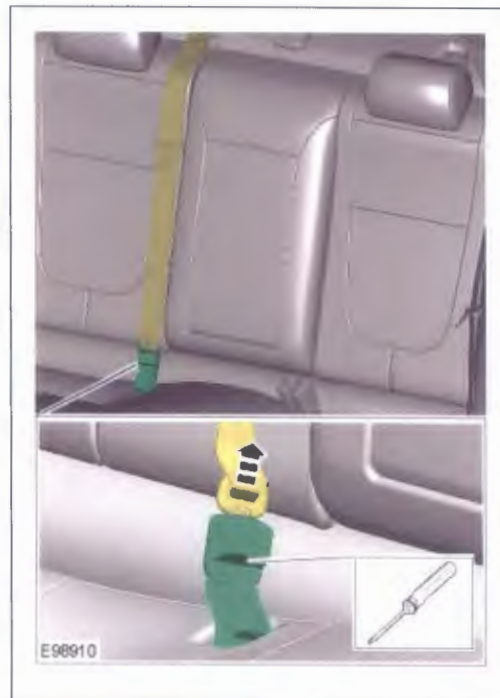
4. Release the rear seat center seatbelt.

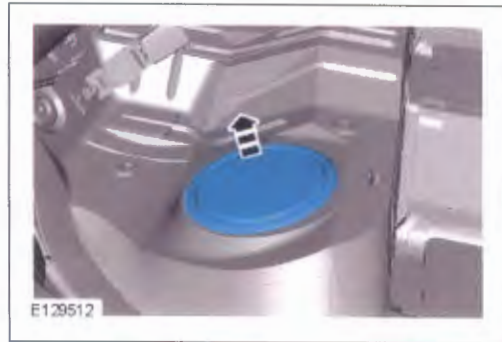
8. Remove the right-side aperture cover.

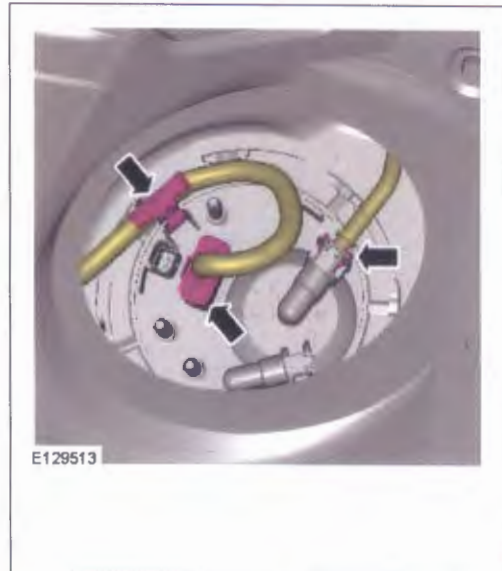
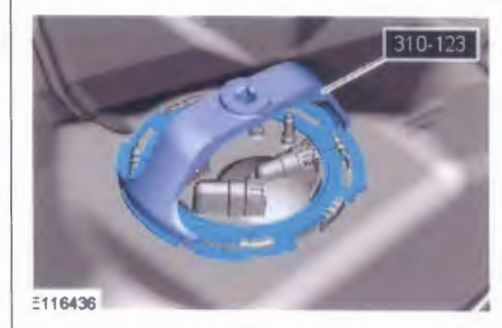
10. **⚠ NOTE:** The locking ring may require a sharp jolt to release the locking tangs.

⚠ NOTE: Using a suitable marker, mark the installed position of the locking ring.

Use special tool 310-123 and remove the locking ring.

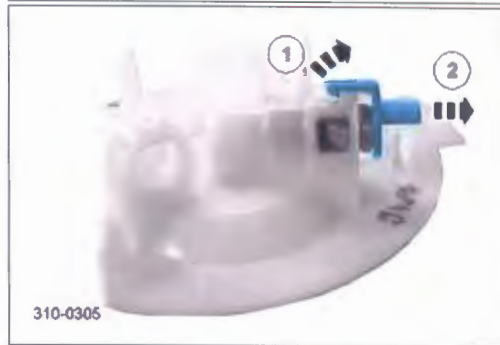
310-0305

12. Remove and discard the blanking plug from the new fuel tank fuel outlet mounting flange.

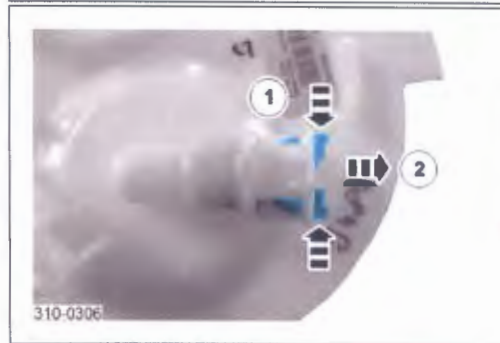
310-0306

13. Remove and discard the clip from the new fuel tank fuel outlet mounting flange.
