INSTRUCTIONS TO PERFORM CAMPAIGN 127 (Via®/Reyo® Models H25Q, H25R, and H25T)

Certain 2009 through 2013 model year Winnebago Via/Itasca Reyo (Models H25Q, H25R, and H25T) motorhomes.

These motorhomes were manufactured November 13, 2007 through August 10, 2012.

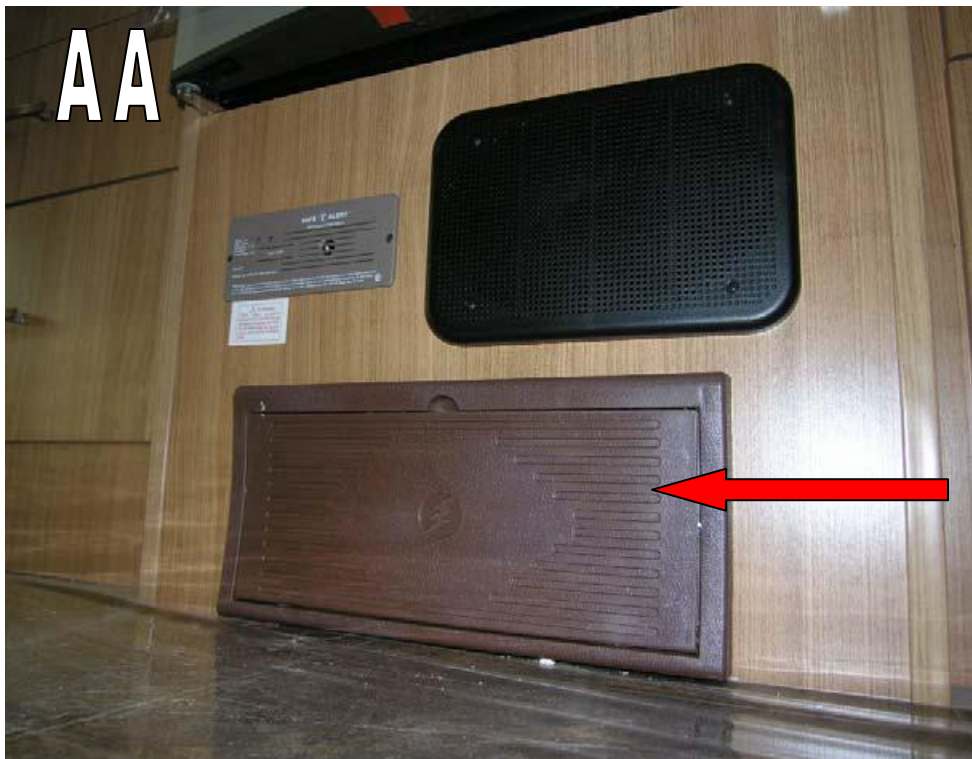
1. Locate the Power Center. See Photo AA.

(Typical View)

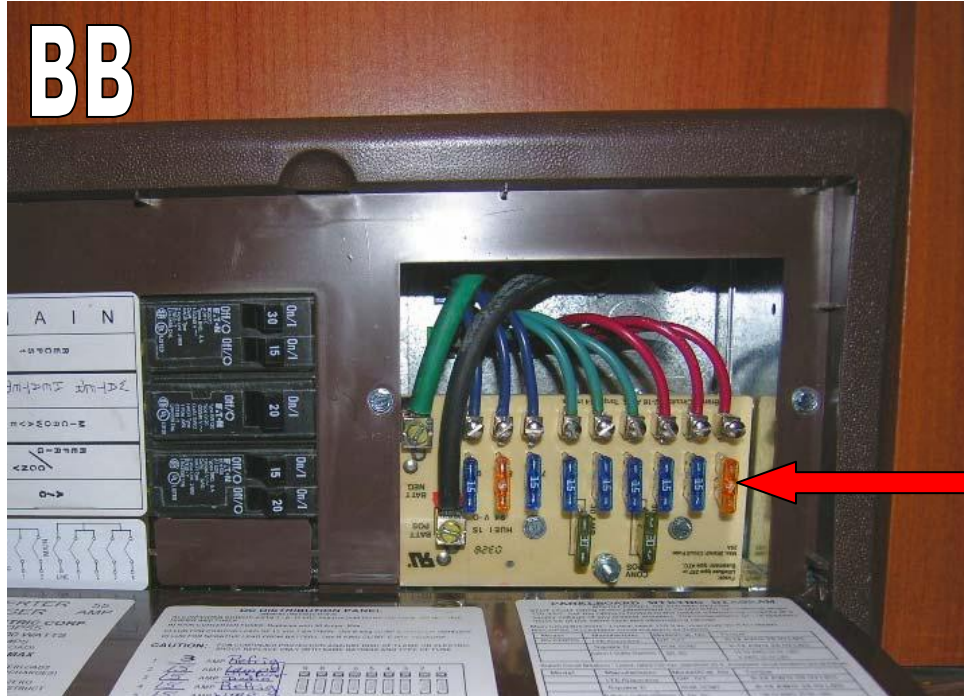
3. View "DC Distribution Panel," label to locate the refrigerator fuse (generally the far right fuse in the power center). Remove the current 5-amp. (tan) fuse and discard. See Photo BB.

(Typical View)
(Fuse Configuration May Vary By Model According to Available Equipment)

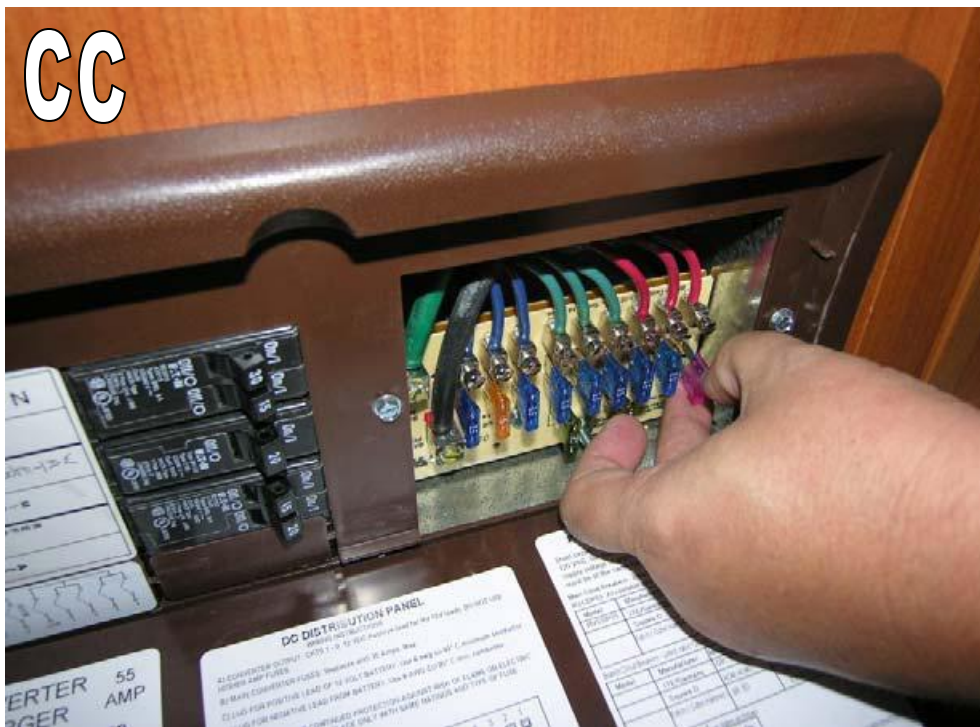
4. Install new 3-amp. (violet) fuse (from kit) into socket. See Photo CC.

(Typical View)

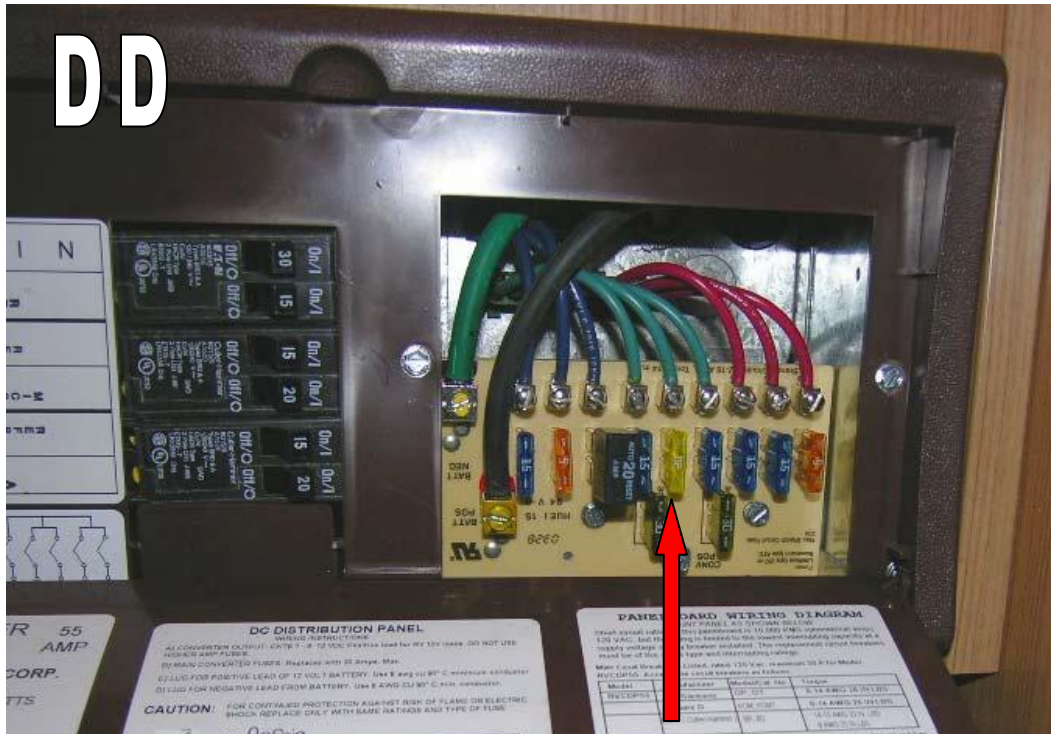
5. View "DC Distribution Panel," label to locate the 20-amp. (yellow) refrigerator fuse location. Remove the current 20-amp. (yellow) fuse and discard. See Photo DD.

(Typical View)

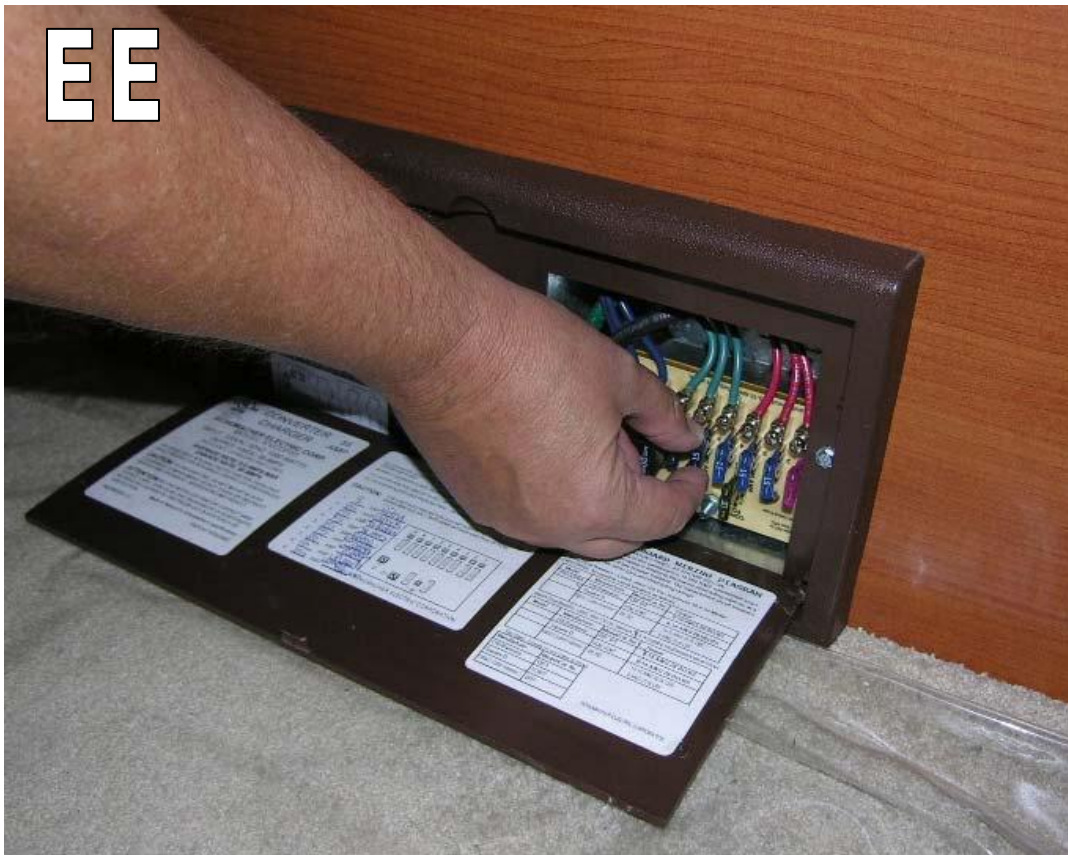
6. Install new 15-amp. (blue) fuse (from kit) into Socket 5. See Photo EE.

(Typical View)

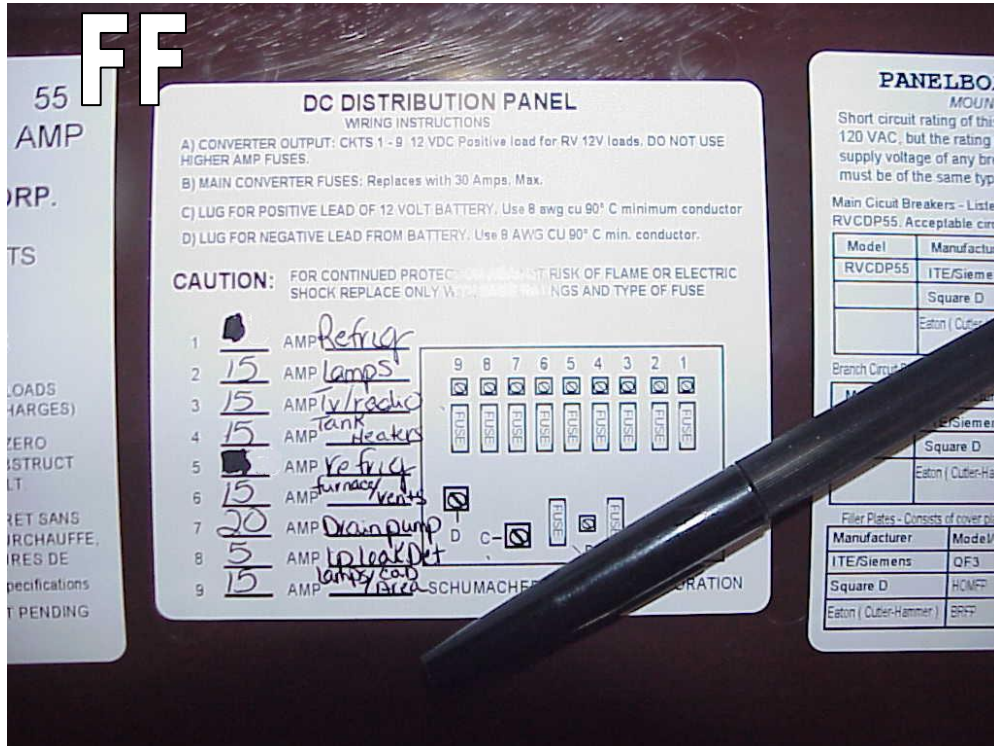
- On the "DC Distribution Panel," label with a permanent marker, black out the "5" and write in a "3" and black out the "20" and write in "15." See Photos FF and GG.

(With a Permanent Marker, Black Out the 5 and 20 Number on the Refrigerator Circuits)

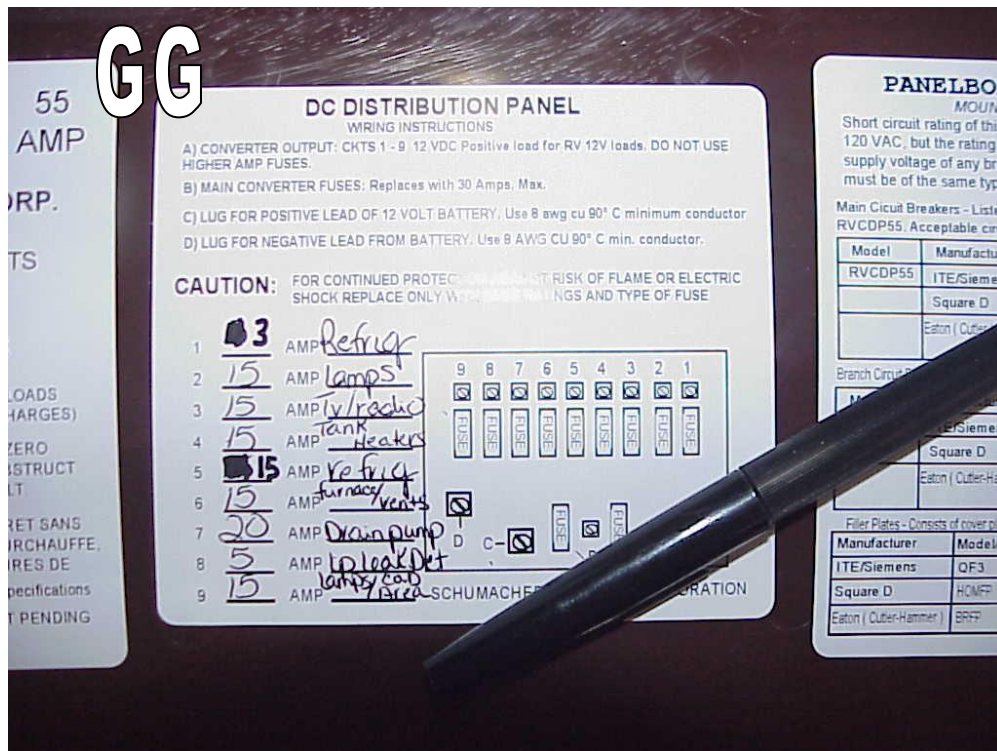
(With a Permanent Marker, Write in the "3" and "15")
