13V-373
(4 pages)

This report serves as Silver Eagle Manufacturing Company's notification to the U.S. Department of Transportation, National Highway Traffic Safety Administration that a defect related to motor vehicle safety exists in certain Trailer Converter Dollies. Silver Eagle decided that this defect existed in these vehicles on August 13, 2013.

III. Description of the Defect and Chronology of Events

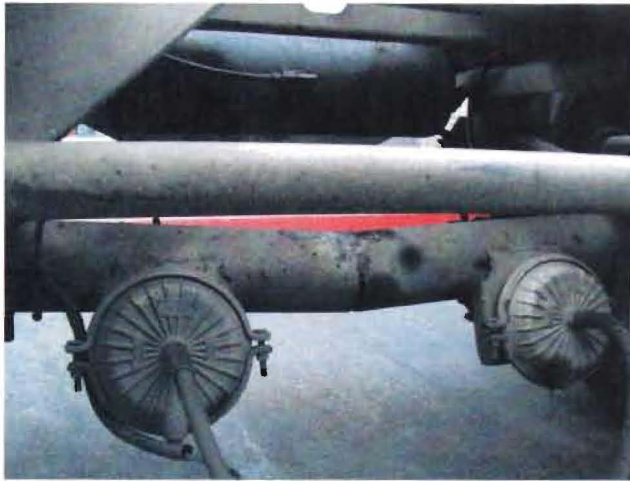
Silver Eagle was notified May 22, 2013 by SYSCO Foodservices in Walnut, California that it had a failed axle on a Model Year 2001 converter dolly produced in October of 2000.

The failed axle shows classic signs of a fatigue failure starting at the bottom of the axle, and radiating upward over a long period of time. The point of initiation was the center hole. Center holes are used to establish Top Dead Center; the hole being at the bottom is not a proper practice because it

causes a stress riser in the tension side of the beam.

There have been no accidents or other reports of similar cracks in axles. As seen in the picture above, the crack eventually becomes obvious during inspection that the part is beginning to fail, additionally the wheels, tire and axle will begin to show negative camber. This form of failure happens over a long period of use, as evidenced by it taking twelve and a half years to get to this state.

Because the vehicles in question are over ten years old, Silver Eagle is not under obligation to provide a free remedy. However, Silver Eagle plans to provide an unused replacement axle beam for no charge, or a \$500.00 credit towards a new converter dolly if they scrap their dolly with the incorrect position center hole. The current vehicle owner will be responsible for the labor to install the replacement axle beam. Only converter dollies that have a bottom center hole will need replacement to ensure continued safe operation.

Replacement parts will likely be from Meritor and will not have a center hole in the bottom. The last Silver Eagle dolly to use a KIC axle was manufactured in October of 2000, no other converter dollies are suspected to have this defect.
