Safety Recall: Brake Booster Loses Vacuum (Supersedes 13-025, dated June 13, 2013; see REVISION SUMMARY)

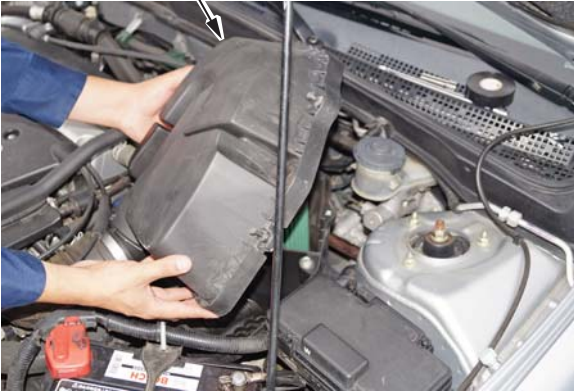
Remove the air cleaner housing cover.

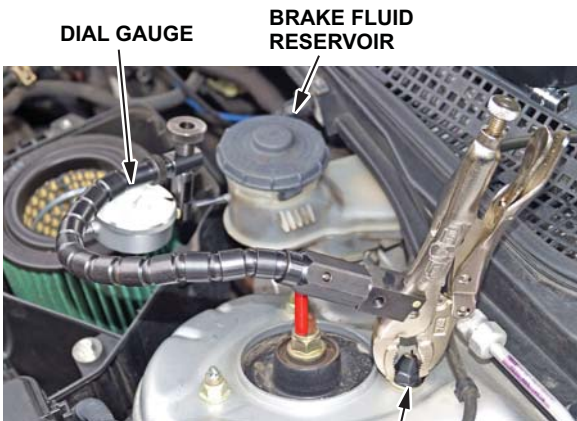
4. Attach the dial gauge indicator to the strut tower mount as shown.

Clamp portion of tool attaches to damper mounting nut.

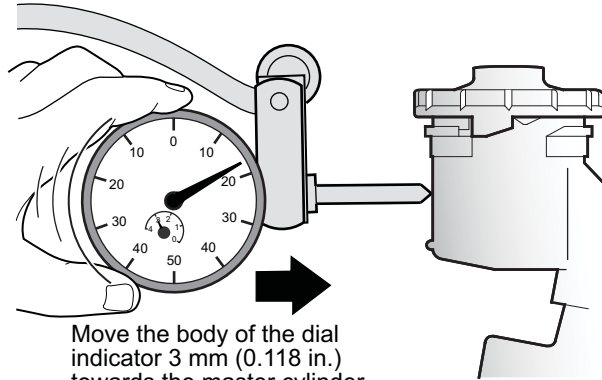
5. Set up the dial indicator so the tip touches the master cylinder as shown. Push in the body of the dial indicator 3 mm (0.118 in.). Once the indicator is set, zero the gauge.

- Make sure the dial indicator is pushed in 3 mm (0.118 in.). If you only zero the gauge, you will not get a proper reading when the master cylinder moves toward the passenger compartment.
- It is imperative that you measure and calculate the movement accurately, and not simply rely on the gauge display.

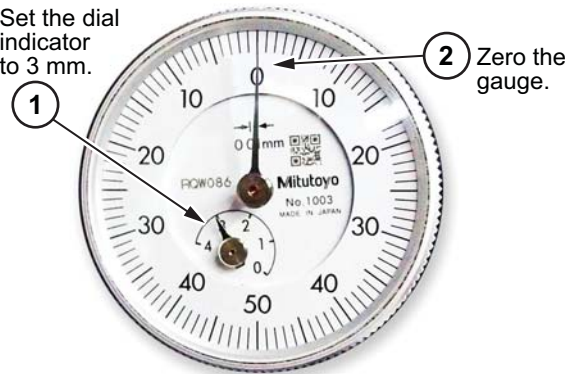
Set the dial indicator to 3 mm.

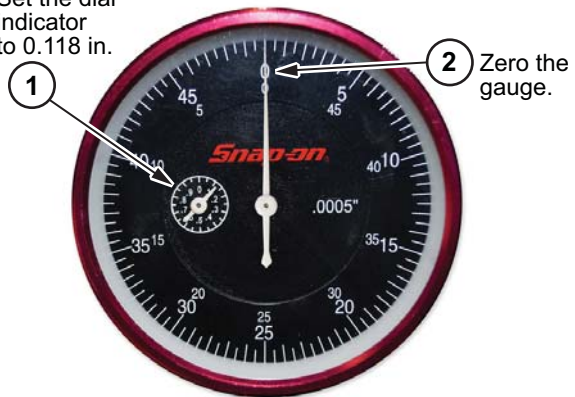
Set the dial indicator to 0.118 in.

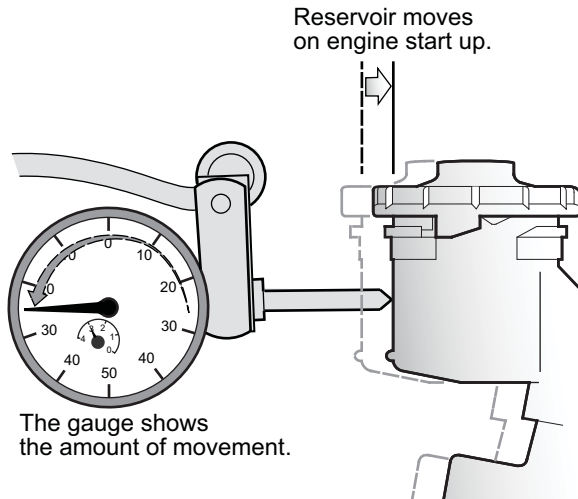
6. Start the engine.
7. Measure the distance the master cylinder reservoir moved toward the passenger compartment.
 - If the master cylinder reservoir moved 0.75 mm (0.030 in.) or less, the vehicle is OK.
 - If the master cylinder reservoir moved more than 0.75 mm (0.030 in.), go to REPAIR PROCEDURE.

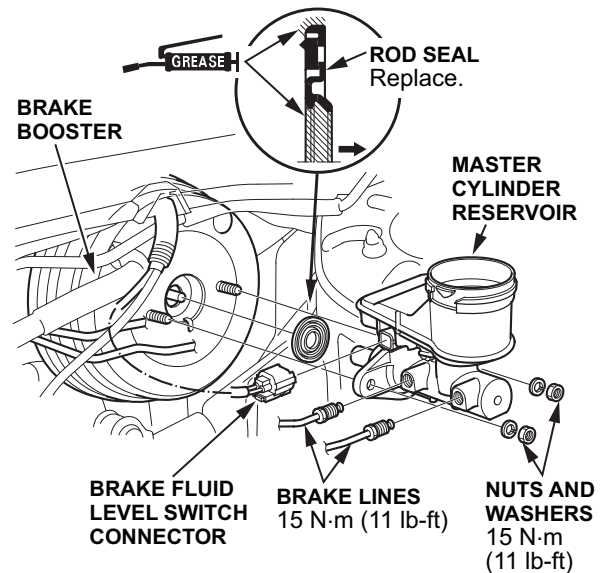
1. Remove the air cleaner.
2. Remove the brake fluid from the master cylinder reservoir with a syringe.
3. Disconnect the brake fluid level switch connector.

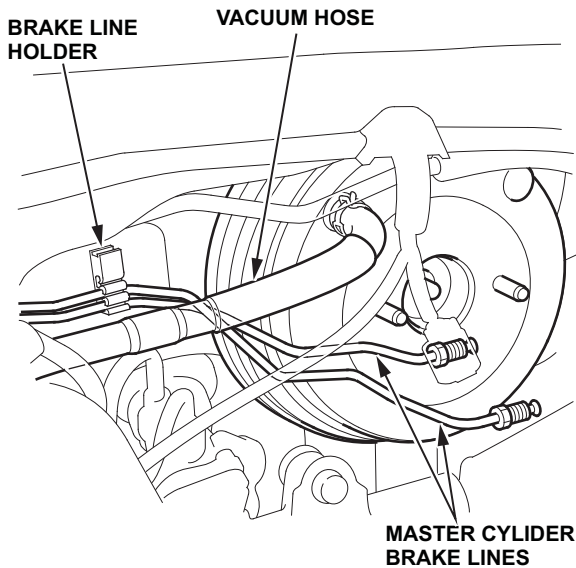
7. Disconnect the brake booster vacuum hose from the brake booster.

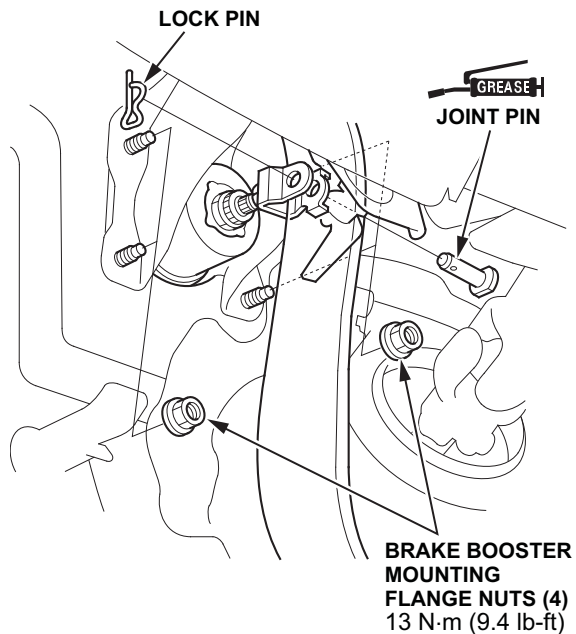
8. Remove the master cylinder brake lines from the brake line holder.
9. Remove the lock pin and the joint pin, then disconnect the yoke from the brake pedal.

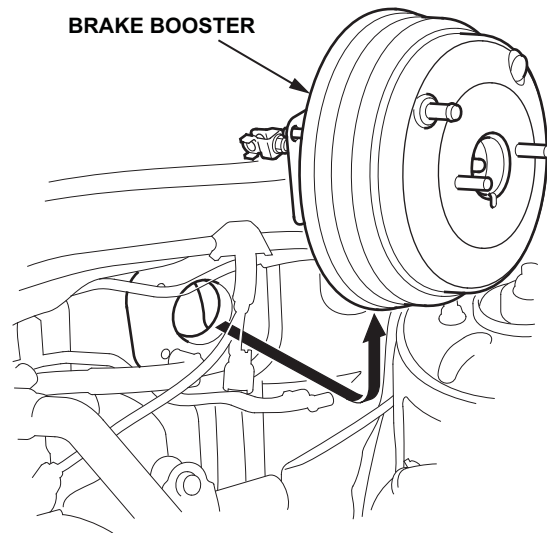
10. Remove the four brake booster mounting flange nuts.

11. Pull the brake booster forward, and remove the brake booster from the engine compartment. Be careful not to bend or damage the brake lines when removing it.

12. Install the new brake booster and the original master cylinder in the reverse order of removal, and note these items:
