**Re: Defect Information Report – Supplemental Report No. 1  
13V-365, FL-643, Auxiliary Fuel Pickup Tube  
Representative Owner Notice**

# Recall Campaign

## Subject: Auxiliary Fuel Pickup Tube Labels

**Models Affected: Specific Thomas Built Buses Saf-T-Liner EF, EFX, and HDX school buses manufactured March 23, 2011, through October 4, 2012.**

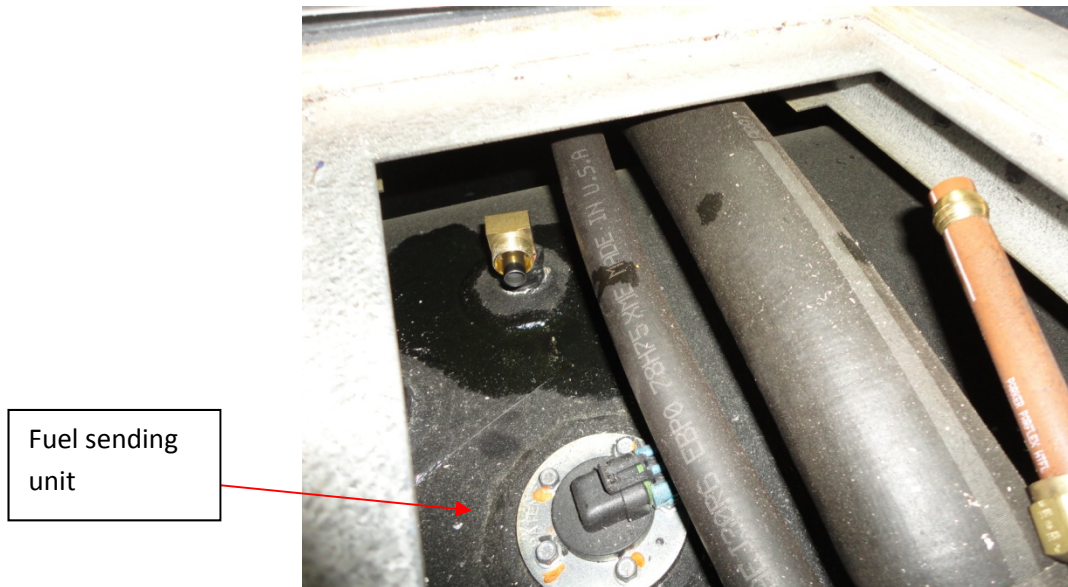
- 4) Remove the hose by loosening the compression fitting using a 15/16" wrench.
- 5) Next, push the hose out of way so that the fuel tube mounting can be reached as in Figure 2

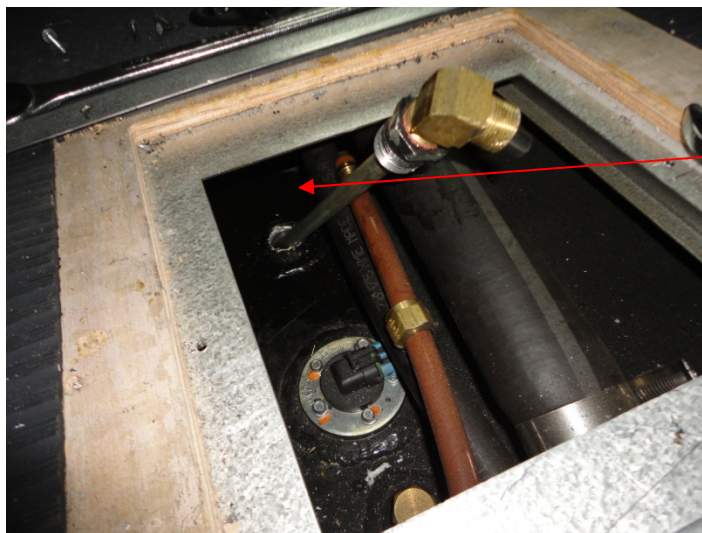
Figure 4

- 10) Reinstall the tube and hose then proceed to next step.
- 11) Remove the main pick-up tube. Loosen the pickup tube in the tank using a pair of pliers or a 15/16" wrench on the head of elbow. Next, turn the tube at an angle to remove as shown in Figure 4.

Main Fuel  
pick-up
