**RE: Defect Information Report – Supplemental Report No. 5  
13V-604NSB, 13V-606SB, FL-654, IMMI Seat Belt Buckles  
Revised Dealer Notice**

March 2014  
FL654A-Z/FL661C-Z  
NHTSA #13V-604 and #14V-150 (Non-School Buses)  
NHTSA #13V-606 (School Buses)  
Transport Canada #13-427

## **Subject: IMMI Seat Belt Buckles**

**Models Affected:** Specific Freightliner 108SD, 114SD, 122SD, Argosy, Business Class M2, Cascadia, Columbia, and Coronado vehicles; Western Star 4700, 4900, and 6900 vehicles; and Thomas Built Buses Saf-T-Liner C2, HDX, and Minotour vehicles with certain IMMI seat belt assemblies.

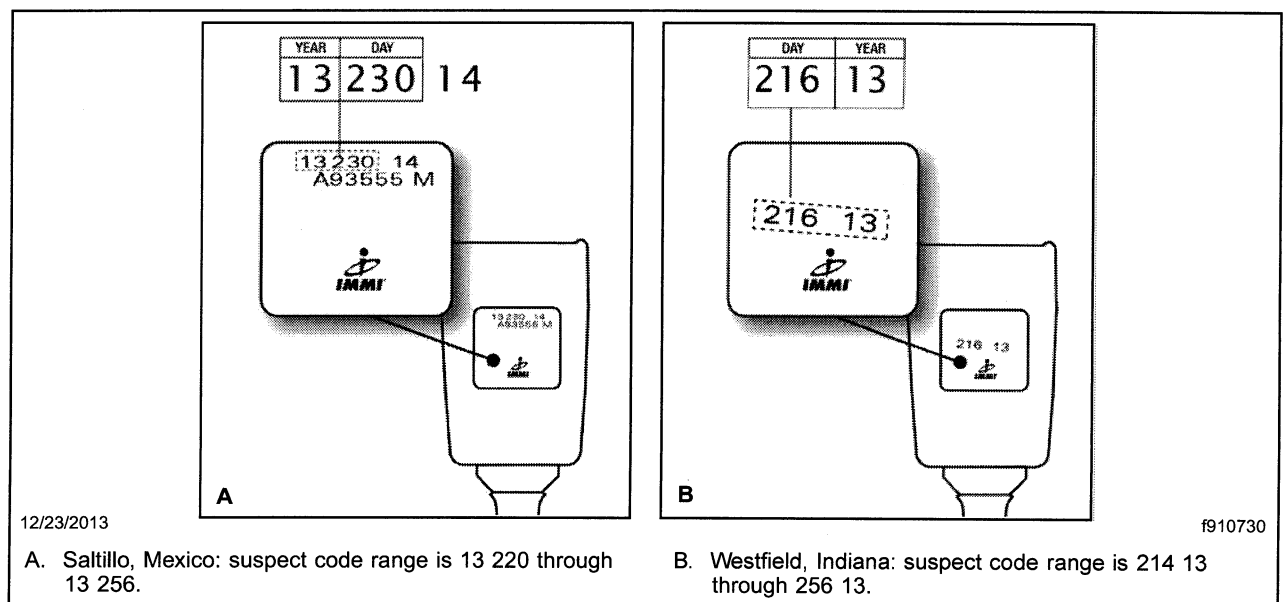
Fig. 3, Buckle Date Code Ranges

If the date code is included in the ranges shown in **Fig. 3**, the buckle needs to be replaced. If the date code is outside these ranges, the buckle does not need to be replaced.

6. If the vehicle has buckles that need to be replaced, go to "Buckle Replacement – School Buses" or "Buckle Replacement – Trucks" as appropriate in these Work Instructions.

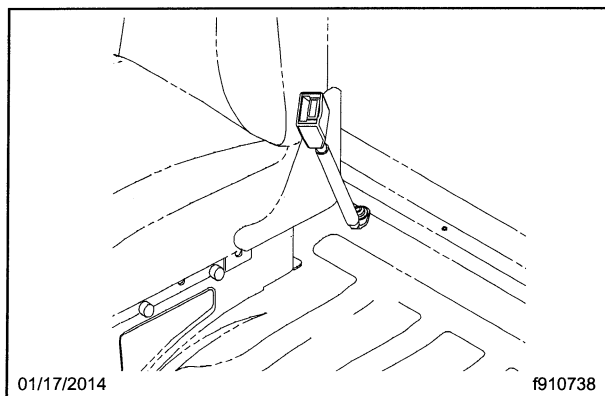
**Fig. 10, Floor-Mounted Buckle**

- Static seats have the buckles mounted directly to the cab floor. See **Fig. 10**.
  - Air suspension seats have buckles mounted to the ICP (intermediate-connection-point bar or bracket), with a tether belt attached to the cab floor. See **Fig. 11**.
  - Bench seats may have floor-mounted buckles at the ends, and floor-bracket-mounted buckles in the middle. One or two buckles may be mounted to each floor bracket. See **Fig. 12** and **Fig. 13**.
1. Go to the replacement steps below for the applicable type of seat belt assembly:
    - Floor-Mounted Buckles
    - ICP-Bar-Mounted Buckles
    - Floor-Bracket-Mounted Buckles
