Applies To: **2014 MDX** – Check the iN VIN status for eligibility**August 6, 2013****Safety Recall: Accessory Trailer Harness Wires Mislabeled**

(Supersedes 13-028, dated July 27, 2013, to revise the information marked by the black bars)

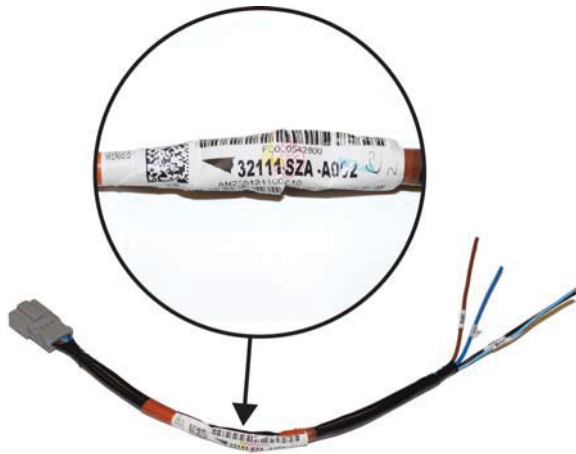
- The ELEC BRAKE label on the BRN/WHT wire
- The P/N 32111-SZA-A002 label on the harness

NOTE: Remove the part number label to make sure that if a replacement subharness is ever needed, the wrong part will not be ordered.

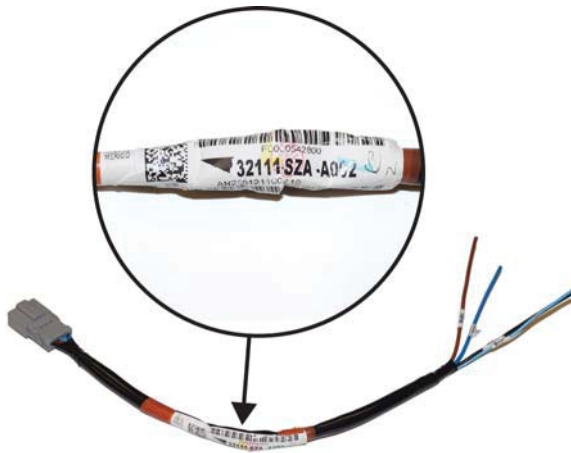
- The ELEC BRAKE label on the BRN/WHT wire
- The P/N 32111-SZA-A002 label on the harness

NOTE: Remove the part number label to make sure that if a replacement harness is ever needed, the wrong part will not be ordered.
