Applies To: **2012–13 Odyssey** – Check the iN VIN status for eligibility

Safety Recall: 2012–13 Odyssey Shift Interlock Stopper

(Supersedes 13-036, dated May 21, 2013, to revise the information marked by the black bars)

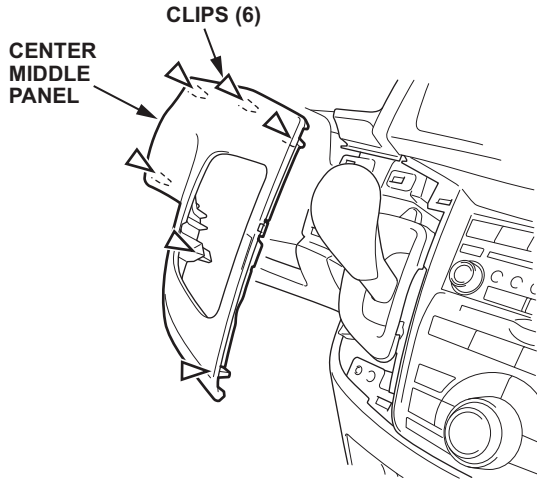
2. Pull out the center middle panel to detach the clips, then remove it.

NOTE: Use the appropriate trim tool to avoid damaging or scratching the panel, the dashboard, or any related parts during removal.

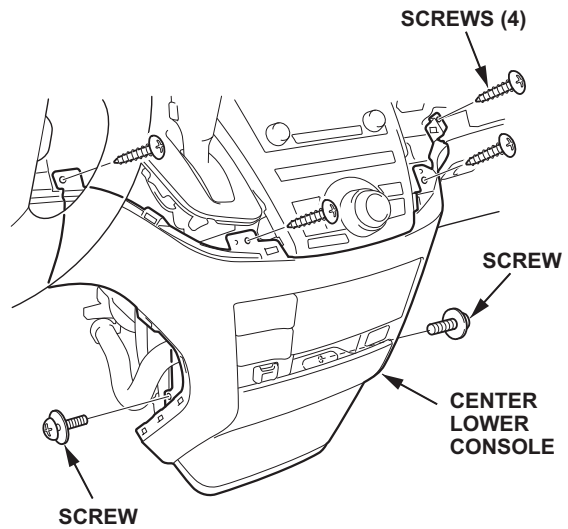
5. Remove the screws securing the center lower console.

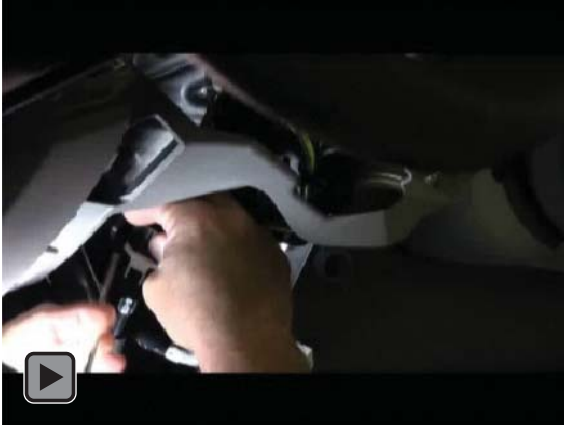
8. Remove the nut securing the shift cable end.
NOTE: Do not use an impact gun because the vibration on the shift cable could break the shift cable guide. If this happens, the entire shift cable must be replaced.

- Remove the shift cable from the shift cable bracket. First click on the video below to see how the step is done.

NOTE: The dashboard brackets may have sharp edges. Wear gloves to protect your hands.

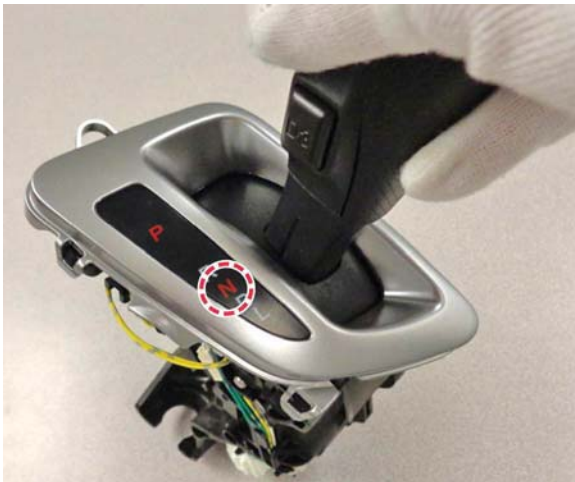
- Remove the pin (6 mm diameter) that you inserted earlier to lock the shift lever assembly in the R position.

11. Move the shift lever to N to avoid interference between the shift knob and the PRNDL trim.

NOTE: Lay the shift lever assembly on a clean cloth to prevent damaging it.

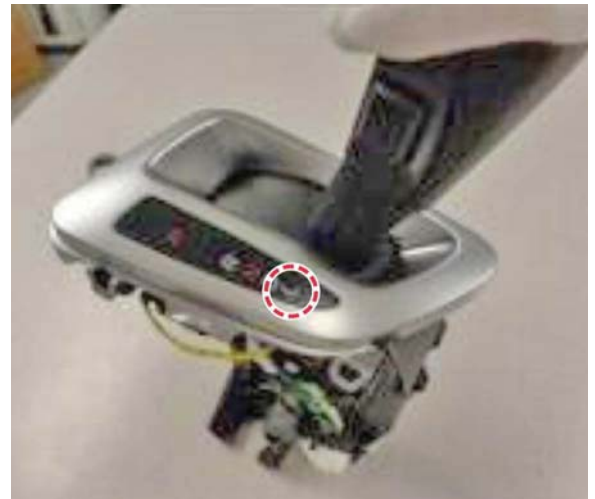
- Move the shift lever to L.

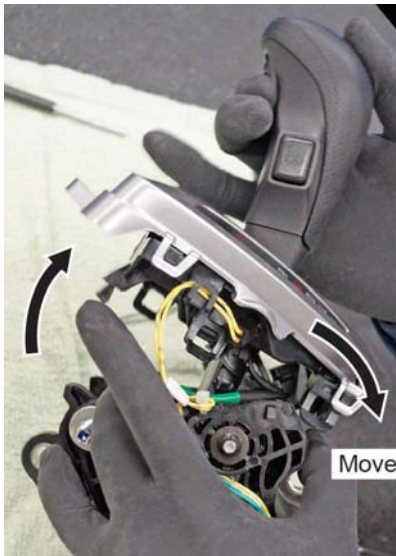
- Move the PRNDL trim down as shown.

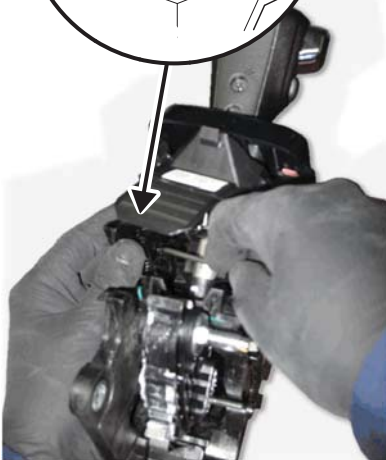
SHIFT LOCK RELEASE

13. Release the shift interlock release by using a pick tool or small flat blade screwdriver (3 mm diameter) to push the tab down and in toward the shift interlock release.

Push tab down and in towards shift lock release.

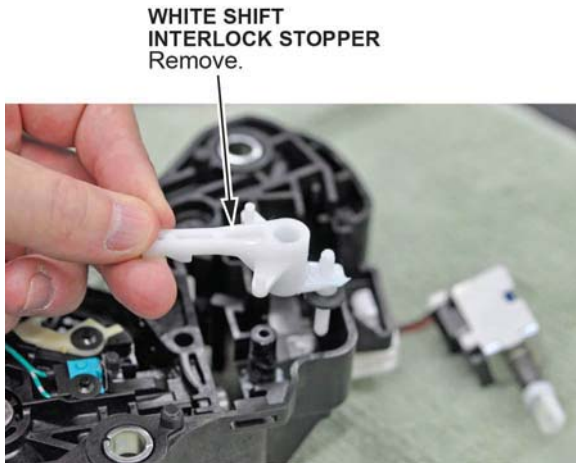
16. Remove the white shift interlock stopper from the shift lever assembly.

NOTE: Do not wipe the grease from the shift lever assembly.

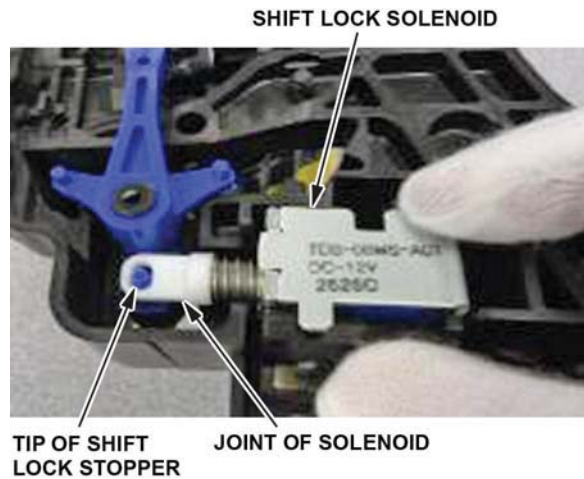
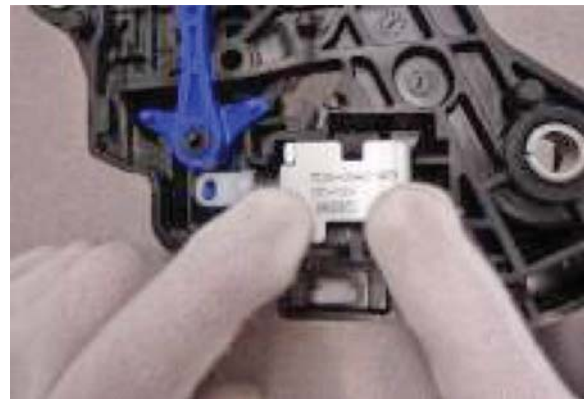
18. Reinstall the shift interlock solenoid by aligning the solenoid plunger joint with the tip of the shift interlock stopper, then push down on the bottom area of the solenoid (side with the printing) until you hear a click.

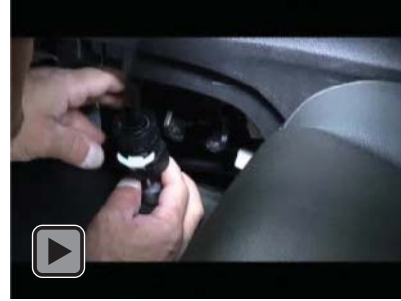
27. Reinstall the shift cable. First click on the video below to see how the step is done.
