HONDA Service Bulletin

Applies To: 2012–13 Odyssey – Check the iN VIN status for eligibility

Safety Recall: 2012–13 Odyssey Shift Interlock Stopper

Replace the shift interlock stopper.

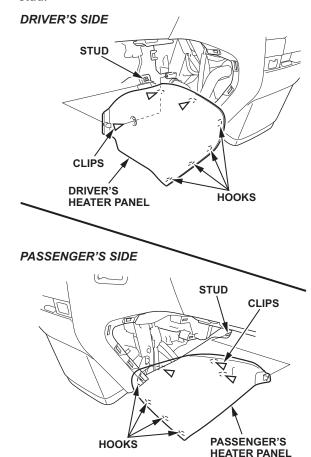
1. Remove the driver's and passenger's heater panels by pulling the panels out to detach the clips and release the hooks, then release the panel from the stud.

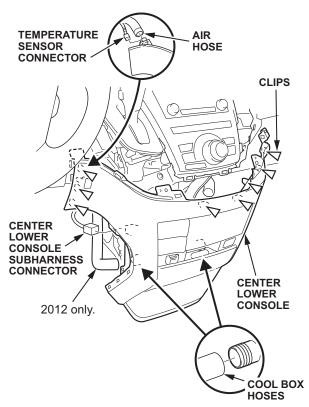
Pull the console out far enough to detach the clips, then disconnect the humidity/in-car temperature sensor connector and the cool box hoses.

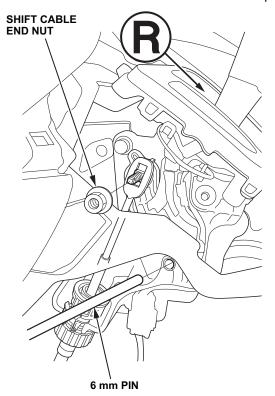
7. Make sure the parking brake is applied, then press the interlock shift button to move the shift lever to R. Insert a pin (6 mm diameter) into the positioning holes to lock the shift lever assembly in R.

NOTE: Make sure there are no burrs on the pin.

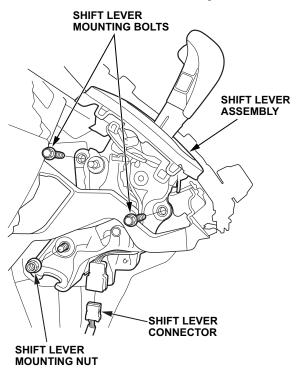
- 10. Remove the shift lever assembly from the instrument panel.
 - · Disconnect the shift lever connector.
 - · Remove the shift lever mounting bolts and nut.

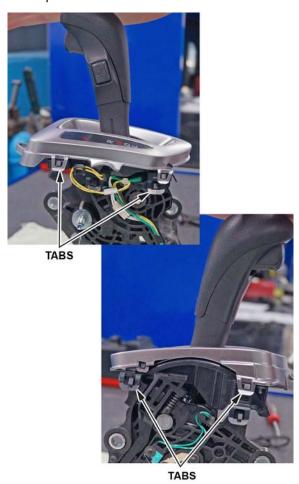
- 12. Move the PRNDL trim to access the shift interlock release.
 - · Unsnap the four tabs.

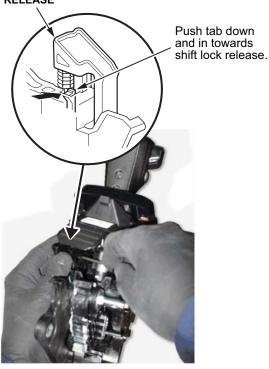
SHIFT LOCK RELEASE

13. Release the shift interlock release by using a pick tool or small flat blade screwdriver (3 mm diameter) to push the tab down and in toward the shift interlock release.

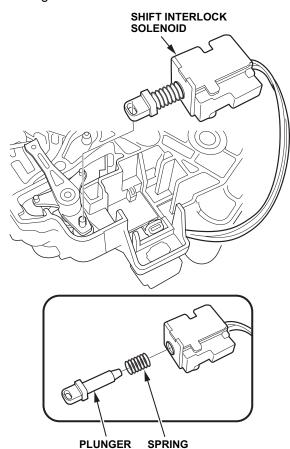
Move the screwdriver handle up to release the tab and pry out the solenoid. Remove the shift interlock solenoid from the selector lever assembly and lay it down next to the shift lever assembly. Do not disconnect the connector.

NOTE: The solenoid plunger and its spring can fall out of the solenoid. If this happens, reassemble the shift interlock solenoid before setting it down.

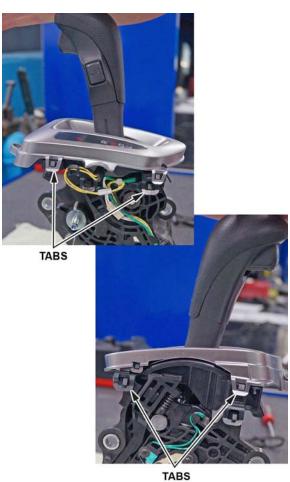
23. Reinstall the PRNDL trim.

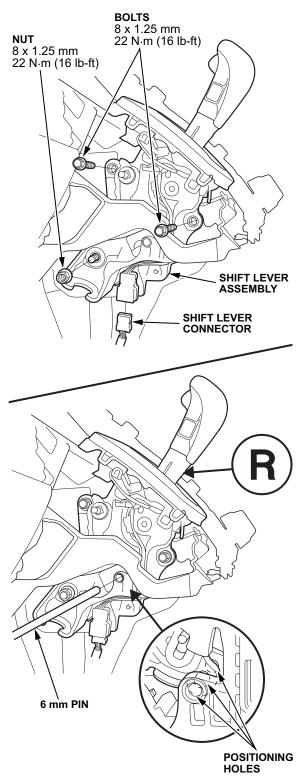
- 26. Reinstall the shift lever assembly.
 - Set the shift lever assembly into the instrument panel, then install and finger-tighten the two bolts and nut.

- · Move the shift lever to R.
- Lock the shift lever in R by inserting the pin (6 mm diameter) into the positioning holes.
- Torque the two shift lever assembly bolts and nut to 22 N·m (16 lb-ft).
- · Connect the shift lever connector.

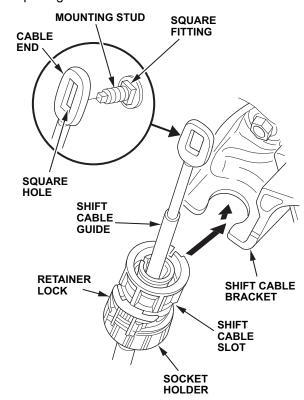
Align the shift cable slot (located between the socket holder and the retainer lock) with the opening of the shift cable bracket.

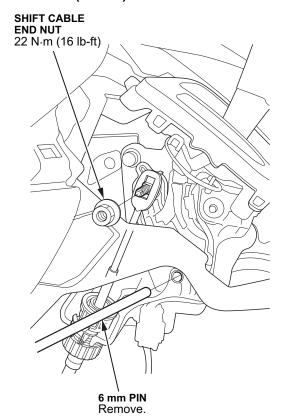
28. Reinstall the nut on the shift cable end and torque it to 22 N·m (16 lb-ft).
