## Technical Service Bulletin

GROUP <b>CAMPAIGN</b>	NUMBER <b>13-01-052</b>
DATE <b>DECEMBER 2013</b>	MODEL(S) <b>GENESIS SEDAN (BH)</b>

**SUBJECT:** BH GENESIS SEDAN HECU INSPECTION AND BRAKE FLUID REPLACEMENT (RECALL 114)

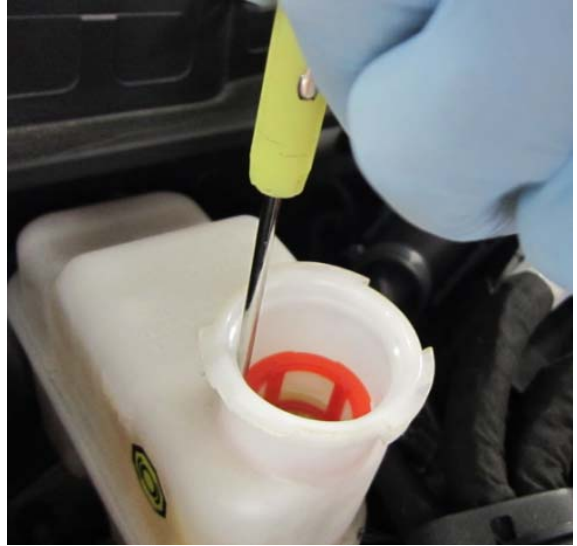
1. Locate the brake master cylinder, remove the cap, and remove the filter.

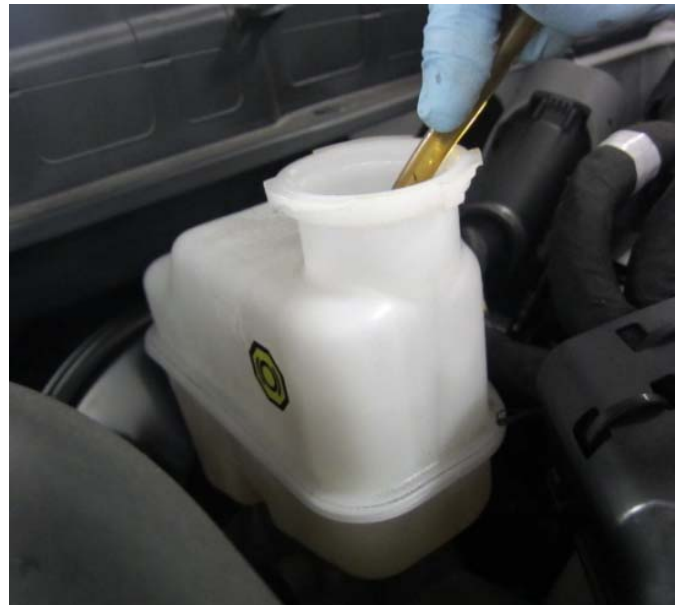
2. Remove as much of the brake fluid as possible using a vacuum pump or similar tool.

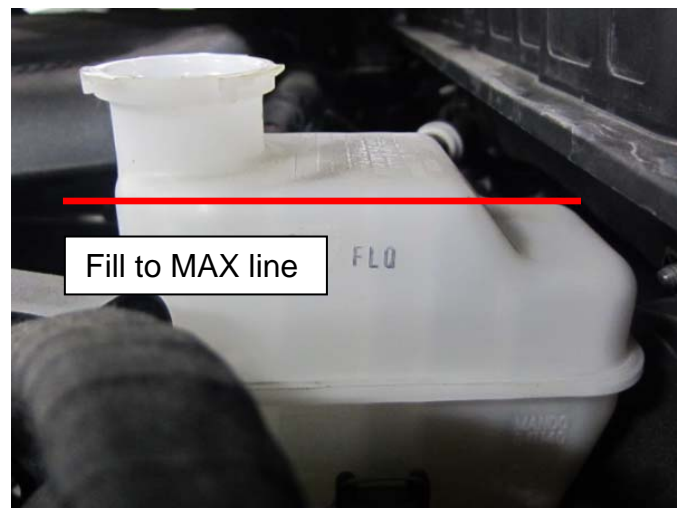
3. Fill the reservoir to the MAX line using DOT4 brake fluid.

Reinstall the filter and master cylinder cap.

If any brake fluid is spilled, immediately clean the spill by generously flushing water over the area.

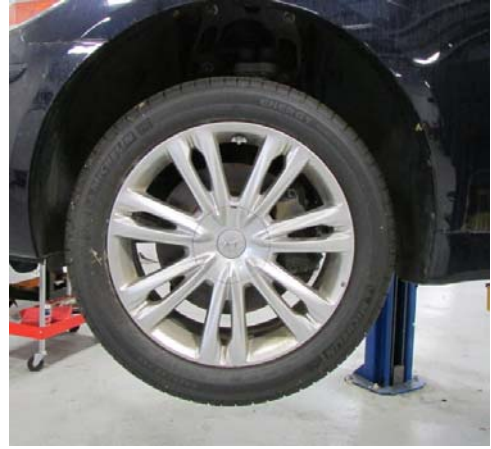
4. Lift the vehicle on a hoist and remove the hub covers from all four wheels. Remove all lug nuts and wheels.

**Tightening torque:**  
90~110 N.m (9~11 kgf.m, 65~80 lb-ft)

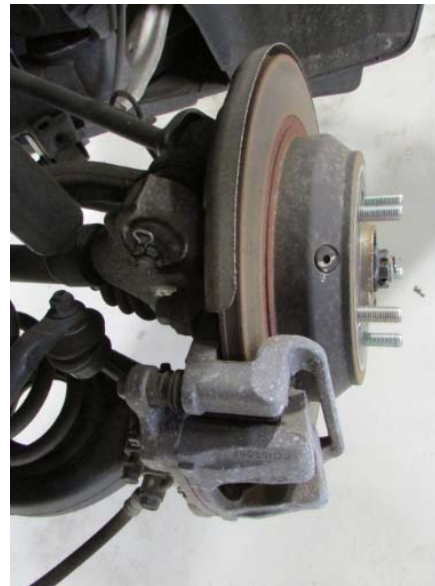
5. **Start at the RIGHT REAR brake assembly.**

Connect one end of a bleeding line to the bleeder screw nipple, and then place the other end in a container to collect brake fluid as it is released.

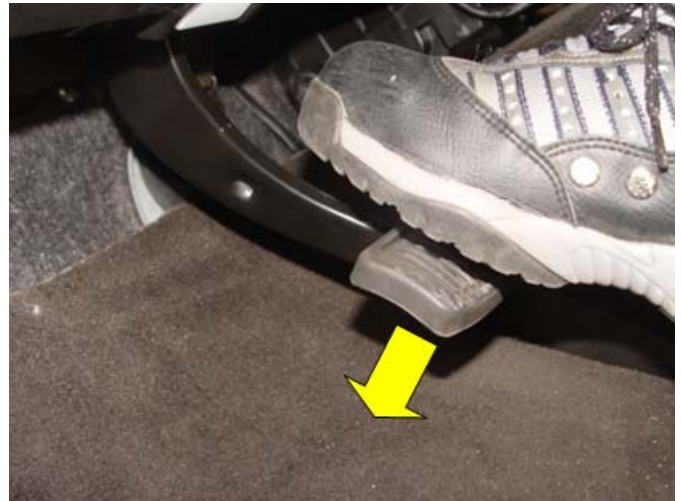
6. Pump the brake pedal 3 times and then hold the pedal down to pressurize the system.

While holding the brake pedal down, open the bleeder to release brake fluid. After fluid is released, close the bleeder, and release pressure from the brake pedal.

DO NOT release the brake pedal until after the bleeder screw is fully closed.

**Bleeder screw tightening torque:**  
6.9~12.7 Nm (0.7~1.3 kgf.m, 5.1~9.4 lb-ft)

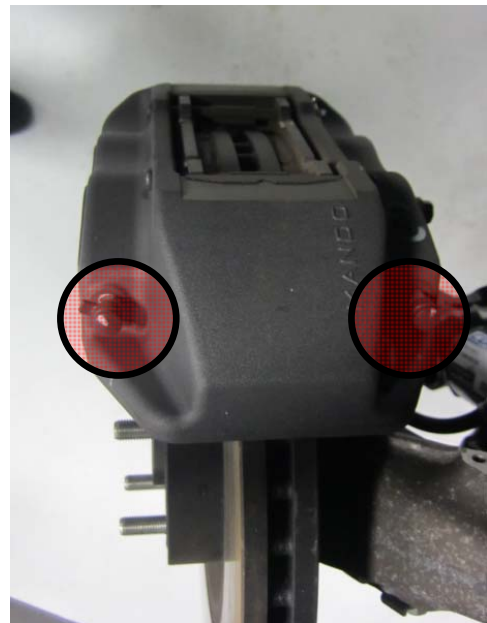
9. ***Move to the FRONT LEFT wheel.***

Repeat the process described in steps 5-8.

Some models may have 2 bleeder screws (one inside, one outside). For these models, bleed the outside first (until the fluid level is halfway between MAX and MIN) then move to the inside bleeder (until the fluid is down to MIN).

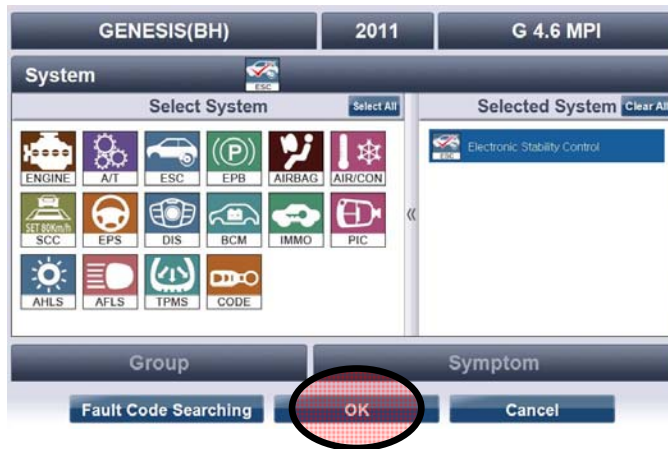
1. Connect GDS VCI to DLC connector. Connect VCI to GDS using USB cable.

Start the engine and verify that all electrical systems are turned off (no electrical load). Select model and ESC (Electronic Stability Control) system, then press “OK” button on the screen.

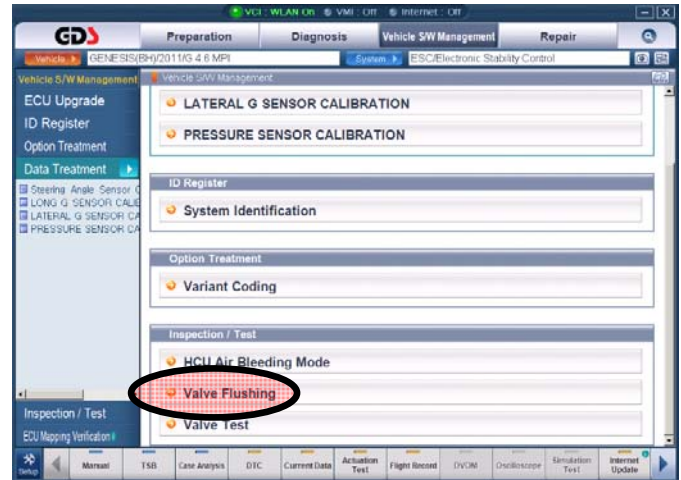
3. Select “Valve Flushing.”

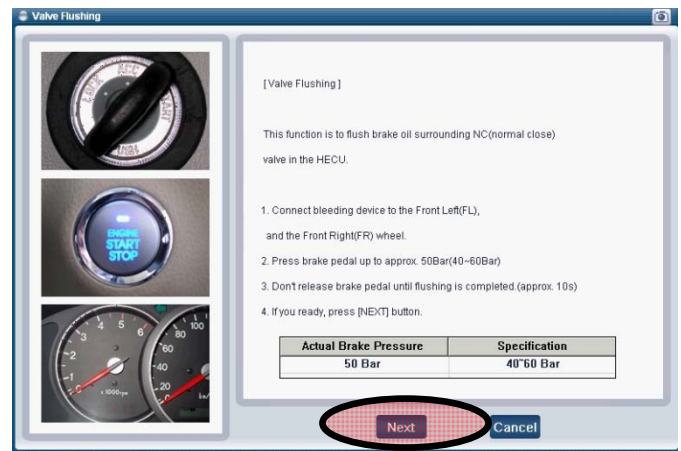
4. As directed by the GDS, press and hold the brake pedal to maintain about 50 bar (725 psi) of brake pressure. Press “NEXT” while holding pressure.

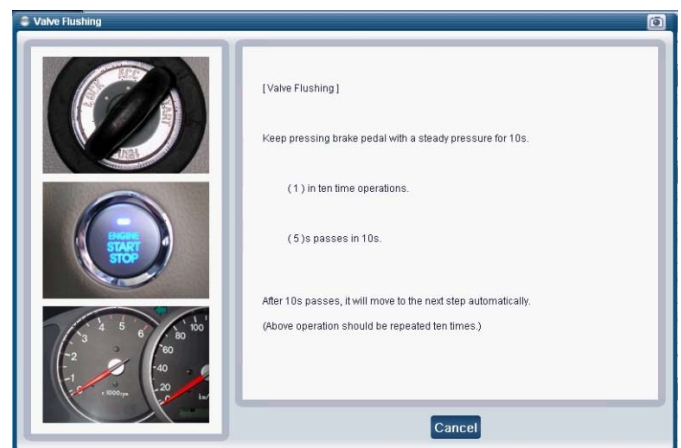
5. The HECU motor will operate and the brake pedal will pulsate for 10 seconds. Maintain holding brake pressure during this time.

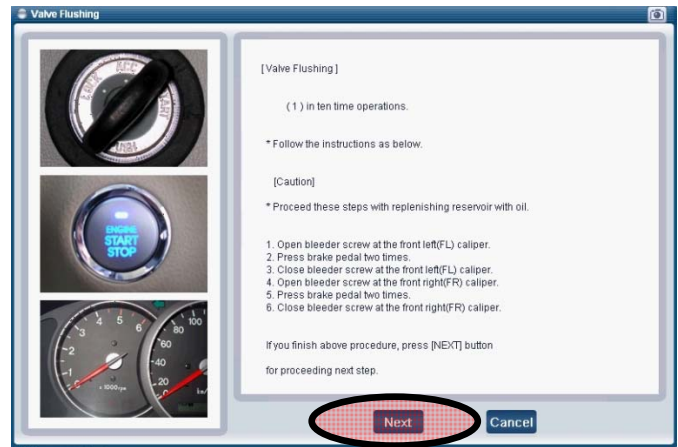
## 6. Bleed front brake assemblies:

Start with the front left brakes.

Press the brake pedal twice and hold. With a bleeding line attached, open the bleeder screw to bleed the line.

Repeat for the front right brakes, then press "NEXT."

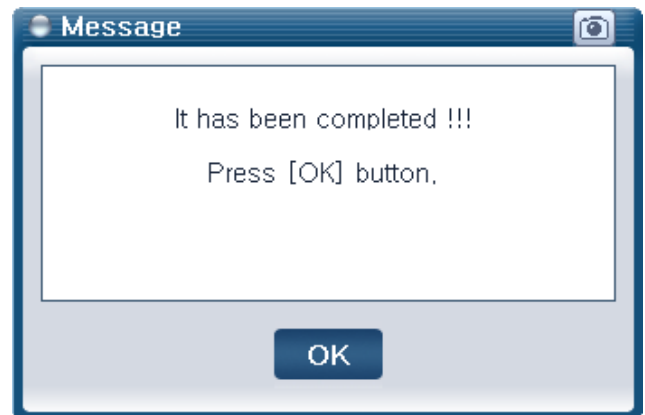
## 7. Repeat steps 5 and 6 for a total of 10 HECU valve flushing operations. GDS menu screen will count number of iterations.

After the 10<sup>th</sup> flushing, the procedure is completed.

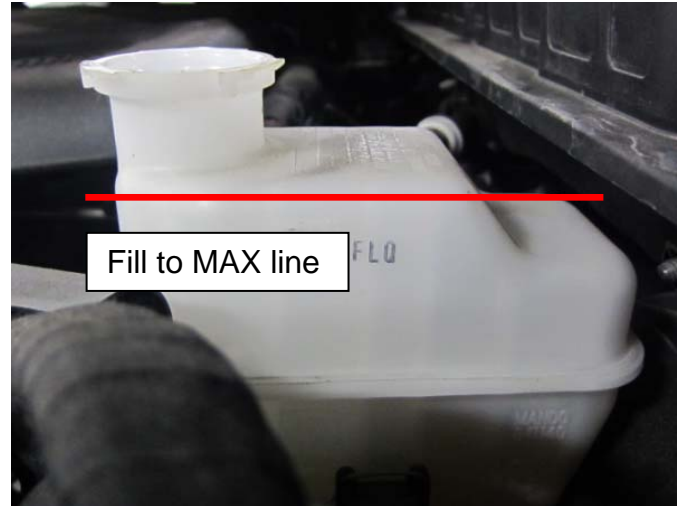
8. Refill the brake fluid in the master cylinder reservoir to the MAX line.

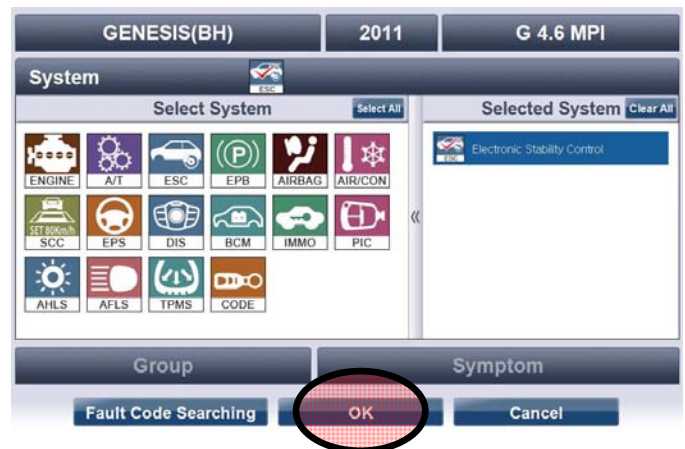
1. Connect GDS VCI to DLC connector. Connect VCI to GDS using USB cable.

Start the engine and verify that all electrical systems are turned off (no electrical load). Select model and ESC (Electronic Stability Control) system, then press “OK” button on the screen.

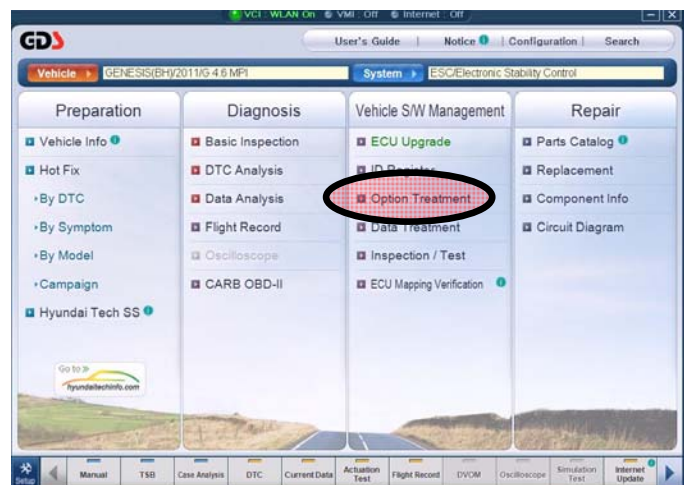
2. Select “Option Treatment” under the Vehicle S/W Management tab.

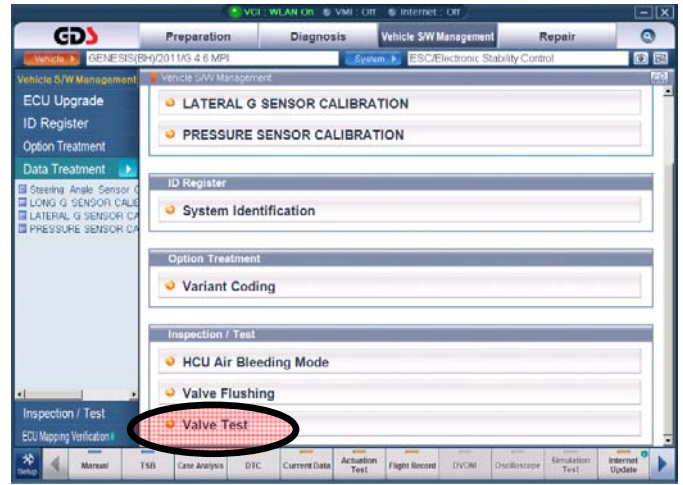
3. Select “Valve Test.”

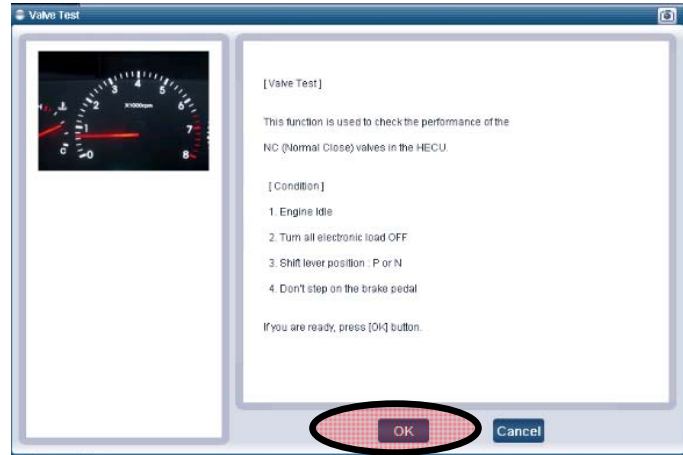
4. Check the vehicle conditions (engine idling, all electronic loads are OFF, shifter in P or N, foot off the brake pedal) and then click “OK.”

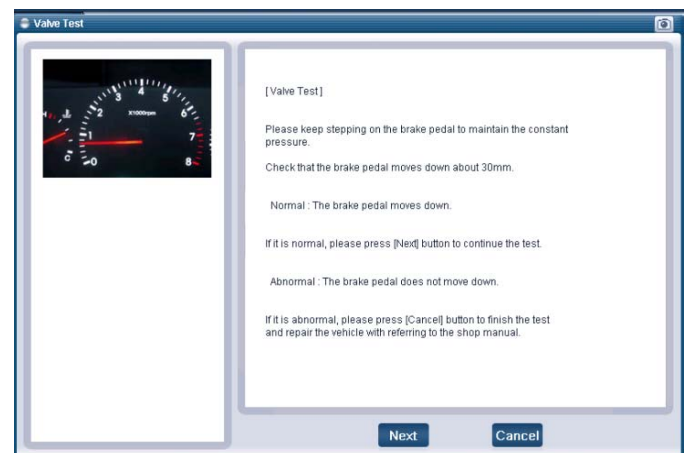
7. While maintaining foot pressure on the brake pedal, check that pedal moves down approximately 30mm (1.18”):

- Pedal moves down: Continue with the HECU inspection (step 8) by clicking “Next.”
- Pedal does not move down: Click “Cancel” to end the inspection procedure, then replace the HECU according to the applicable shop manual procedures.

After HECU replacement, bleed any air from the brake lines at all four calipers in the correct order, then perform the calibration procedures on page 13.

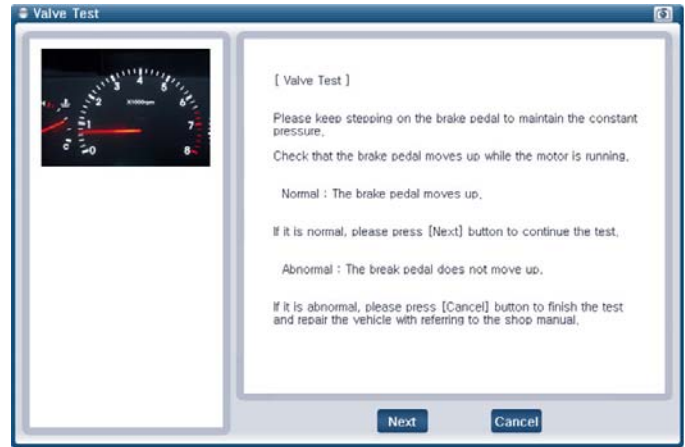
8. While maintaining foot pressure on the brake pedal, check that pedal comes back up:
- Pedal comes back up: Continue with the HECU inspection (step 9) by clicking “Next.”
  - Pedal does not come back up: Click “Cancel” to end the inspection procedure, then replace the HECU according to the applicable shop manual procedures.

After HECU replacement, bleed any air from the brake lines at all four calipers in the correct order, then perform the calibration procedures on page 13.

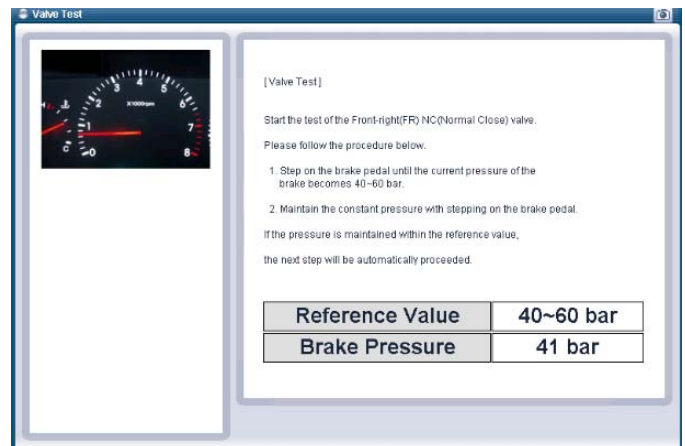
9. The valve test continues with the front right NC (normally closed) valve.

Repeat steps 6-8 for the front right valve, then move onto the rear left, and rear right valves using the same procedures as directed by the GDS.

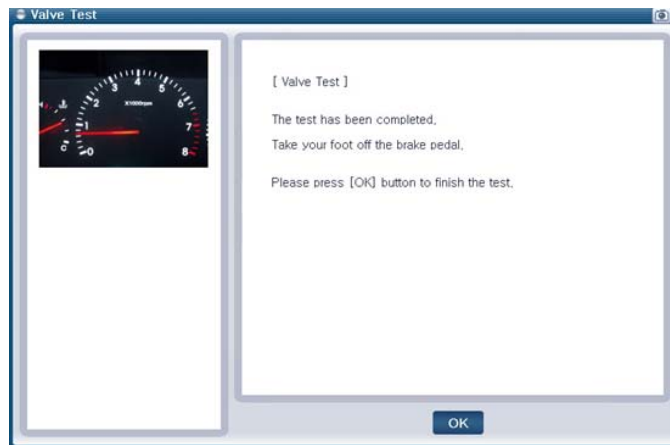
10. After all four valves are tested, the test is complete. Press the “OK” button to finish:

- If all valves tested OK: The service procedure is completed.
- If any valve did not pass the test: Replace the HECU according to the applicable shop manual procedures.

After HECU replacement, bleed any air from the brake lines at all four calipers in the correct order, then perform the calibration procedures on page 13.

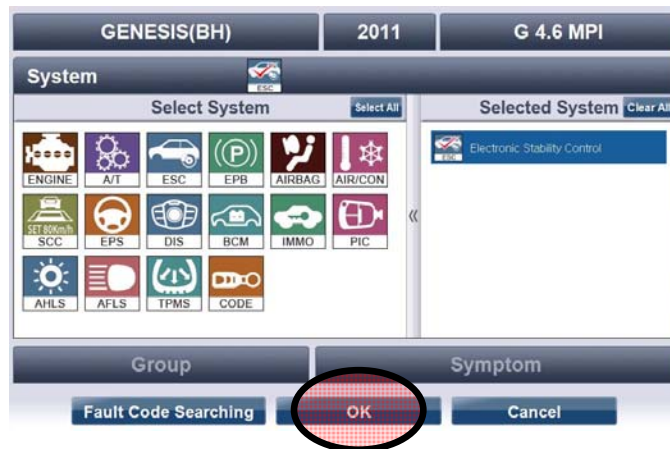
1. Connect GDS VCI to DLC connector. Connect VCI to GDS using USB cable.

Start the engine and verify that all electrical systems are turned off (no electrical load). Select model and ESC (Electronic Stability Control) system, then press “OK” button on the screen.

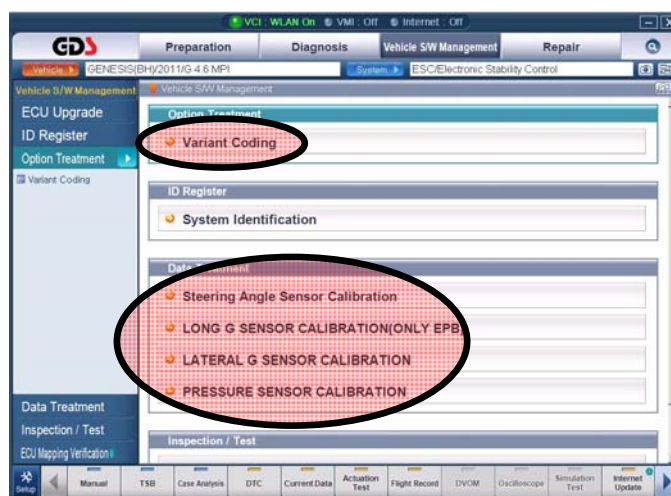
3. After HECU replacement, it is required to perform 5 calibrations:

- Variant Coding
- Steering Angle Sensor Calibration
- Long G Sensor Calibration (ONLY EPB)
- Lateral G Sensor Calibration
- Pressure Sensor Calibration

Perform these by clicking on each one, and following the GDS instructions.
