## SAFETY RECALL

**SR13-72**

| SUBJECT: <b>ACCELERATOR PEDAL INSPECTION</b> | |

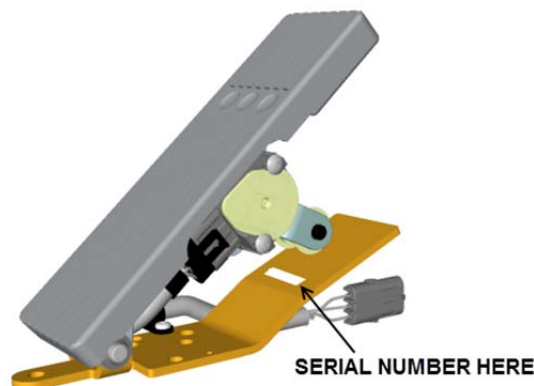
1. Check the serial number on the accelerator pedal assembly.
2. If the accelerator pedal serial number matches with a serial number found in the following list, a replacement of the accelerator pedal is needed. To do so, perform Part 2 of this campaign.
3. If your accelerator pedal serial number is not within the range of affected accelerator pedal, no replacement is needed. No other verification or repair is necessary.

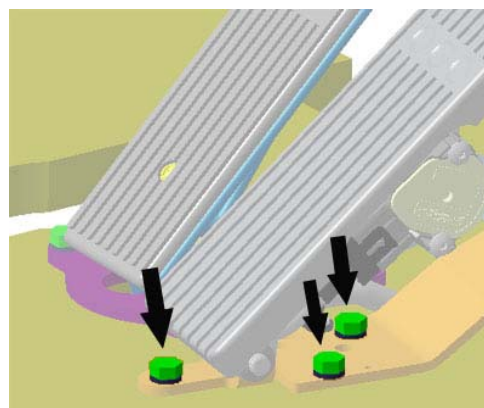
1. Remove accelerator pedal mounting bolts (3x).

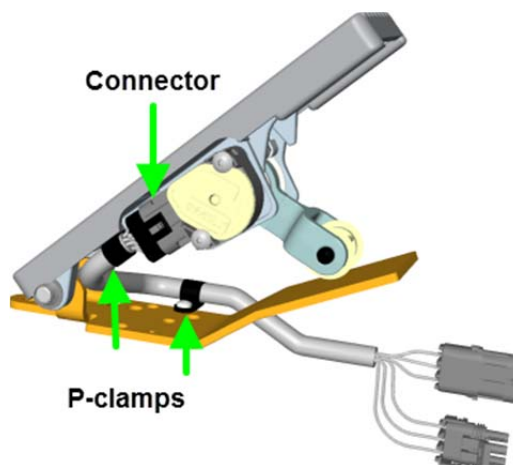
2. Unscrew the electrical harness P-clamps (2x).
3. Unplug the connector from the acceleration pedal. Unless it is in bad condition, reuse the existing harness and connect it to new accelerator pedal.
4. Plug connector to new acceleration pedal. Secure P-clamps onto the new acceleration pedal.
5. Bolt the new accelerator pedal to the floor using the existing hardware.
6. Start the engine. With the parking brake applied and transmission in neutral position (N), test the accelerator pedal for proper functioning.
