ALL 2013 MODEL YEAR ESCAPE VEHICLES EQUIPPED WITH A 1.6L ENGINE — RISK OF OVERHEATING THAT MAY RESULT IN ENGINE FIRES

Safety Recall 13S12 applies to 2013 Model Year Escape models equipped with a 1.6L engine due to potential localized overheating of the engine cylinder head. The localized overheating may cause the engine cylinder head to crack, causing an oil leak that may result in a fire in the engine compartment. Repairs include enhancements to the engine shielding system, engine cooling system, and engine control systems. Additionally, some vehicles have been observed with an engine oil overfill condition that occurred during service when the oil capacity was not properly identified. An improved dip stick and label will be added to facilitate proper maintenance and improve customer satisfaction.

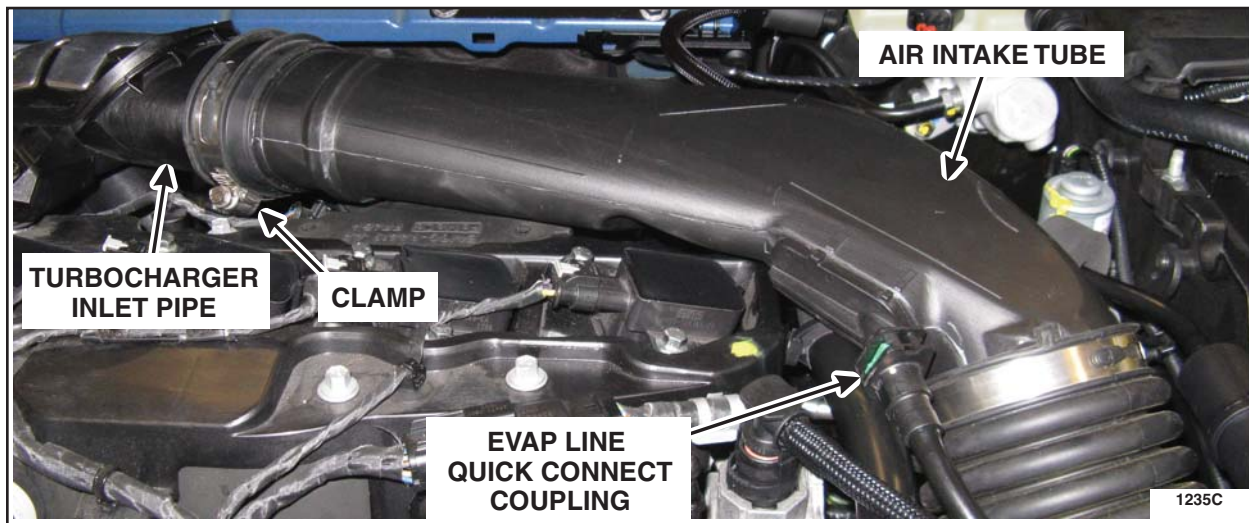
FIGURE A1

8. Disconnect the EVAP line quick connect coupling from the air intake tube center section. Set the clip aside for re-installation to prevent it from falling into the engine compartment. See Figure A1.
9. Loosen the clamp and disconnect the air intake tube from the turbocharger inlet pipe. See Figure A1.

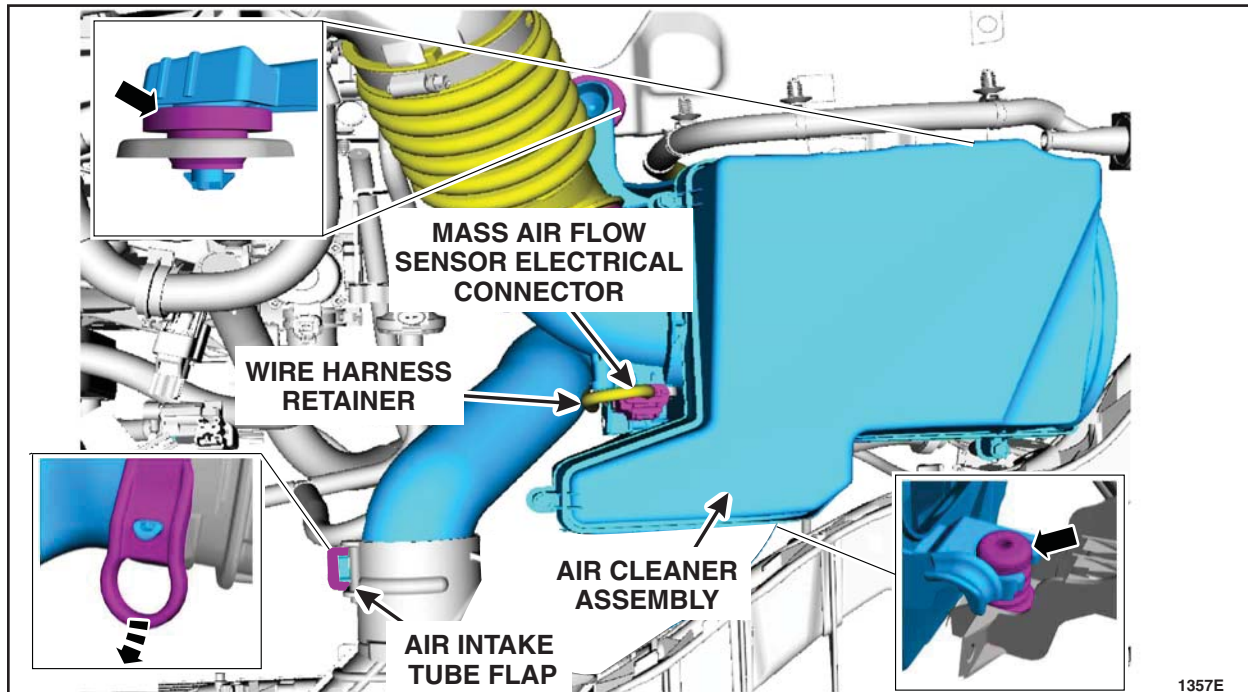
FIGURE A2

- a. Disconnect the mass air flow sensor electrical connector.
- b. Release the fresh air intake tube flap.
- c. Detach the mass air flow sensor wire harness retainer from the air cleaner assembly.
- d. Lift upward to disengage the two retaining grommets and remove the air cleaner assembly.

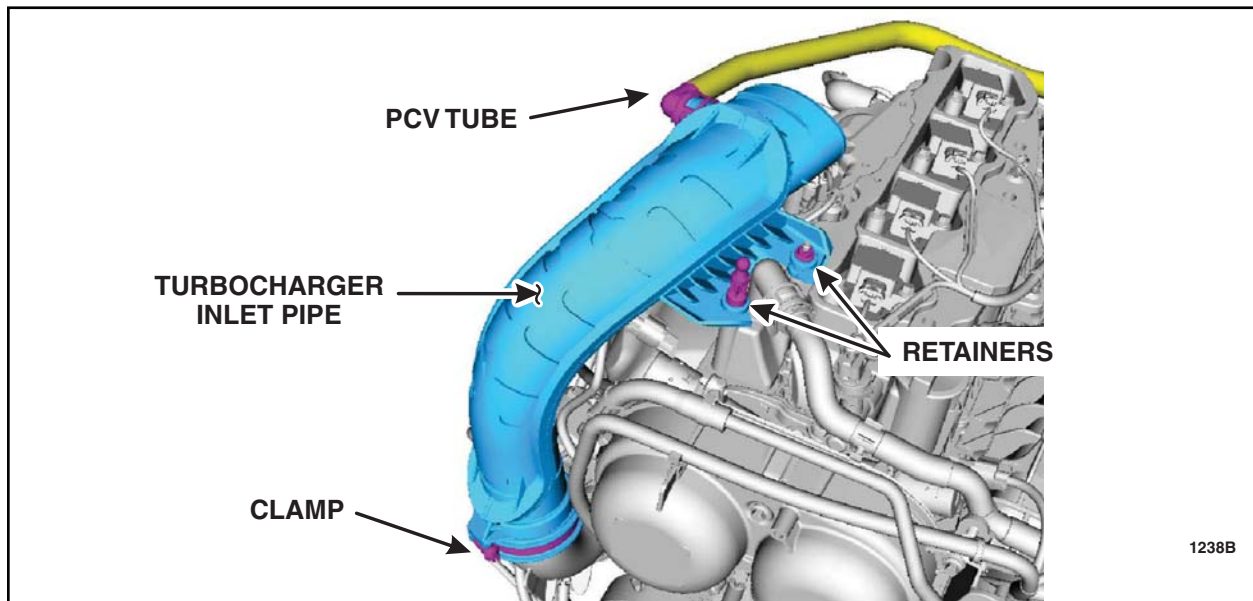
FIGURE A3

12. Disconnect the PCV tube from the turbocharger inlet pipe. Remove the retainers and loosen the clamp at the turbocharger. Remove the turbocharger inlet pipe. See Figure A3.

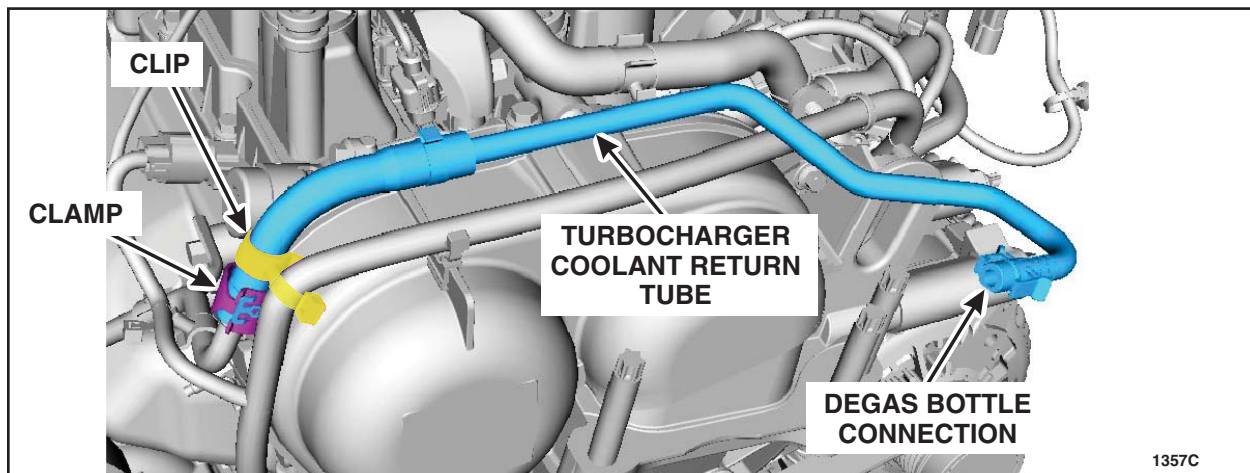
FIGURE C1

1. Drain the cooling system. For additional information, refer to WSM Section 303-03A.
2. Remove and discard the turbocharger coolant return tube. See Figure C1.
 - a. Disconnect the turbocharger coolant return tube from the degas bottle.
 - b. Detach the clip from the coolant return tube.
 - c. Release the clamp, remove and discard the coolant return tube.

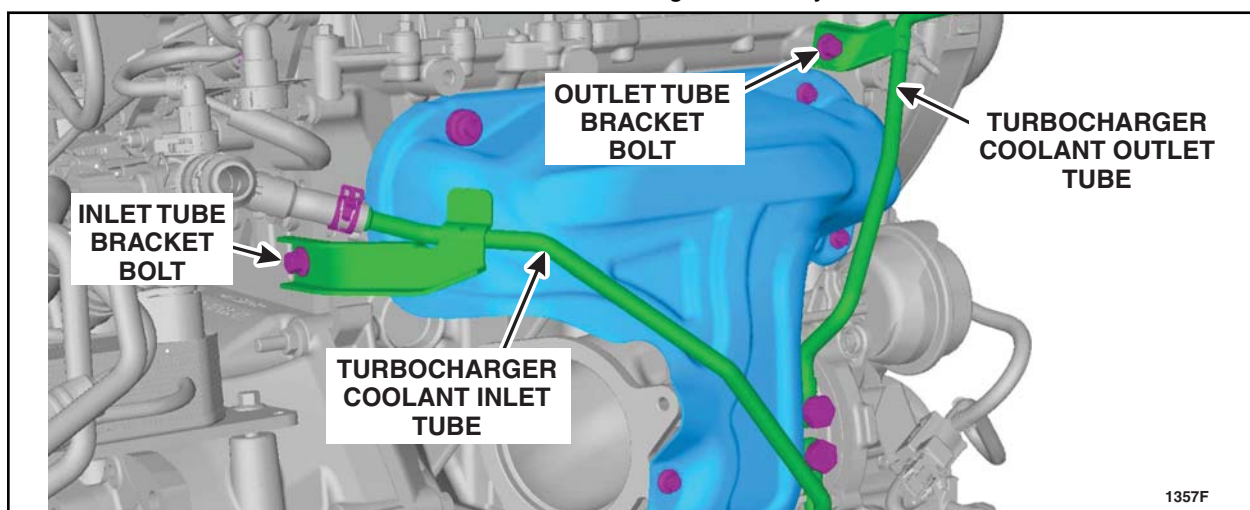
FIGURE C2

3. Remove the turbocharger coolant inlet and outlet tube bracket bolts. See Figure C2.
 - Discard the turbocharger outlet tube bolt.
 - The inlet tube bracket bolt will be reused during reassembly.

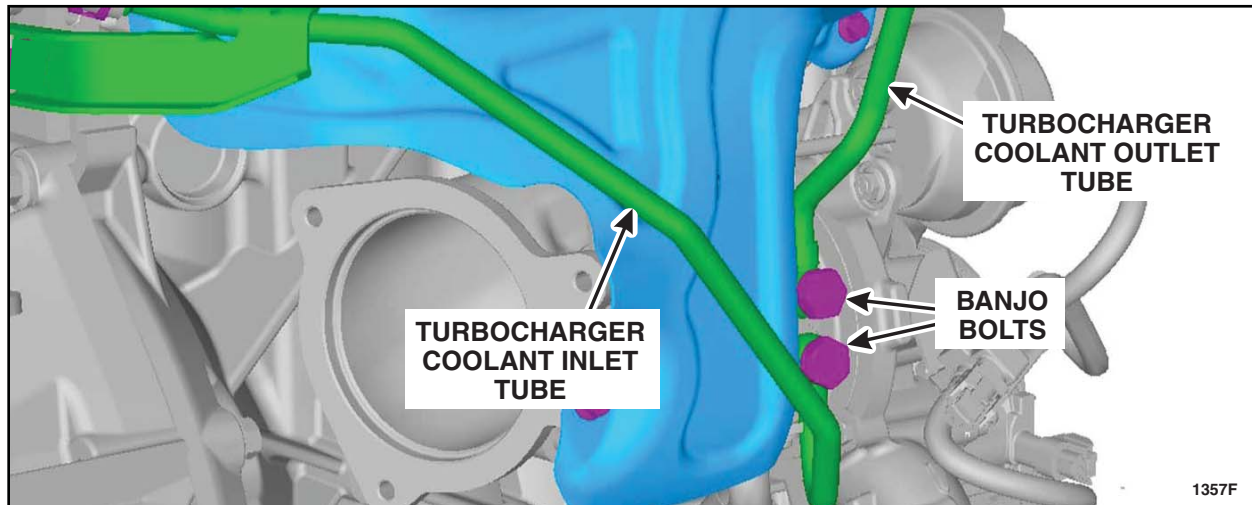
FIGURE C3

4. Remove the banjo bolts and the turbocharger coolant outlet tube. Position aside the turbocharger coolant inlet tube. See Figure C3.
 - Discard both copper washers after removal.
 - If required, use a pair of needle nose pliers to hold the copper washers while turning the banjo bolt to thread the washer off of the bolt.

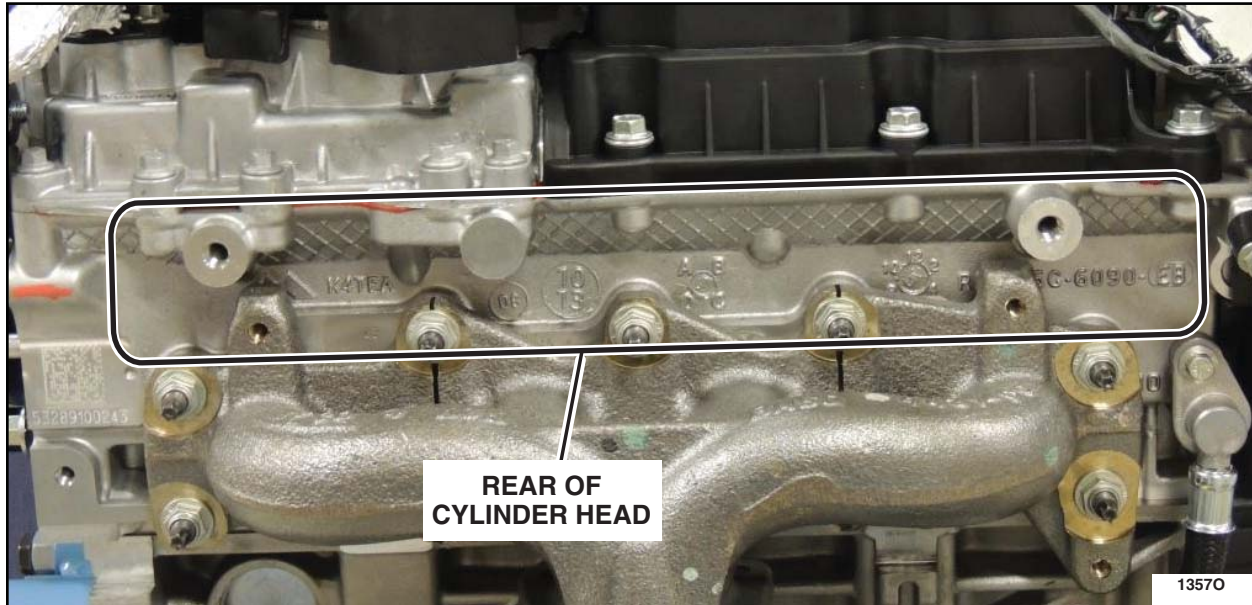
FIGURE C5

6. Prepare the cylinder head for the *new* cast engine shield installation. See Figure C5.
- Spray and wipe down the rear of the cylinder head using Motorcraft® Metal Brake Parts Cleaner (PM-4-A or PM-4-B).
 - Repeat this step a second time and ensure the surface is oil free.
 - Blow dry using compressed air to remove any puddles.
 - Using one (1) towelette from the Motorcraft® ZC-31B (Bonderite 1455) canister, wipe the rear of the cylinder head in the area shown. This etches the aluminum to allow proper bond with the LOCTITE® 5920 copper RTV silicone.

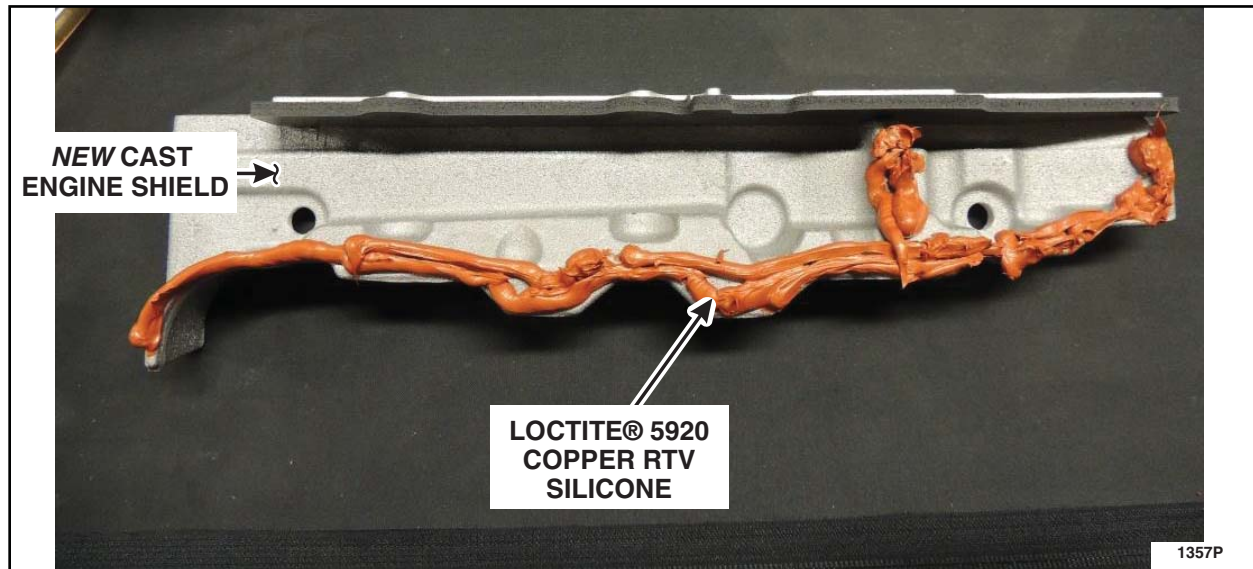
FIGURE C6

7. Apply two (2) 3 mm to 5 mm beads of LOCTITE® 5920 copper RTV silicone (approximately 1/2 tube) that is supplied in the vehicle parts kit to the *new* cast engine shield. See Figure C6.

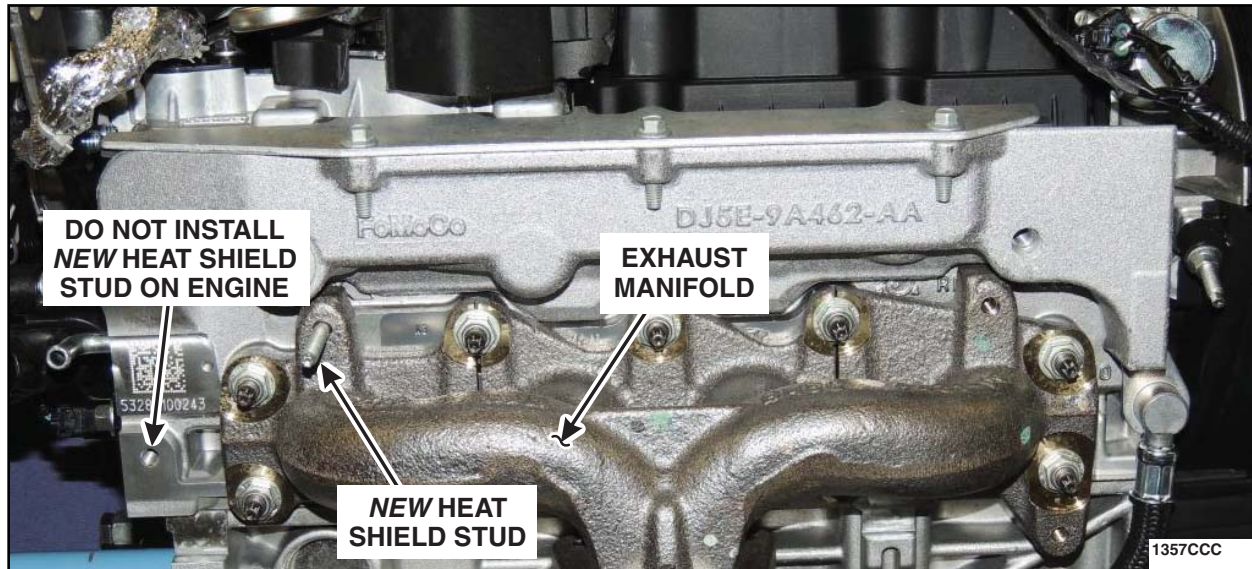
FIGURE C8

NOTE: Ensure the *new* heat shield stud is installed onto the exhaust manifold as shown. Do not install onto the engine. See Figure C8.

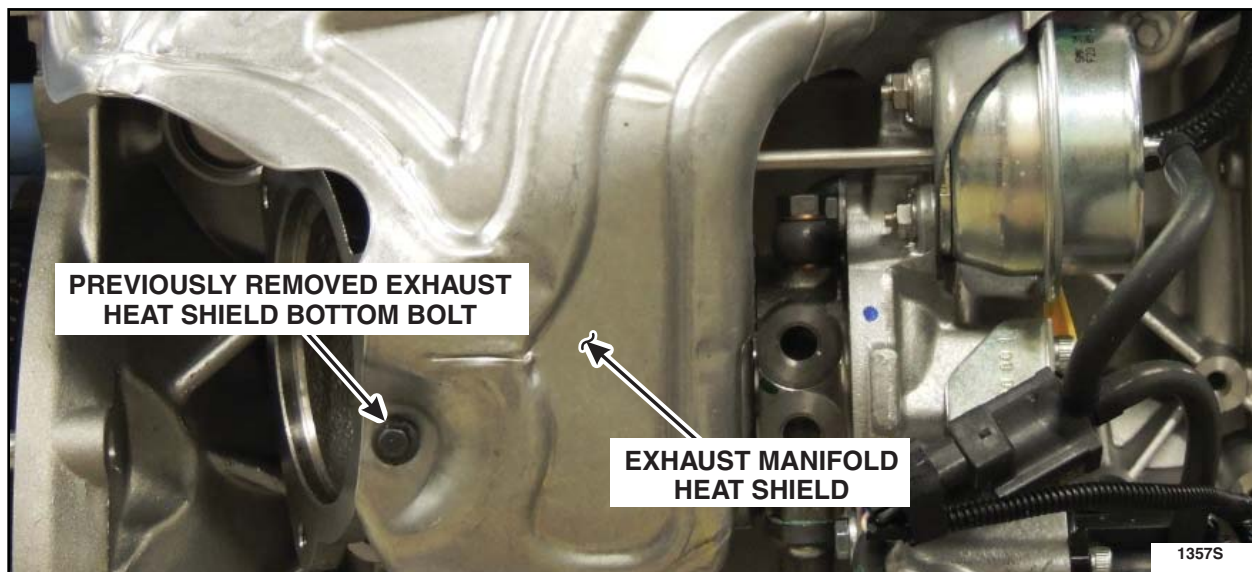
FIGURE C9

10. While holding the heat shield in position, loosely install the previously removed exhaust heat shield bottom bolt. Do not attempt to secure the upper portion of the heat shield into place until the bottom bolt is started into the threads on the turbocharger housing boss. See Figure C9.

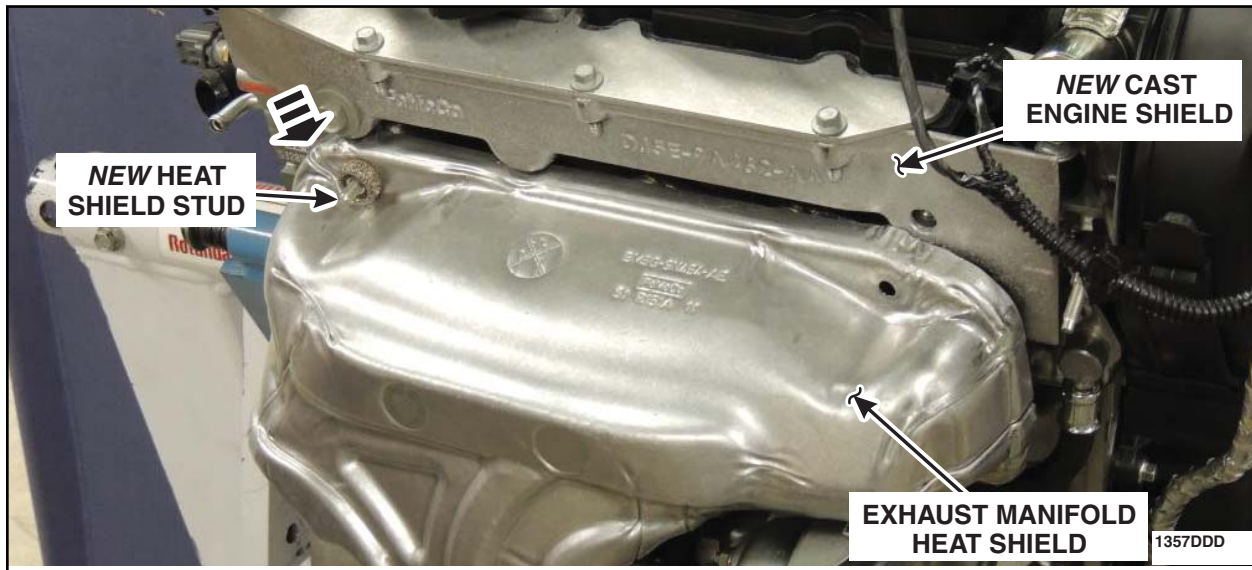
FIGURE C10

11. While pressing downward, position the exhaust heat shield onto the new heat shield stud and under the RH side of the *new* cast engine shield. See Figure C10.

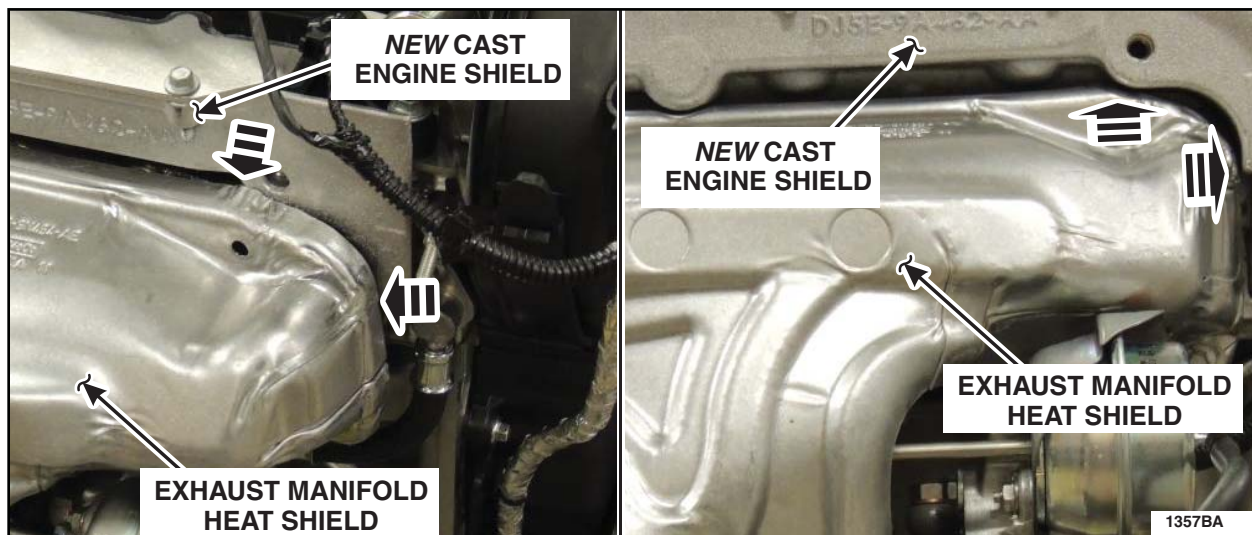
FIGURE C11

12. Continue to press downward and pull forward to roll the exhaust manifold heat shield under the *new* cast engine shield. See Figure C11.

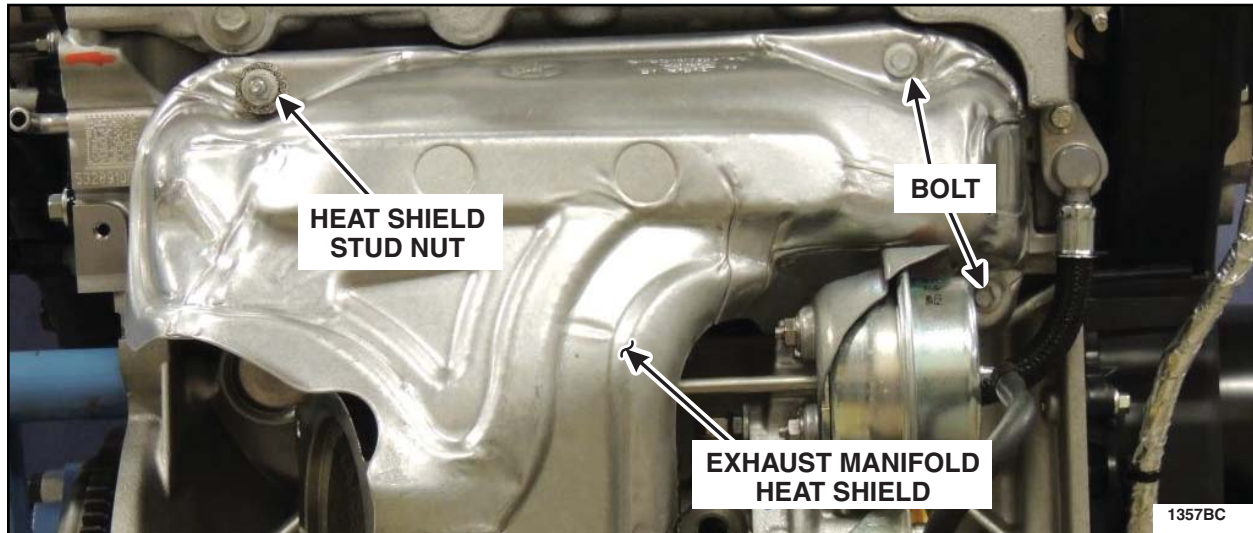
FIGURE C12

13. Install the two (2) *new* bolts and *new* heat shield stud nut onto the exhaust manifold heat shield.
See Figure C12.

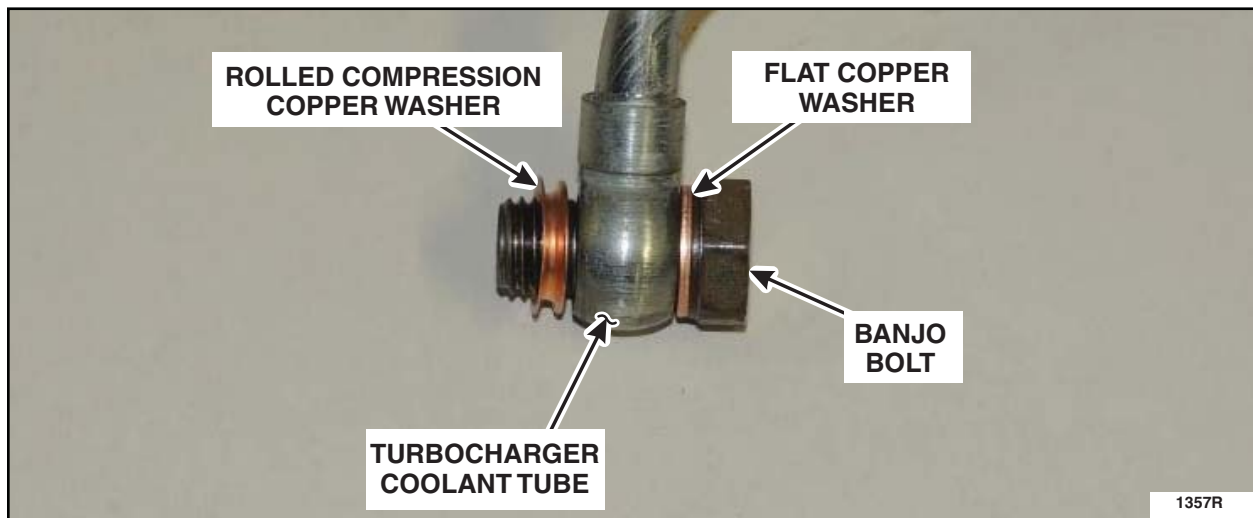
FIGURE C13

- The rolled compression copper washer should be installed between the turbocharger inlet and outlet coolant tubes and the turbocharger.
- The flat copper washer should be installed between the banjo bolt head and the turbocharger inlet and outlet coolant tubes.

15. Install the vehicle parts kit supplied banjo bolt copper washers and the banjo bolts onto the turbocharger coolant inlet and outlet tubes. See Figure C13.
16. Loosely install the turbocharger coolant inlet and outlet tubes and banjo bolts onto the turbocharger. See Figure C3.
17. Loosely install the coolant inlet tube bracket bolt. See Figure C2.
18. Loosely install the remaining *new* cast engine shield bolt. This bolt also will retain the turbocharger coolant outlet tube bracket. See Figure C14.
19. Tighten the turbocharger coolant inlet and outlet tube banjo bolts to 28 Nm (21 lb-ft). See Figure C3.
20. Tighten both *new* cast engine shield bolts to 28 Nm (21 lb-ft). See Figure C14.

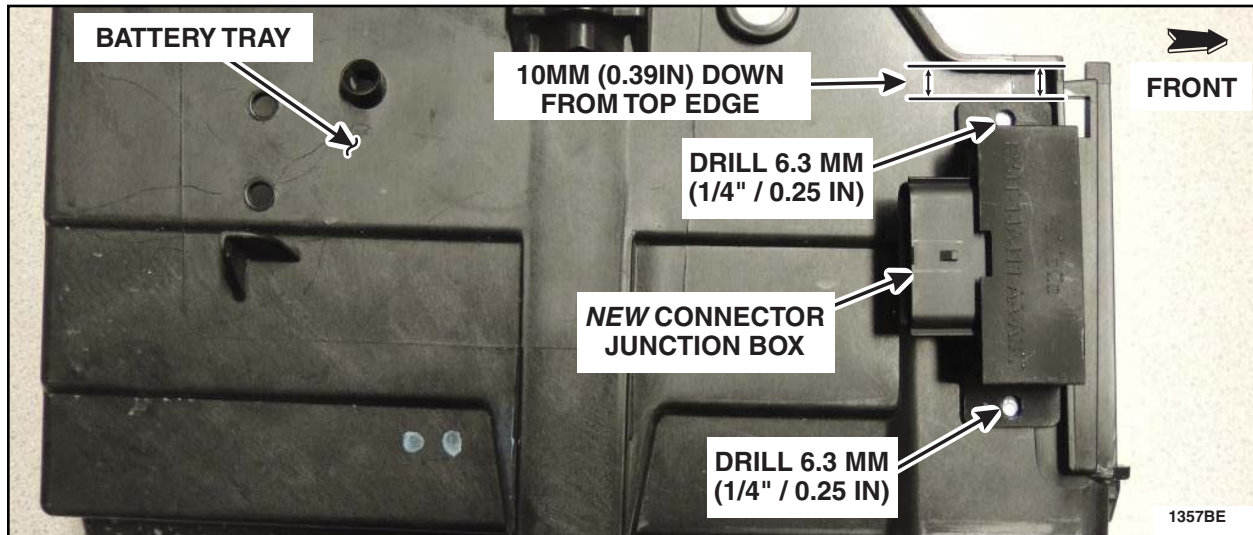
FIGURE D1

1. Using the dimensions shown below, mark and drill the locations of the two (2) holes that are required for the new connector junction box, in the right side of the battery tray. See Figure D1.
 - a. Position the *new* connector junction box on the forward right side of the battery tray, 10mm (0.39 in) down from the top edge of the battery tray. Using the *new* connector junction box as a template, mark the two (2) hole locations on the battery tray. See Figure D1.
 - b. Remove the *new* connector junction box from the battery tray.
 - c. Using a 6.3 mm (1/4" / 0.25 in) drill bit, drill the two marked locations on the battery tray.

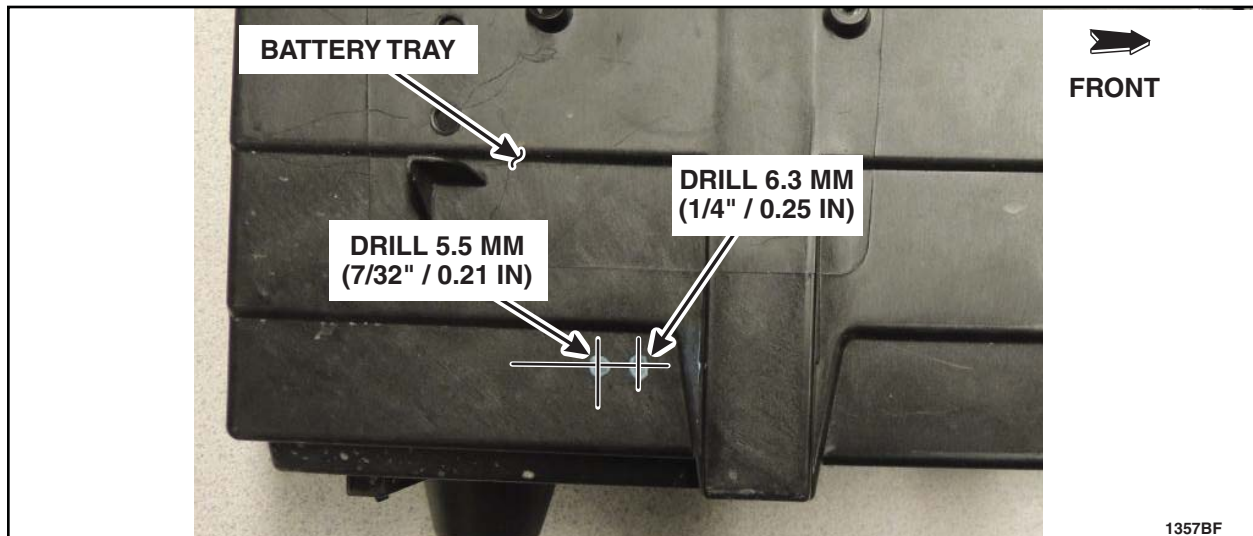
FIGURE D3

- Using the appropriate size drill bit for two (2) remaining marked locations on the battery tray, 5.5 mm (7/32" / 0.21 in) and 6.3 mm (1/4" / 0.25) as indicated in Figure D3, drill the two (2) holes. See Figure D3.

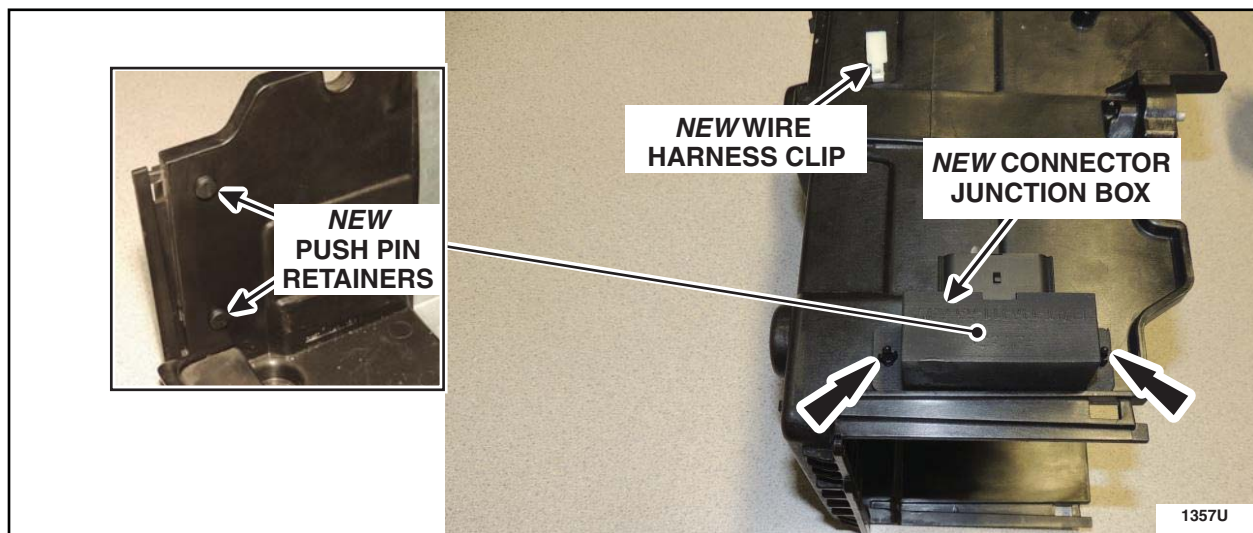
FIGURE D4

- Deburr the four (4) previously drilled holes on the battery tray as necessary.
- Attach the *new* connector junction box to the battery tray using the two (2) *new* push pin retainers. Install the *new* push pin retainers so the heads of the retainers are on the **inside** of the battery tray. See Figure D4.
- Install the *new* wire harness clip onto the battery tray. The christmas tree portion of the *new* wire harness clip is to be installed into the larger of the two mounting holes. See Figure D4.

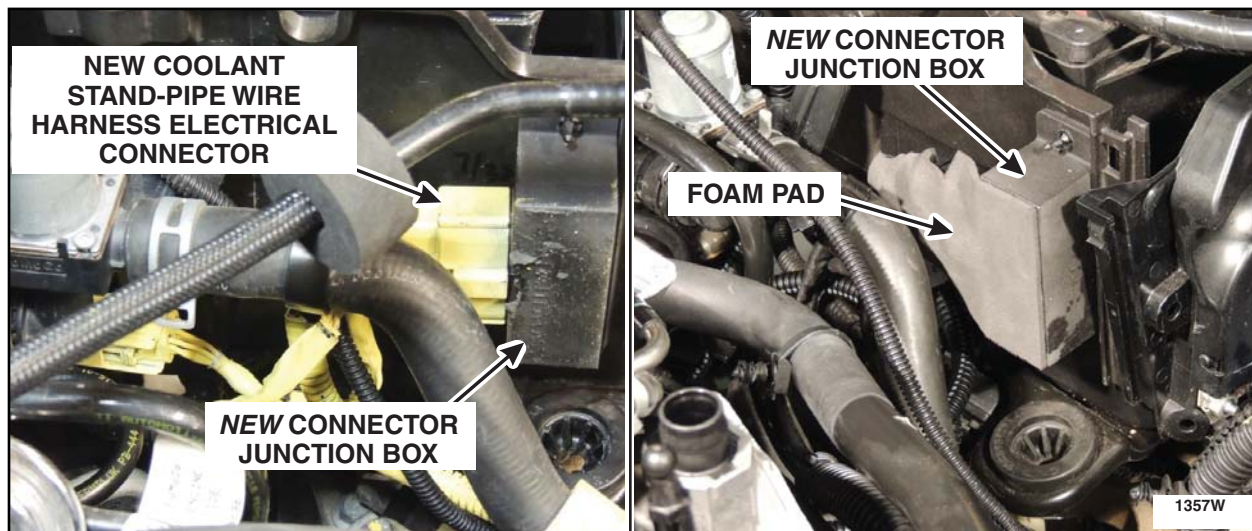
FIGURE E2

NOTE: The *new* coolant stand-pipe wire harness is highlighted to show routing and connection points.

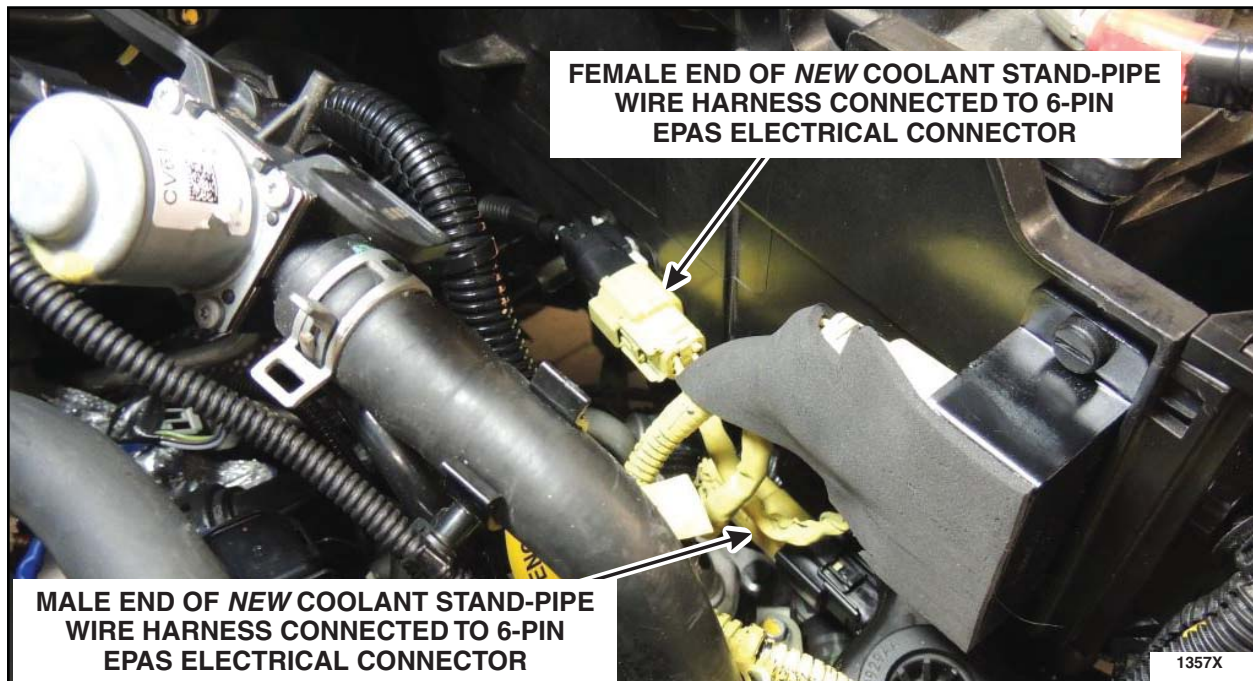
FIGURE E3

3. Connect the *new* coolant stand-pipe wire harness 6-pin electrical connectors to the 6-pin EPAS electrical connectors. See Figure E3.
4. Attach the electrical connectors (female end of coolant stand-pipe / male end of 6-pin EPAS electrical connectors) to the white retaining clip that was previously installed on the battery tray. See Figure E3.
5. Attach the electrical connectors (male end of coolant stand-pipe / female end of 6-pin EPAS electrical connectors) to the battery tray mounting bracket. See Figure E3.

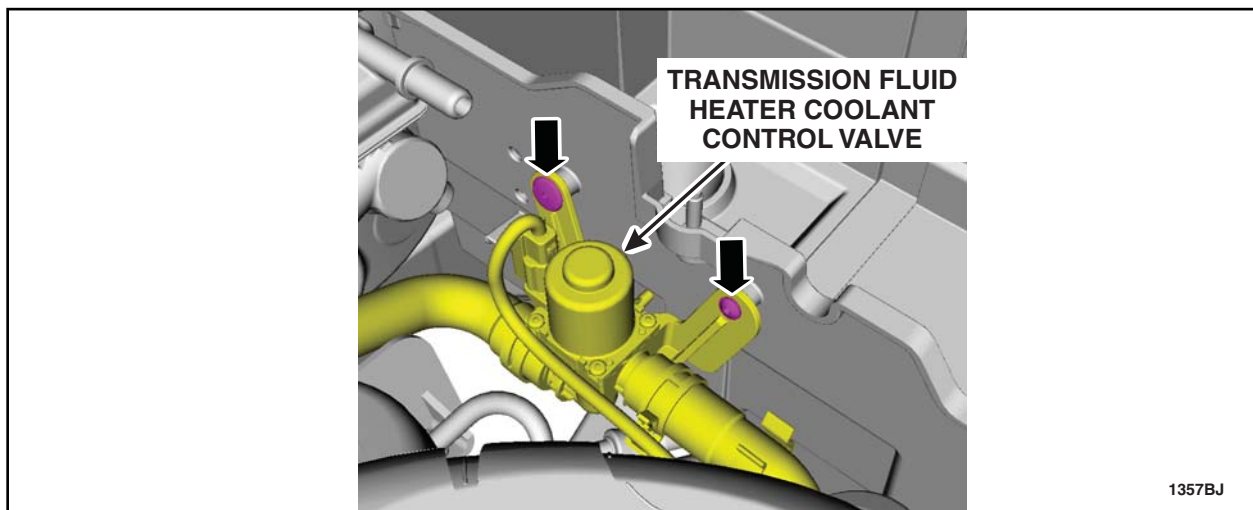
FIGURE E5

7. Position the stand-pipe wire harness aside. It will be routed/secured and connected later.
8. Install the transmission fluid heater coolant control valve to the battery tray and install the two (2) retainers. See Figure E5.

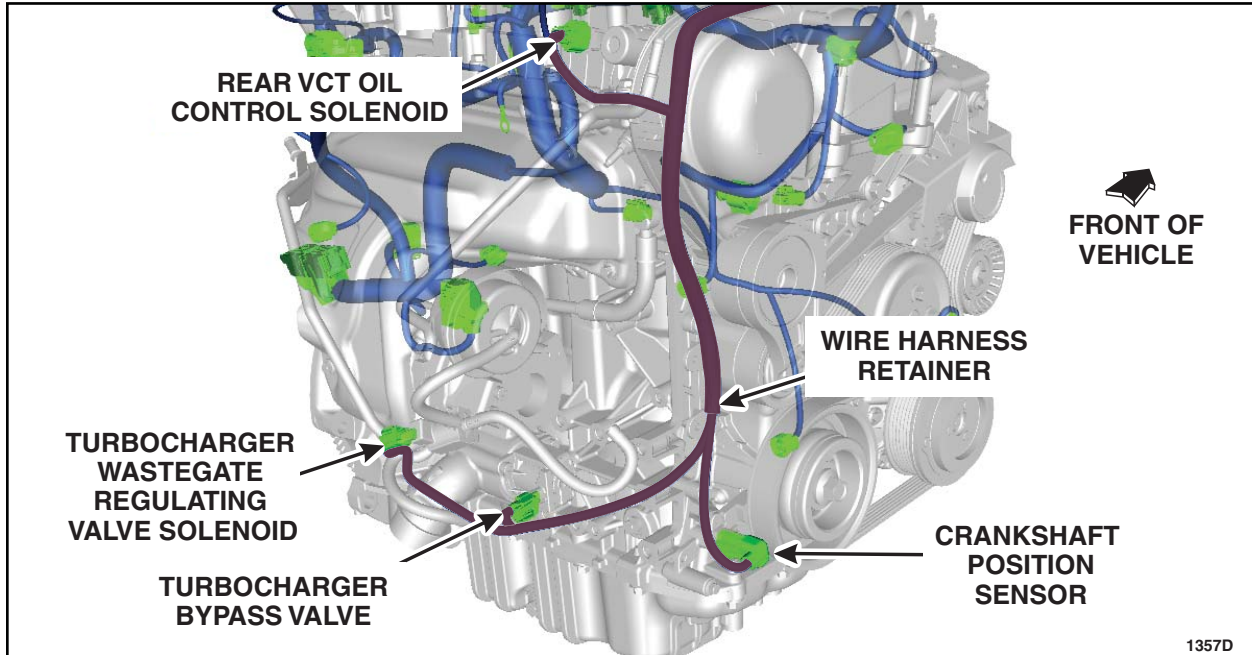
FIGURE G1

1. Detach the wire harness retainer from the front cover, disconnect the crankshaft position sensor, turbocharger wastegate regulating valve solenoid, and turbocharger bypass valve electrical connectors. See Figure G1.

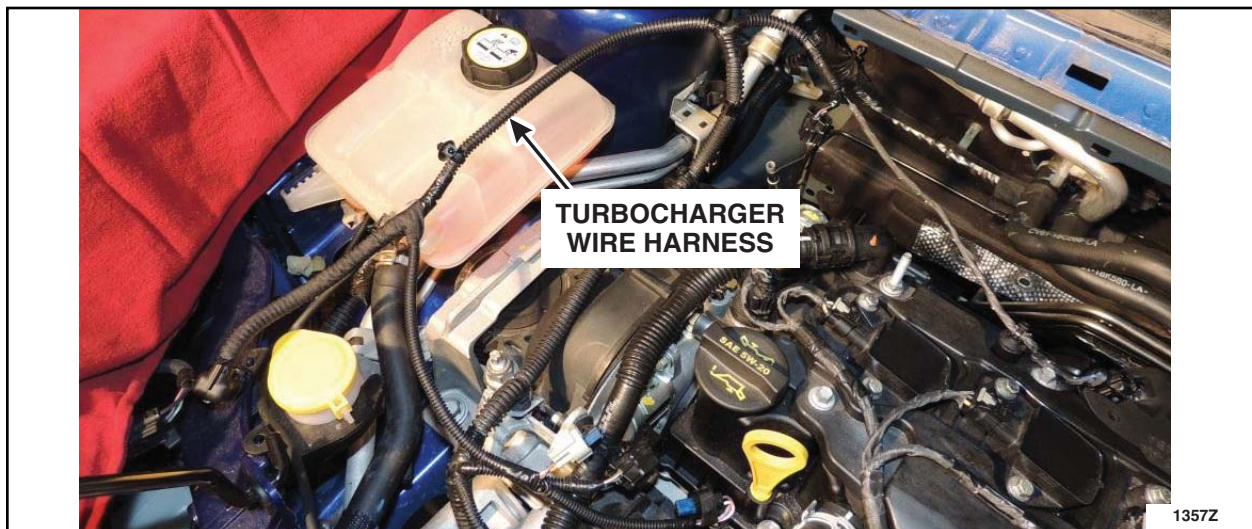
FIGURE G2

2. Route the turbocharger wire harness to the top of the engine compartment. See Figure G2.

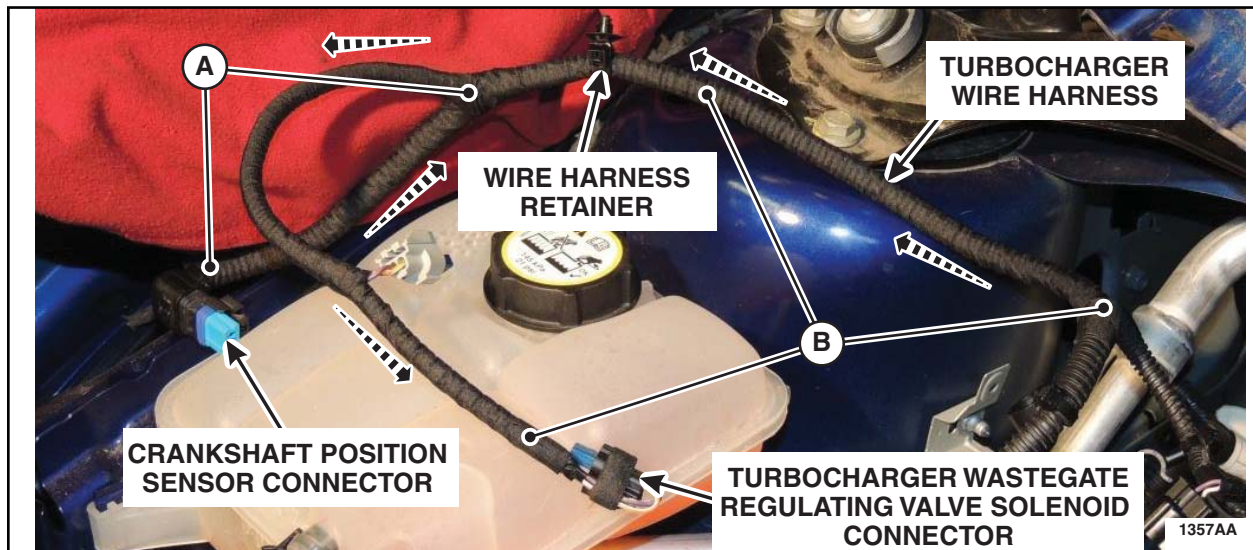
FIGURE G3

4. Replace the wire harness retainer with a *new* one supplied in the vehicle parts kit. See Figure G3.
 - Mark the wire harness retainer location before removal.

- Wrap the turbocharger harness starting at the takeout to the rear VCT solenoid. Proceed down the remaining length of harness to the turbocharger wastegate regulating valve solenoid connector. See Figure G3, (B).

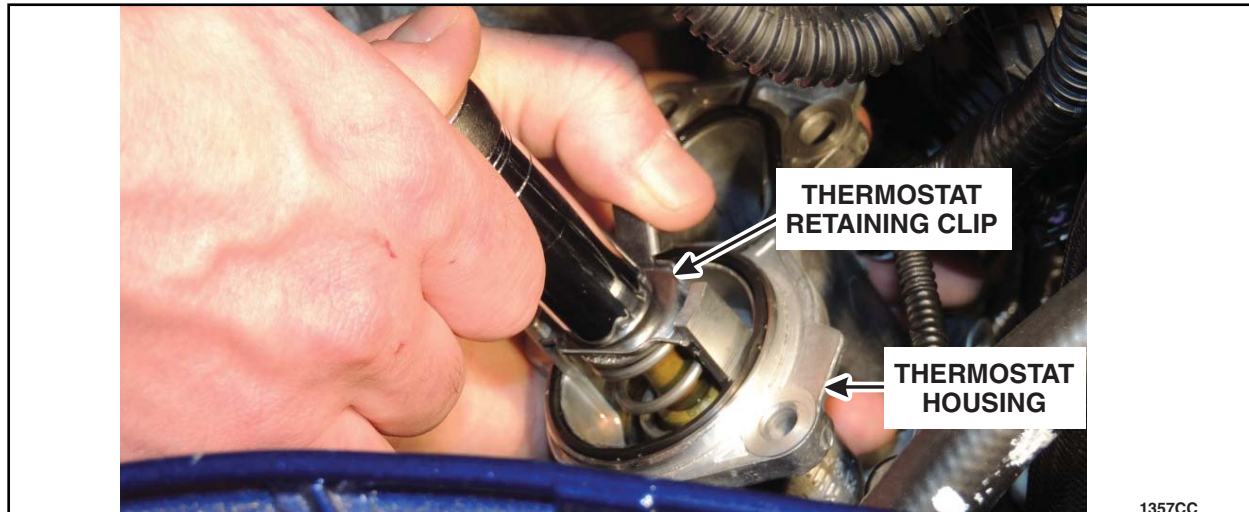
FIGURE H2

3. Use a 13 mm (1/2 in) deep well socket to press downward on the thermostat retaining clip and rotate to remove it from the thermostat housing. Remove the thermostat spring. See Figure H2.
 - Note the position of the thermostat retaining clip and thermostat prior to removing. See Figures H2 and H4.

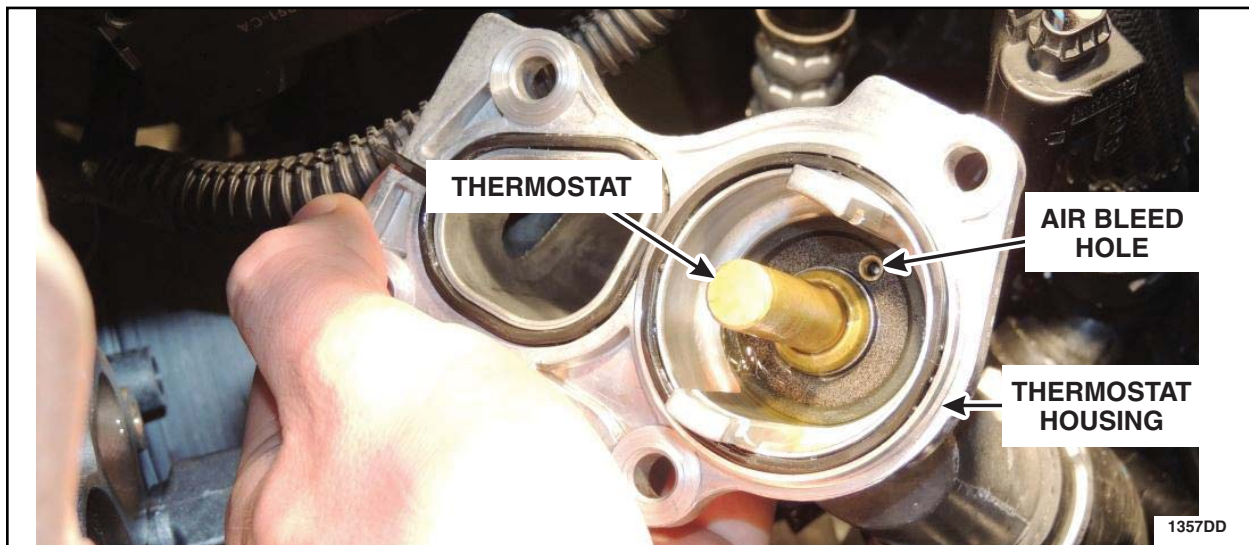
FIGURE H3

4. Remove and discard the thermostat. See Figure H3.
5. Position the *new* thermostat into the housing with the air bleed hole positioned upward. Use a 13 mm (1/2 in) deep well socket to install the thermostat spring and clip. The retaining clip must be in the same orientation that it was in prior to removal. See Figures H3 and H4.

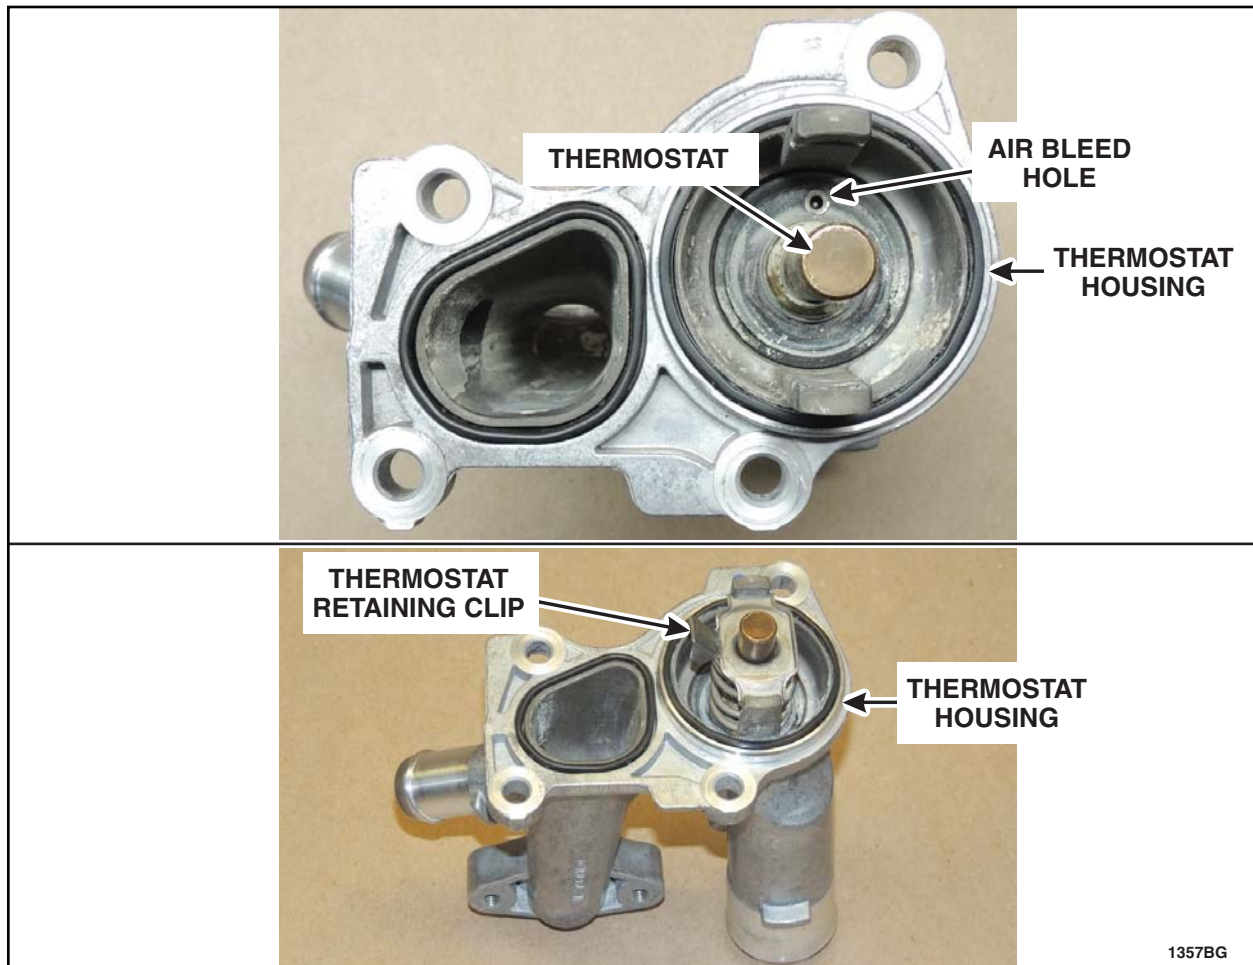
FIGURE H4

NOTE: The thermostat retaining clip must be installed in the position as shown. See Figure H4.

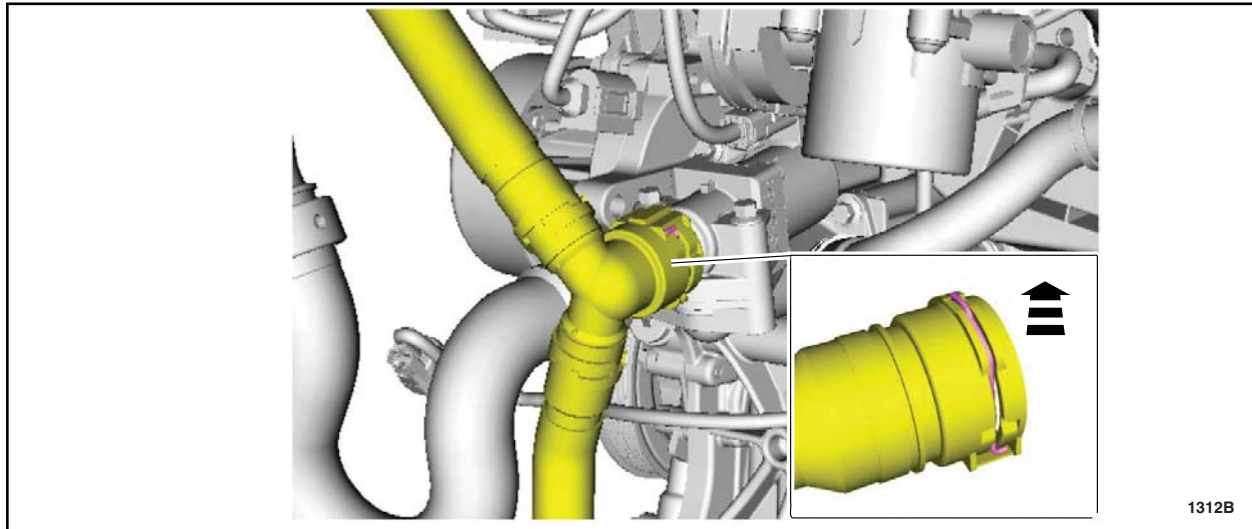
FIGURE I1

1. Remove and discard the coolant degas bottle and degas bottle cap. For additional information, refer to WSM Section 303-03A.
2. If not done previously, release the clip and disconnect the quick connect T-fitting from the coolant shutoff solenoid valve. See Figure I1.

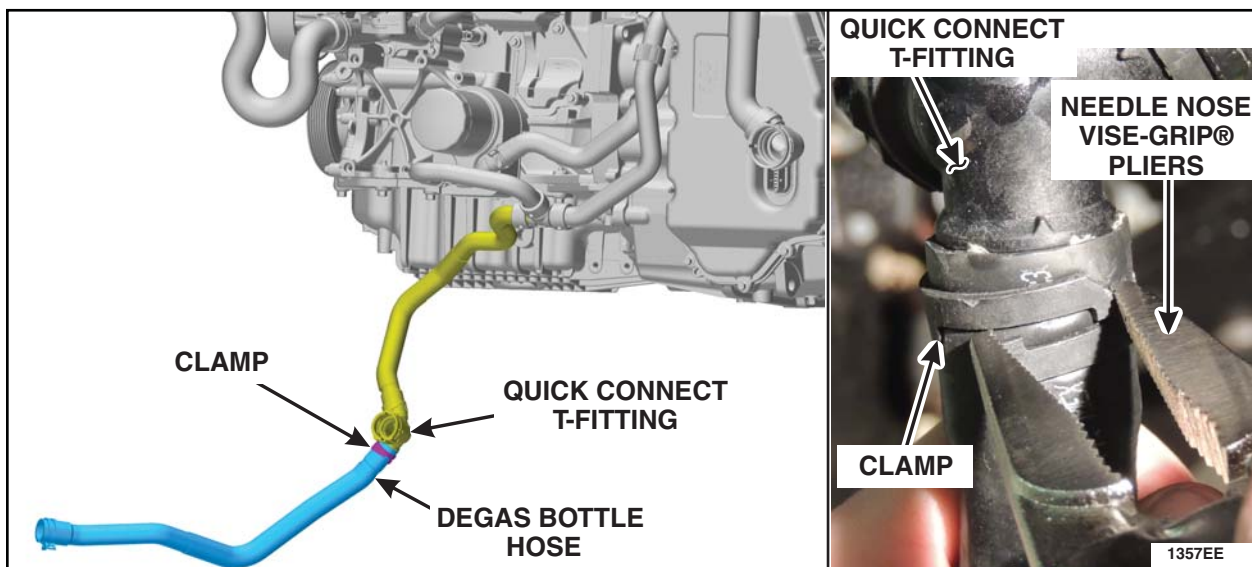
FIGURE I2

3. Position the degas bottle hose downward out the bottom of the engine compartment. See Figure I2.
 4. Use a pair of needle nose VISE-GRIP® pliers to compress the degas bottle hose clamp and slide the clamp downward off of the quick connect T-fitting. See Figure I2.
- Space the needle nose VISE-GRIP® plier teeth 6.35 mm (0.25 in) apart when closed so that they will fully compress the hose clamp when locked, to allow the clamp to be slid down the hose for hose removal.
