ALL 2013 MODEL YEAR ESCAPE VEHICLES EQUIPPED WITH A 1.6L ENGINE — RISK OF OVERHEATING THAT MAY RESULT IN ENGINE FIRES

Safety Recall 13S12 applies to 2013 Model Year Escape models equipped with a 1.6L engine due to potential localized overheating of the engine cylinder head. The localized overheating may cause the engine cylinder head to crack, causing an oil leak that may result in a fire in the engine compartment. Repairs include enhancements to the engine shielding system, engine cooling system, and engine control systems. Additionally, some vehicles have been observed with an engine oil overfill condition that occurred during service when the oil capacity was not properly identified. An improved dip stick and label will be added to facilitate proper maintenance and improve customer satisfaction.

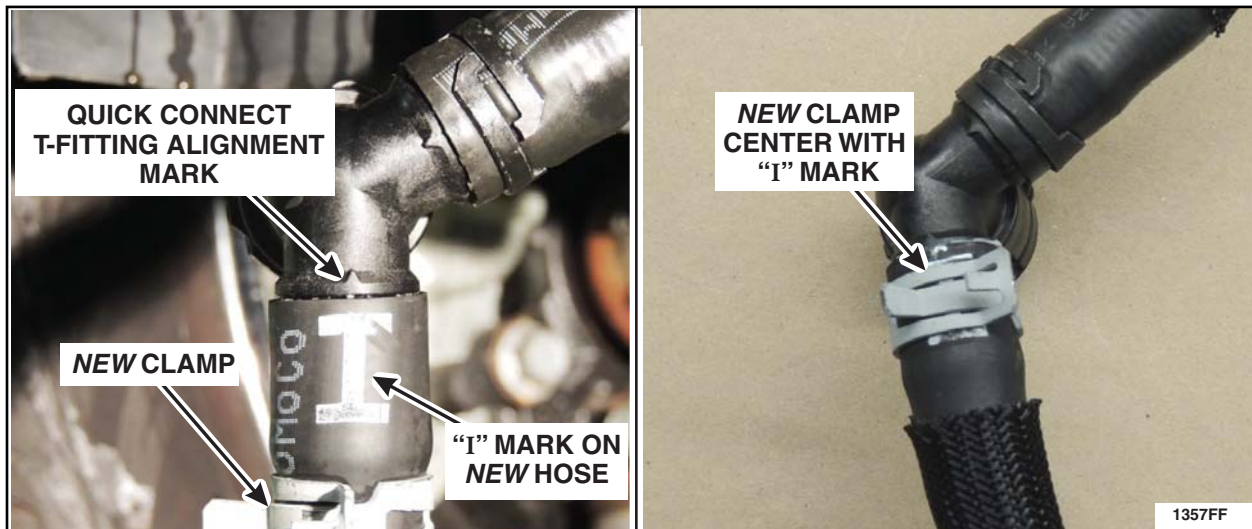
FIGURE I3

6. Position a *new* clamp onto the longer section of the *new* degas bottle hose and install the hose onto the quick connect T-fitting. Ensure the "I" mark on the *new* degas bottle hose is aligned with the alignment mark on the quick connect T-fitting. Also align the clamp center with the "I" mark. See Figure I3.

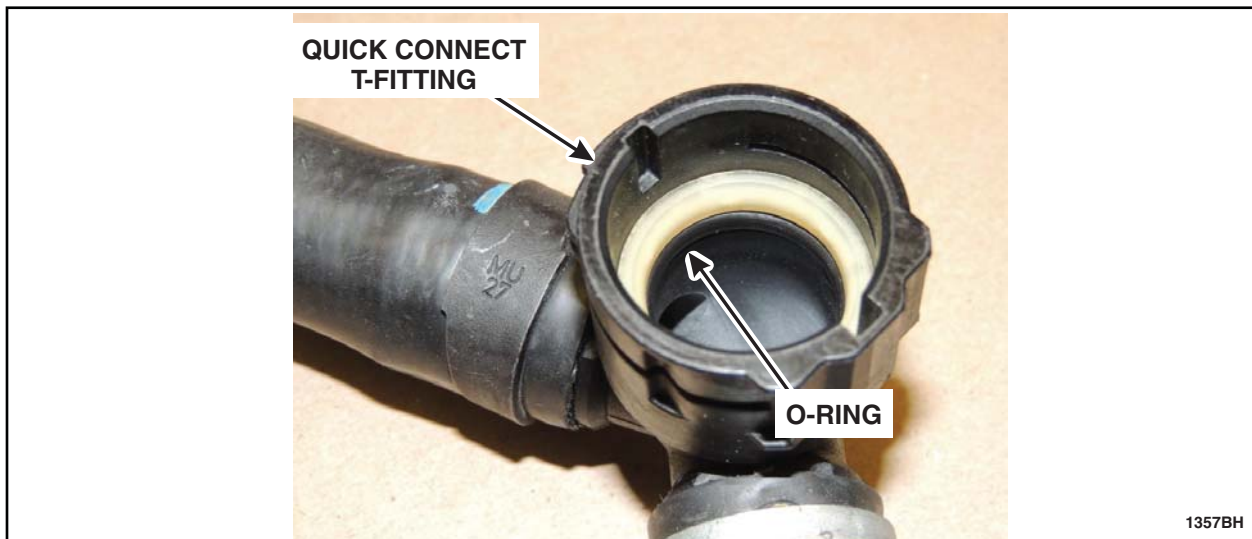
FIGURE I4

7. Remove and discard the o-ring inside the quick connect T-fitting. See Figure I4.

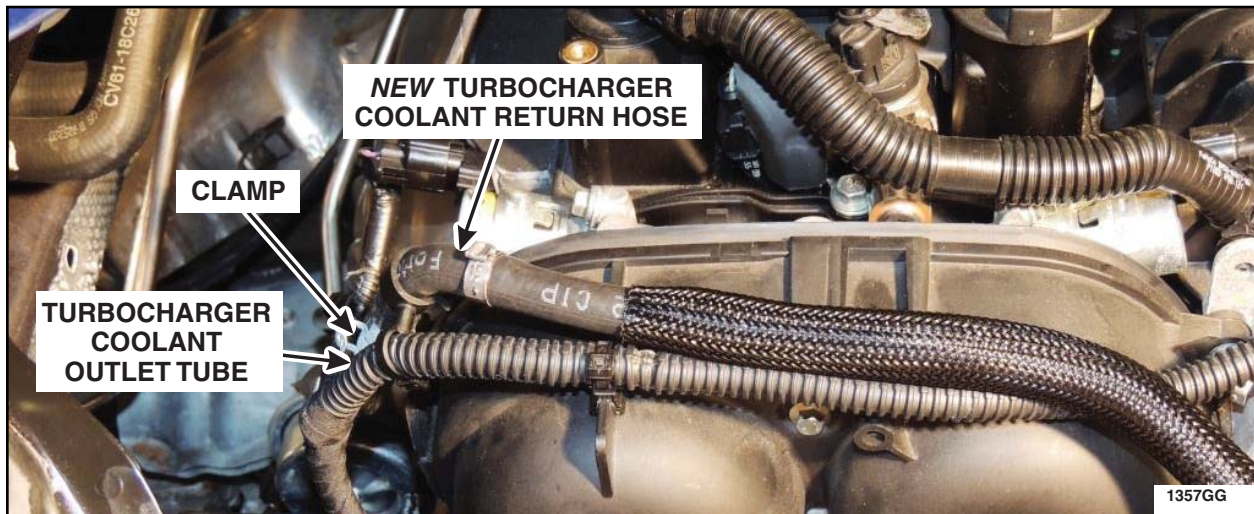
FIGURE I6

13. Connect the *new* turbocharger coolant return hose to the turbocharger coolant outlet tube and release the clamp. Attach the wire harness retainer to the *new* turbocharger coolant return hose. See Figure I6.

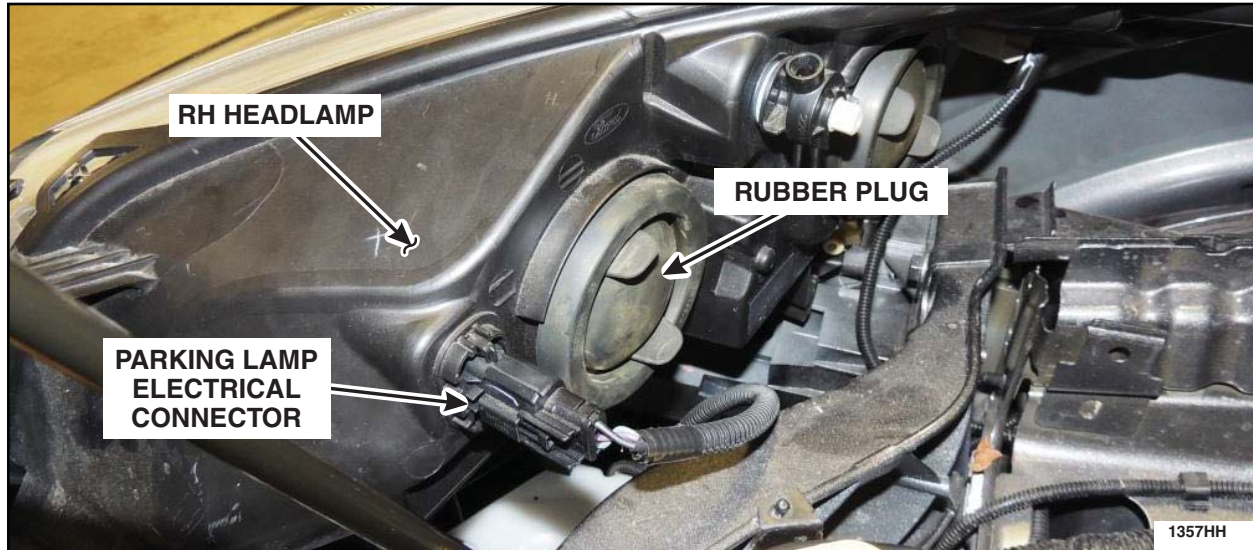
FIGURE J1

1. Disconnect the parking lamp electrical connector at the RH headlamp. See Figure J1.
2. Remove the rubber plug from the RH headlamp. See Figure J1.

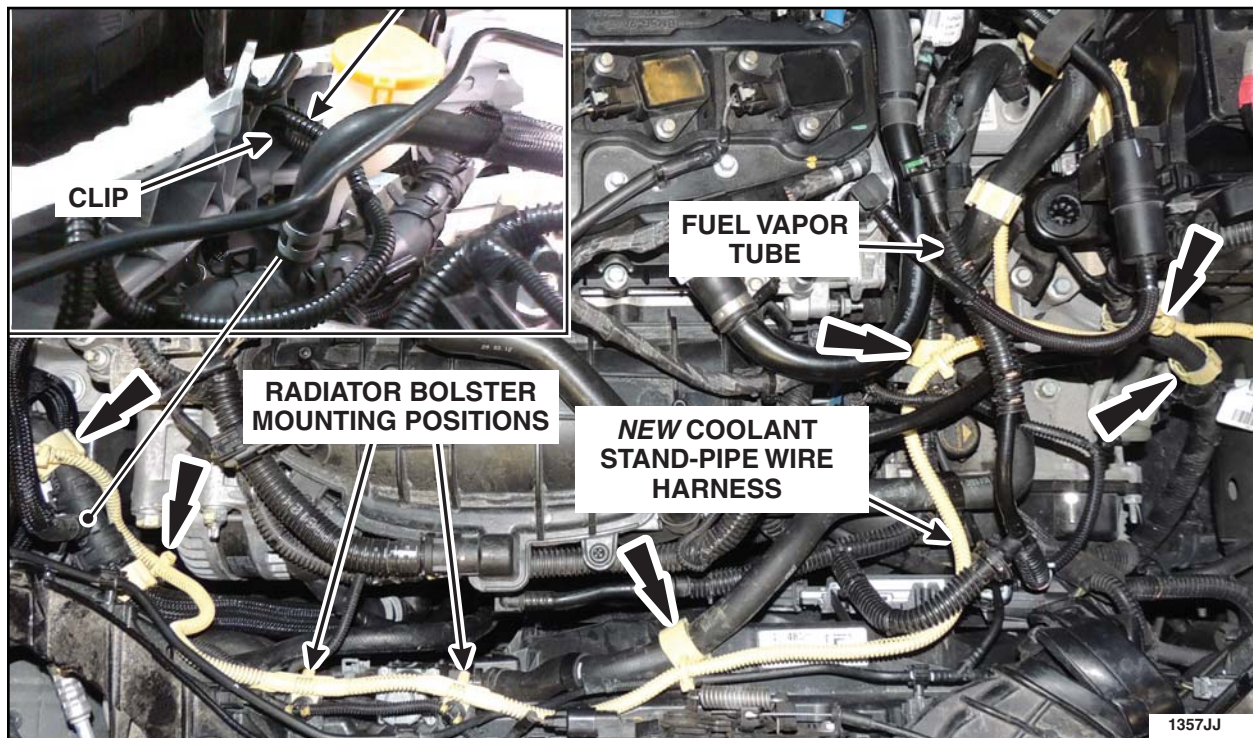
FIGURE J3

5. Route and secure the *new* coolant stand-pipe wire harness along the front of the engine and radiator bolster. See Figure J3.
 - a. Route the coolant stand-pipe wire harness **under the fuel vapor tube**.
 - b. For vehicles equipped with an anti-theft hood switch, release the two (2) anti-theft hood switch wire harness retainers at the right front radiator bolster. If damaged replace the two wire harness retainers with the two (2) wire harness retainers supplied in the vehicle parts kit. Secure the coolant stand-pipe harness retainers in the radiator bolster mounting positions and then re-secure the anti-theft hood switch harness to the mounting positions in the *new* harness.
 - c. For vehicles **not** equipped with an anti-theft hood switch, secure the coolant stand-pipe harness retainers in the unused radiator bolster mounting positions.

NOTE: The *new* coolant stand-pipe wire harness is highlighted to show routing and connection points.

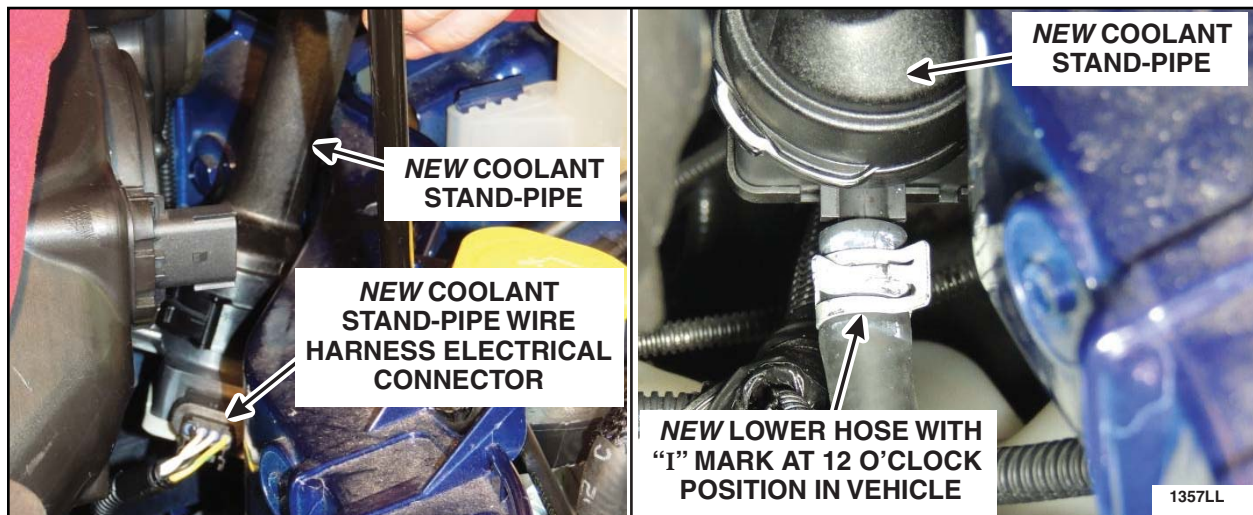
FIGURE J4

6. Connect the *new* coolant stand-pipe wire harness electrical connector to the *new* coolant stand-pipe. See Figure J4.
7. Install the *new* clamp onto the *new* lower hose. Align and connect the *new* lower hose from the previously installed *new* coolant hose assembly to the lower port on the *new* coolant stand-pipe. See Figures J4 and J5.
 - Route the lower hose between the A/C lines and to the *new* coolant stand-pipe. See Figure J5.
 - Ensure the "I" mark on the *new* lower hose is in the 12 o'clock position. See Figure J4.
 - The *new* clamp, when installed, should also be aligned with the "I" mark, in the 12 o'clock position. See Figure J4.

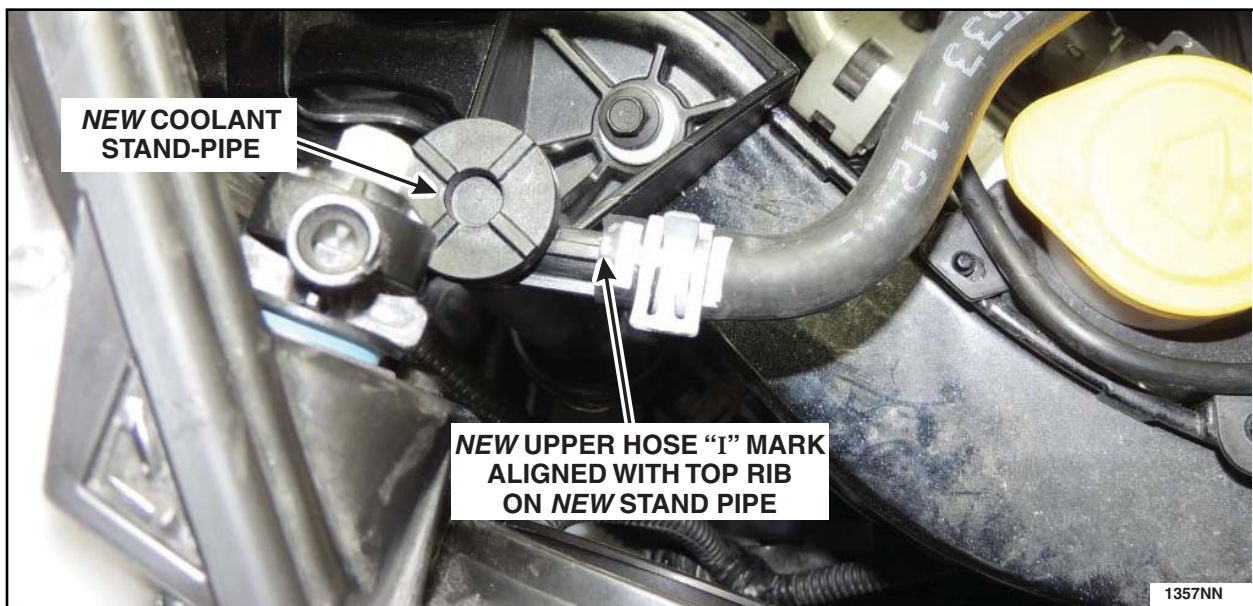
FIGURE J7

- Ensure the "I" mark on the *new* upper hose is in the 12 o'clock position, aligned with top rib of stand-pipe top port. See Figure J7.
- The *new* clamp when installed should also be aligned with the "I" mark in the 12 o'clock position. See Figure J7.

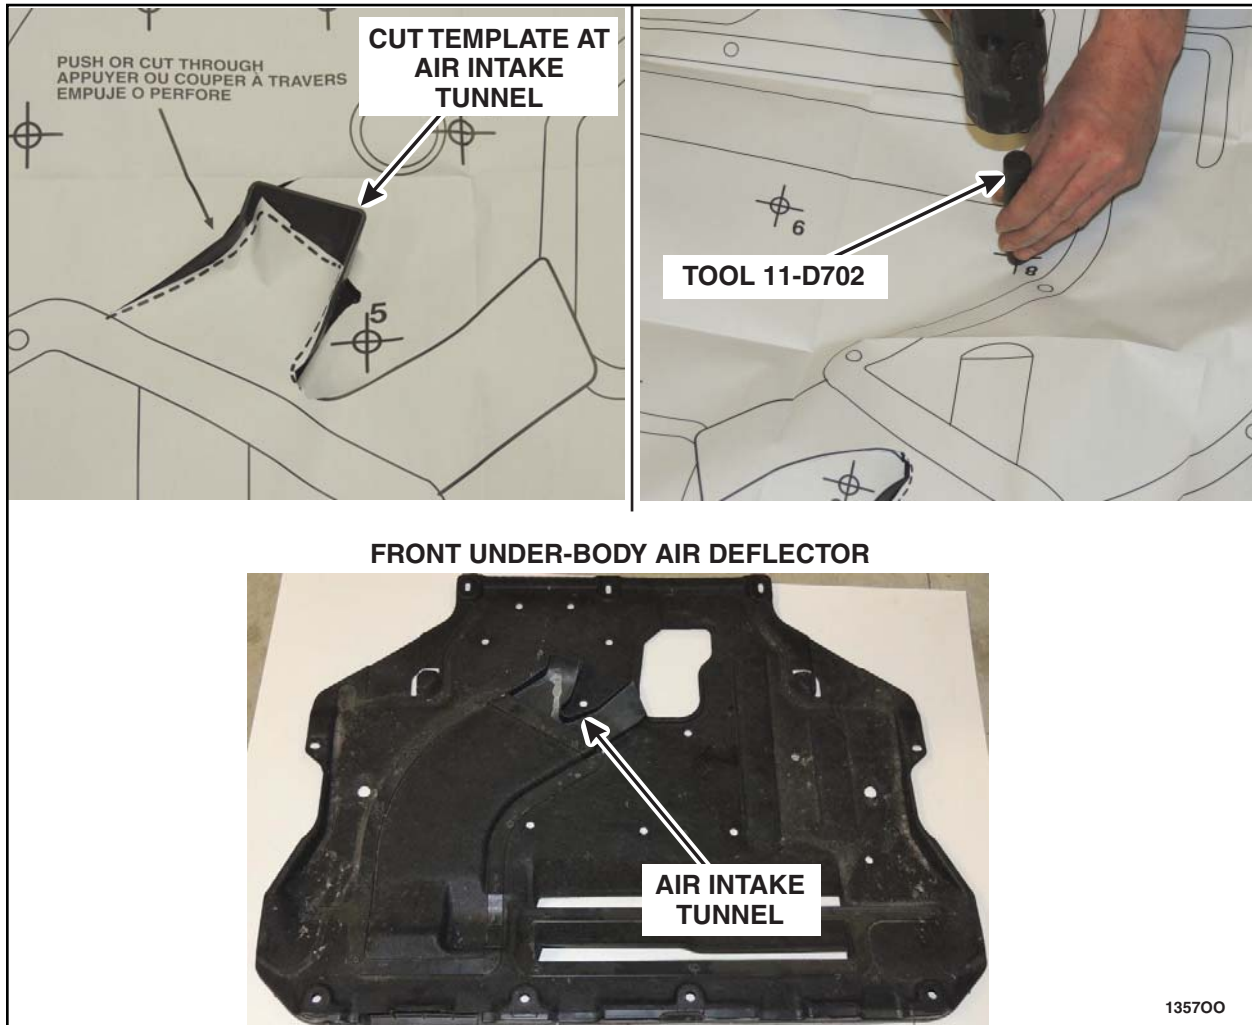
FIGURE K1

1. Place hole punch template included in the kit over the engine side of the front under-body air deflector. Align the two mounting holes identified on the template with the two corresponding holes on the air deflector. See Figure K1.

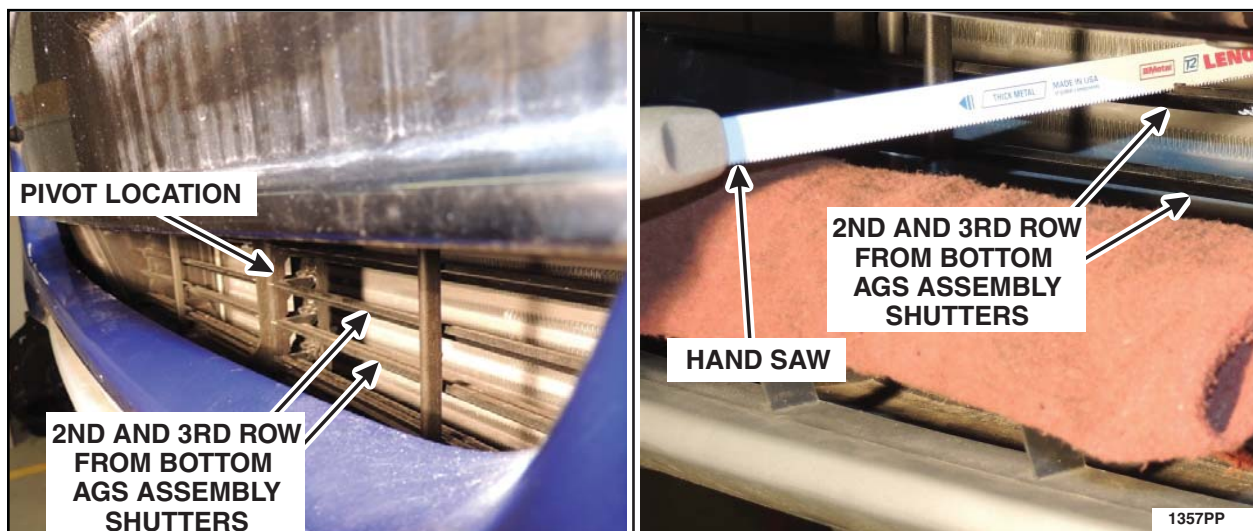
FIGURE L1

1. Locate the shutters in the 2nd and 3rd positions from the bottom of the lower AGS assembly through the lower front bumper grille opening. See Figure L1.

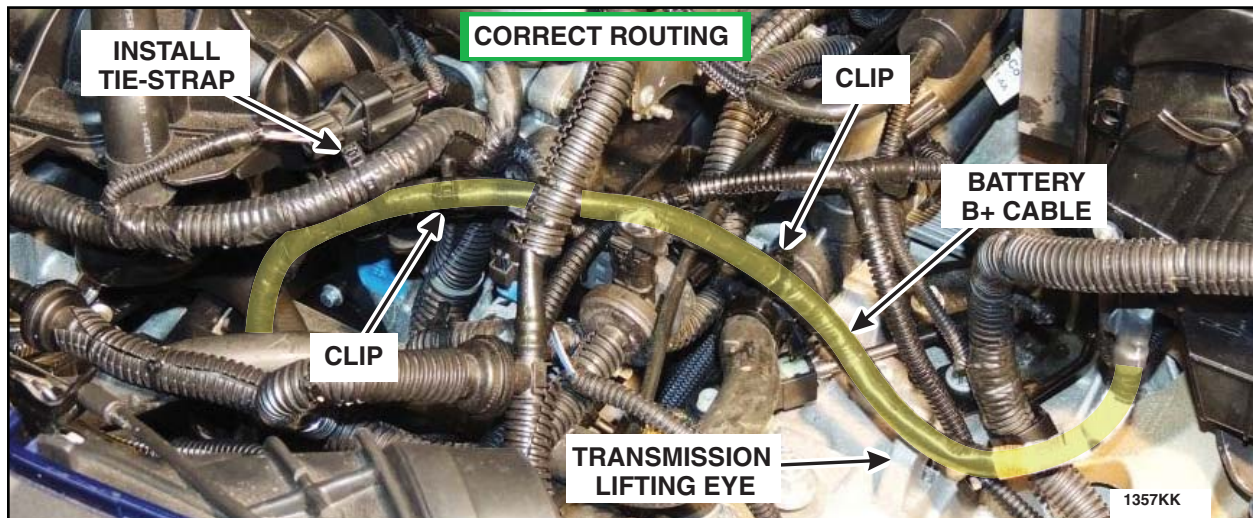
FIGURE M1

1. Inspect the battery B+ terminal cable for improper routing and/or any signs of wire and insulation damage. See Figure M1.

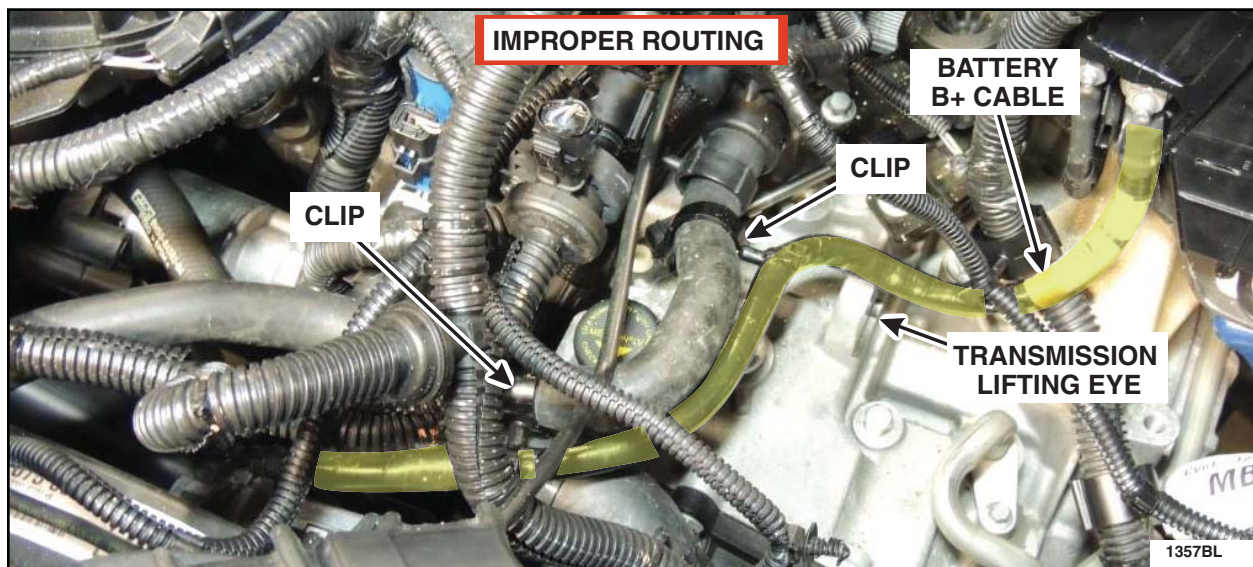
FIGURE M2

- If the battery cable is damaged, replace it prior to proceeding.
- A **properly routed** cable can be identified by having the cable routed from the generator across the front of the engine and with the cable secured to the main engine wiring harness with a zip tie near the forward left side of the intake manifold. See Figure M1.
- An **improperly routed** cable can be identified by the cable being routed forward of the engine near the radiator, and is not attached to the main engine wiring harness with a zip tie. See Figure M2.

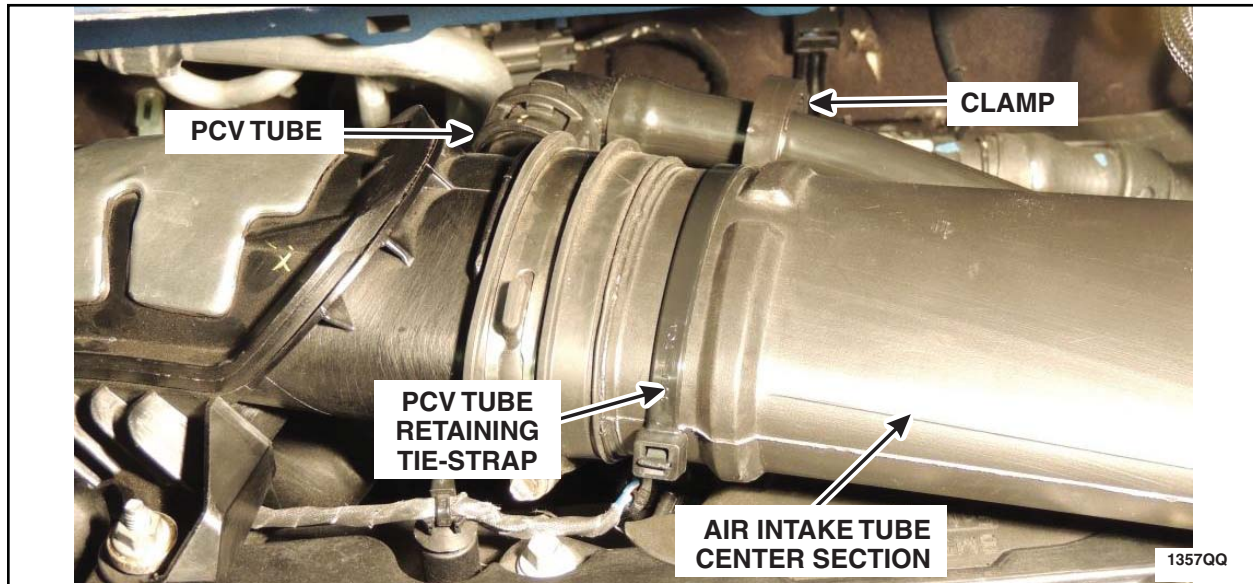
FIGURE N1

8. Install the PCV tube retainer / tie strap provided in the vehicle parts kit. See Figure N1.
 - a. Attach the clamp onto the PCV tube and secure.
 - b. Wrap the tie strap around the air intake tube center section and tighten.
 - c. Trim the excess length from the tie strap.

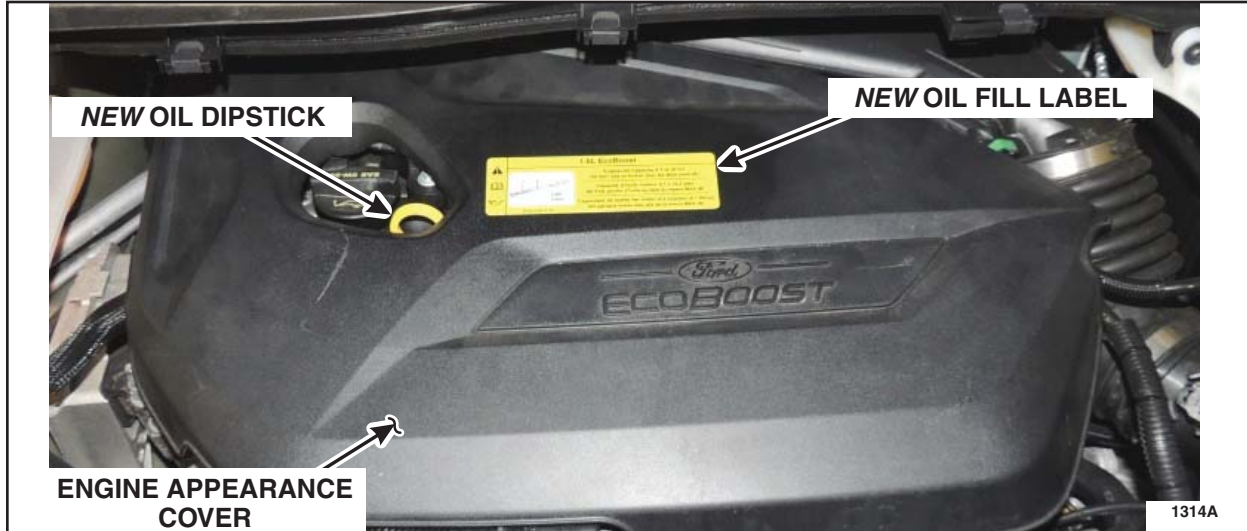
FIGURE N3

17. Install the *new* engine oil fill label onto the engine appearance cover as shown. See Figure N3.

18. Replace the vehicle's engine oil dipstick with the *new* engine oil dipstick. See Figure N3.
