Published January 27, 2016

Subject: Safety Recall E02 (Interim E12)– **Remedy Notice**
Certain 2005-2011 Model Year Tacoma Pre-Runner and 4x4 Vehicles
Rear Leaf Spring

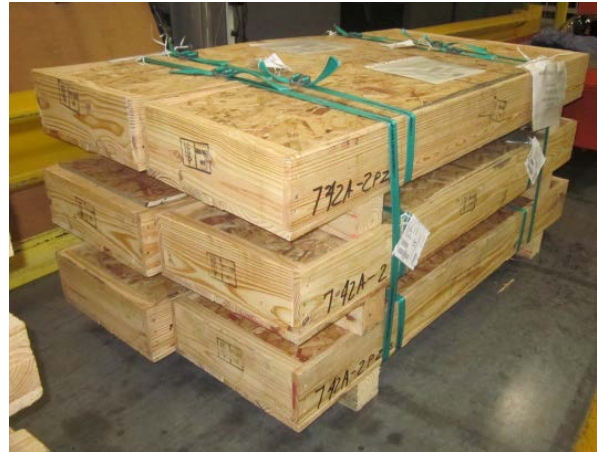
The leaf spring kits for this campaign are large and heavy, please take note of the following weight and dimension specs when preparing your parts department for receiving these campaign parts.

Individual Leaf Spring Kits:

- Weight 142 lbs
- 61" x 16" x 9.5"

Bulk Leaf Spring Kit Packaging:

- Banded in Sets of 6
- Weight 852 lbs
- Dimension 61" x 32" x 28.5"
