## IMPORTANT SAFETY RECALL

RE: Safety Recall 14V- 478

<p> <input checked="" type="checkbox"/> Safety Recall  <input type="checkbox"/> Field Campaign  <input type="checkbox"/> Service Information  <input type="checkbox"/> Product Improvement </p>	<p align="center"> <b><u>FIELD SERVICE BULLETIN</u></b>   <b><u>All Models</u></b>   <b><u>Passenger Seat Securement</u></b> </p>	<p> <b>FSB_2014-107</b>  <b>Revision: 0</b>  <b>Issue Date: 11/26/14</b>  <b>Manual Section: N/A</b>  <b>Author: JNaracon</b>  <b>Approval: RP</b>  <b>Form Rev. D 11/21/14</b> </p>
---	---	--

**DESCRIPTION:** Spring Nuts used in seat securement did not pass durability testing.

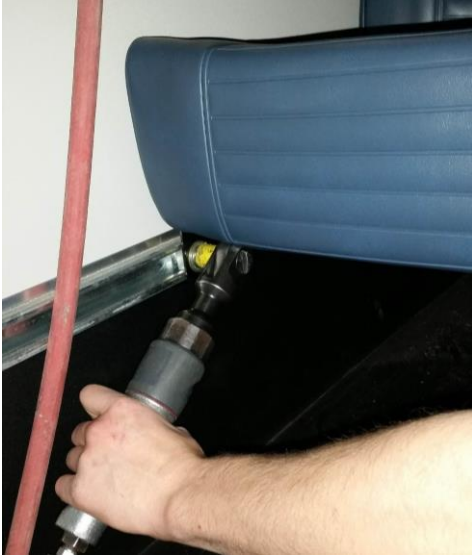
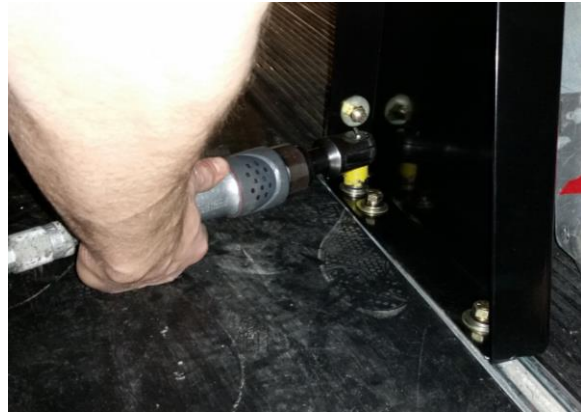
- 1.) Remove (6) bolts retaining seats (4) from floor, (2) from wall.

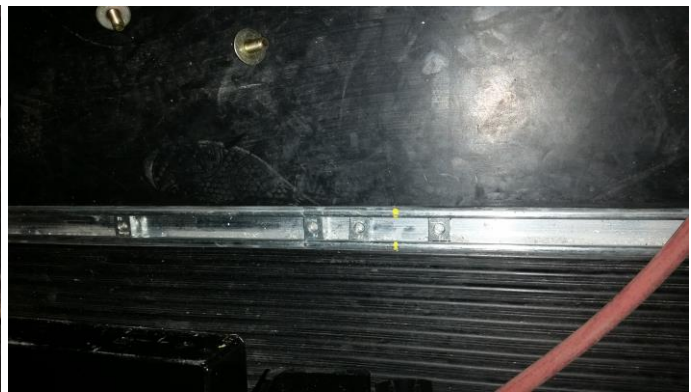
- 2.) Compress and twist (6) spring nuts out of seat track.
