Recall Information Bulletin

No: C1006610 **Issued:** 2/13/2014

Re: DUONIC ATF Contamination

Safety Recall C1006610 – DUONIC ATF Contamination

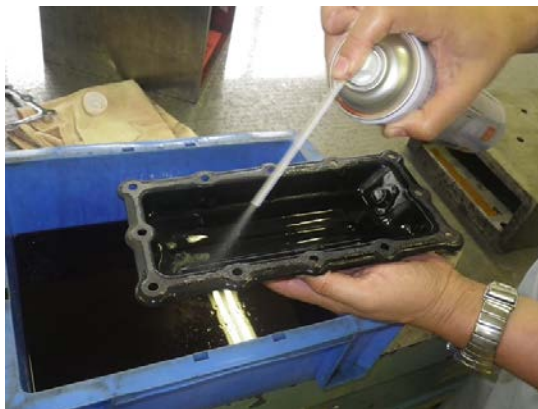
2. Remove and clean the oil pan

Remove ATF and contaminants from the oil pan using parts cleaner.
