Remedy Instructions

NHTSA RECALL NUMBER: 14V-097

SUBJECT: Landi Renzo USA determined a defect relating to the left and right rear side arm brackets that support the rear CNG cylinder cradle assembly.

How to replace 1001034 & 1001035 Side Arm Brackets

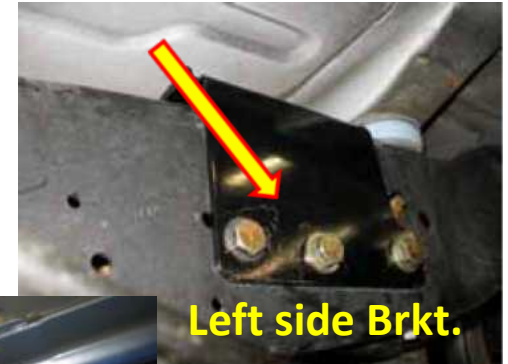
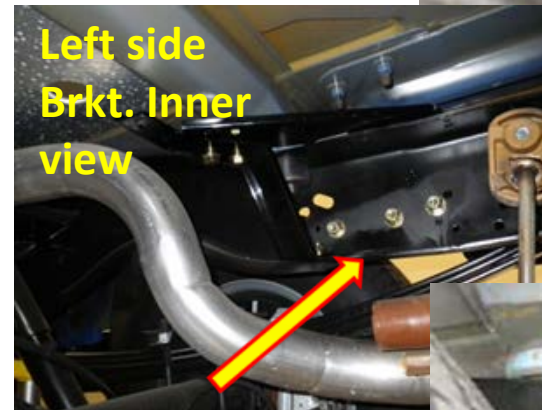
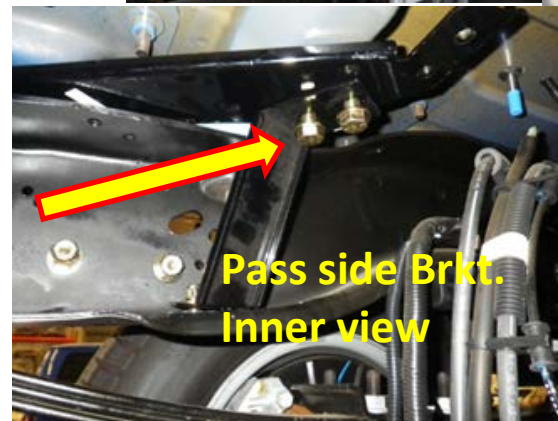
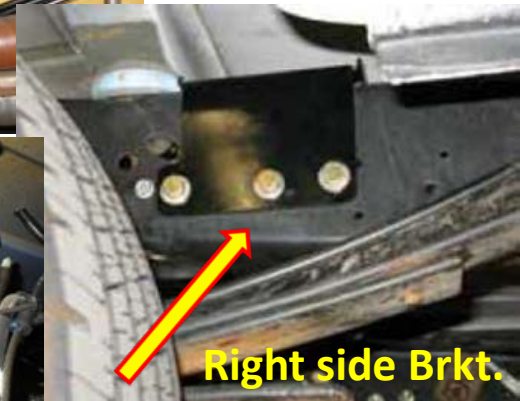
CONDITION: Due to excessive wear and tear, the ears of the brackets could develop cracks and eventually break.

1. Inspect complete rear structure for any and all structural integrity. Take photos of any structural damage and submit to Landi Renzo Service Department. **If any structural damage is found on rear assembly notify Landi Renzo immediately.**
2. Remove (6) 1000167 Bolt, Hex, Gr8, 1/2 "-13X1-3/4" w/ (12) 1000164 Washer, Flat, gr8, 1/2" & (6) 1000143 Nut, Lock, Nylon, gr8, 1/2"-13
3. Remove (8) 1000159 Hex, Bolt, 1/2"X1" & (8) 1000164 Flat, washer, 1/2"
4. Remove both side arm rear brackets, 1001034 & 1001035.
