January 15, 2016

03086 Version 4

Safety Recall: Odyssey Fuel PumpSupersedes 14-032, dated July 25, 2014, to revise the information highlighted in **yellow**.**AFFECTED VEHICLES**

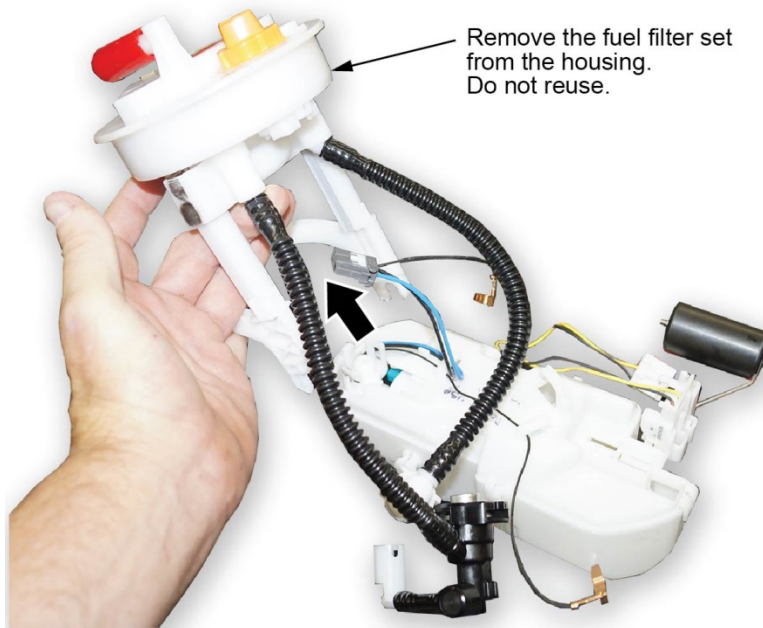
12. Remove the corrugated line connector from the fuel pump housing.
13. Disconnect the three wire harness connectors from the fuel filter set.
14. Remove the original fuel filter set from the fuel pump housing.
