# After-sales Retailer Support

## 2014 QX80 Certification Label Voluntary Recall Campaign

Reference: R1403

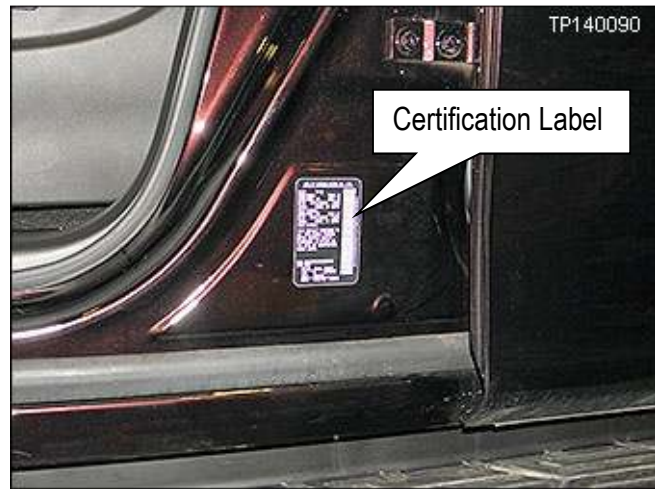
Figure 1

3. Locate the existing certification label (see Figure 1).

**NOTE:** The certification label has the VIN on it.

7. Peel the new label from the backing sheet and affix it directly over the top of the existing label.

**NOTE:** The adhesive on the label is permanent. Extra care should be taken when applying the new label since it can not be moved once it is attached.
