Safety Notice

SN-610-14

Models Affected: TL37M, TL41M, TL42M, TL45M aerials installed on 84" CA Ford F550 trucks

SUBJECT: *Ford F550 Frame Cracks*

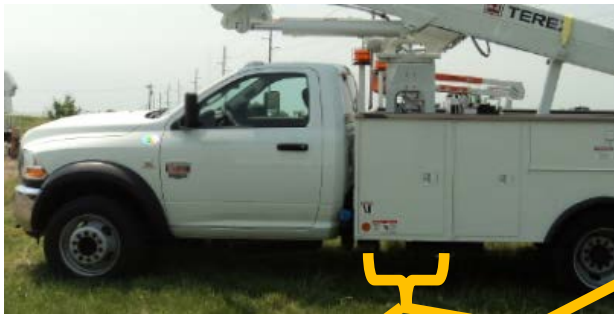
Inspect behind the cab on both sides in this area of truck frame and cross brace. At area of notch, rivets, and holes in bottom flange and sides.

1. **If cracks are detected do not operate the unit, take it out of service immediately.** Contact your local Terex dealer or TEREX Utilities at 605-882-4000, or email machine information to utilities.warranty@terex.com to arrange repair before further use.
2. If no cracks are detected you may continue to use the unit provided the Truck frame is inspected, using this bulletin as guidance, weekly until reinforcement can be added. Contact your local Terex dealer or TEREX Utilities at 605-882-4000 or email machine information to utilities.warranty@terex.com to schedule an appointment for reinforcement within 45 days.

- The repair for cracked frames will consist of reinforcing the frame and extending the aerial attachment past the repaired area to under the truck cab.
- Frames that are not cracked will be reinforced as needed.

There are two kits available; Z1286 is used to repair the frame if it is cracked while Z1220 will be used to reinforce the frame if it is not cracked.

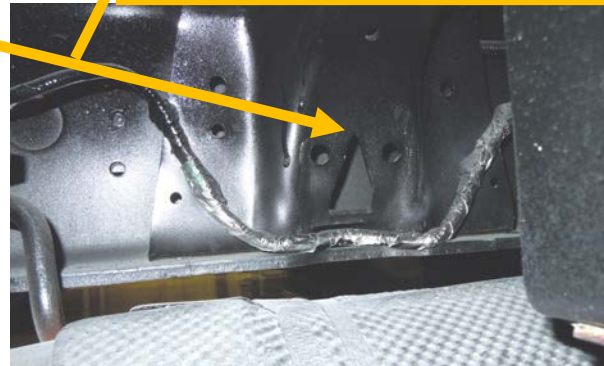
View of cross brace inside frame

Inspect cross brace on both sides inside the frame rails.
