**September 12, 2014**

ATB 51968-52554 REV1 (1409)

## Recall: Front Passenger's Airbag Inflator May Produce Excessive Pressure After Long-Term Exposure To High Absolute Humidity

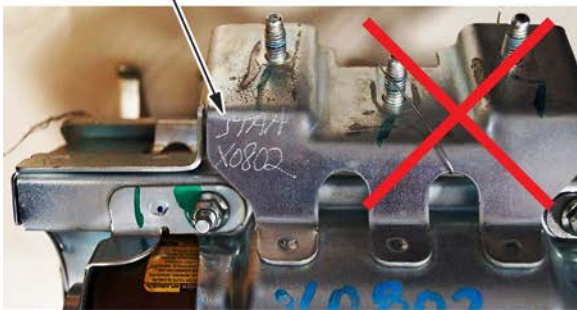
HAND ENGRAVING

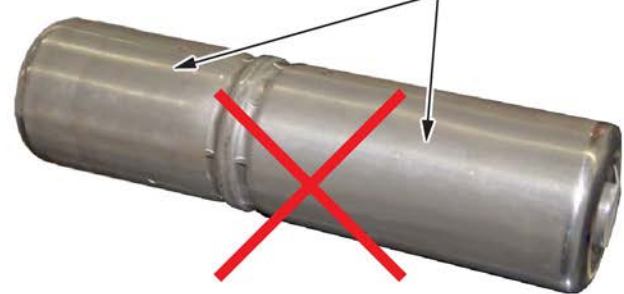
NO LABELS ON INFLATOR
