ATB 51968-00411 REV3 (1411)

## **Recall: Front Passenger's Airbag Inflator May Produce Excessive Pressure After Long-Term Exposure To High Absolute Humidity**

**Supersedes 14-046, dated October 31, 2014 to revise the information highlighted in yellow**

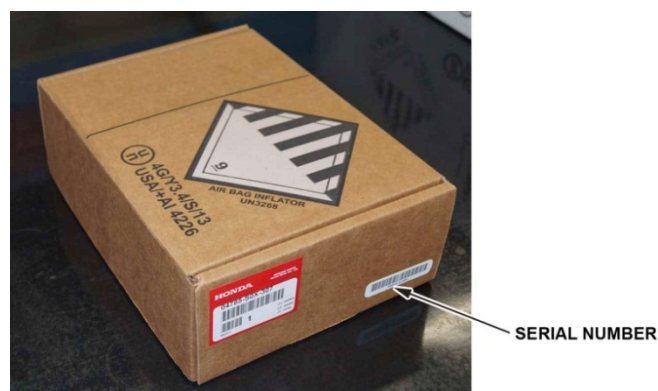
- If the VIN status inquiry indicates that the vehicle is subject to any open safety recalls, including the driver's airbag inflator, make sure to also complete those recall repairs before returning the vehicle to the customer. If you are unable to complete any open recall, advise the customer of the recall status and when the recall could be completed.
  - Be careful not to damage any parts when replacing the inflator, and follow the procedure exactly.
  - If, before removing the airbag, you suspect that it may be the incorrect airbag for the vehicle or a counterfeit, **do not remove the airbag**. Contact your DPSM for assistance.
1. Write down the serial number located on the right side of the new inflator box. For the warranty claim to be paid, your warranty clerk must enter this serial number in the Diagnostic Trouble Codes field on the warranty claim.

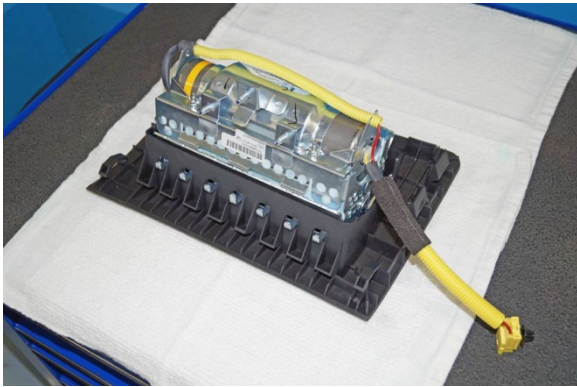
2. Remove the front passenger's airbag.
3. Place the airbag, face-down, on a clean shop towel.

- The orientation of the airbag is critical because if the inflator is installed incorrectly, the harness will be too short when you reinstall the airbag.
- The brackets between the various models are similar but may differ from the example shown.

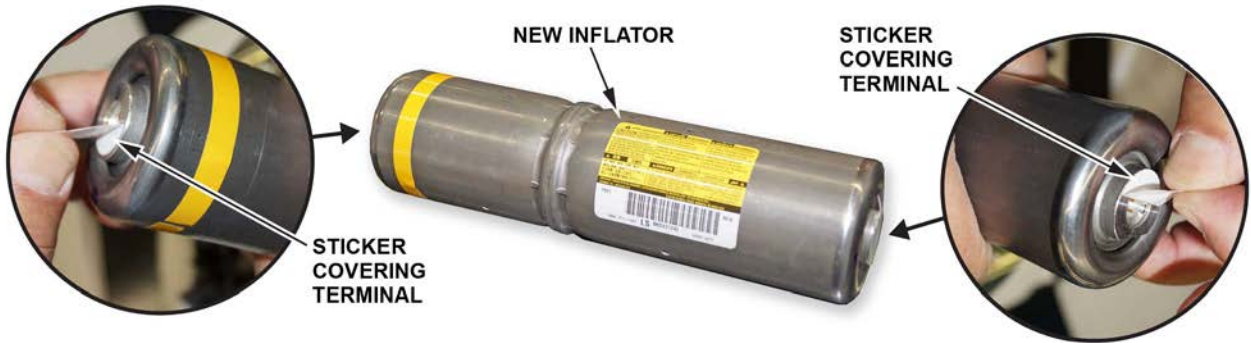
12. Remove the stickers covering the terminals on both sides of the new inflator.
