**April 24, 2015**

51968-01885 Version 7

## **Recall: Front Passenger's Airbag Inflator May Produce Excessive Pressure After Long-Term Exposure To High Absolute Humidity**

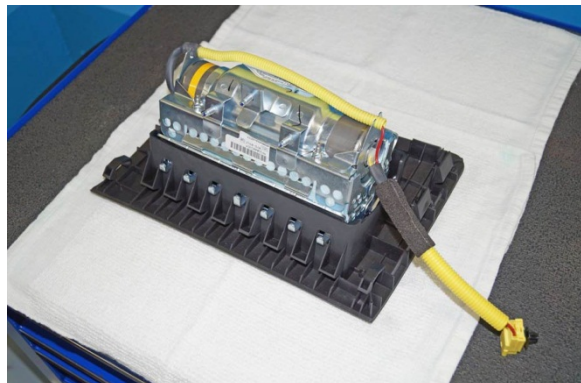
- The orientation of the airbag is critical because if the inflator is installed incorrectly, the harness will be too short when you reinstall the airbag.
- The brackets between the various models are similar but may differ from the example shown.

2. Remove the front passenger's airbag.
3. Place the airbag, face-down, on a clean shop towel.
