L9 SEAT BELT BUCKLE INSPECTION GUIDE

Follow these instructions to determine if your L9 seat belt buckle needs to be replaced.

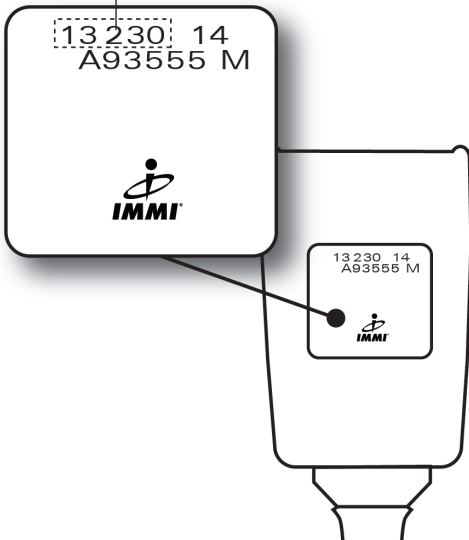
SALTILLO MEXICO

**Suspect code range is
13220 through 13256**

YEAR	DAY
13	230

13 230 14
A93555 M

- 5) If your buckle code is within either of the ranges above, replace your buckle with the substitute buckle.
- 6) If your code does **NOT** fall within either range, you do **NOT** need to replace your buckle.

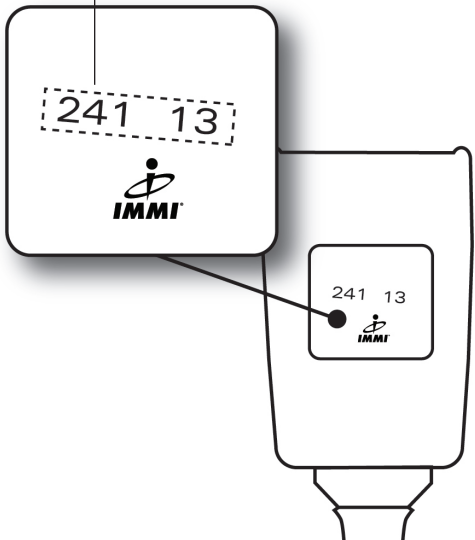
WESTFIELD, IN US

**Suspect code range is
214 13 through 256 13**

DAY	YEAR
241	13
